# Release Notes for Cisco Aironet 350, 1100, and 1200 Series Access Points for Cisco IOS Release 12.2(13)JA1

November 17, 2003

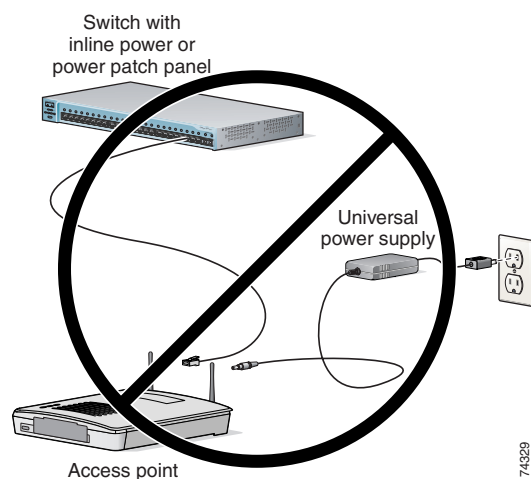
**Figure 1** Improper Power Configuration Using Two Power Sources

You cannot provide redundant power to 1100 and 1200 series access points with both DC power to its power port and inline power from a patch panel or powered switch to the access point's Ethernet port. If you apply power to the access point from both sources, the switch or power patch panel might shut down the port to which the access point is connected. [Figure 1](#) shows the power configuration that can shut down the port on the patch panel or powered switch.
