ASR 5000/5500 Series que resuelven problemas los asuntos relacionados del puerto/NPU

Introducción

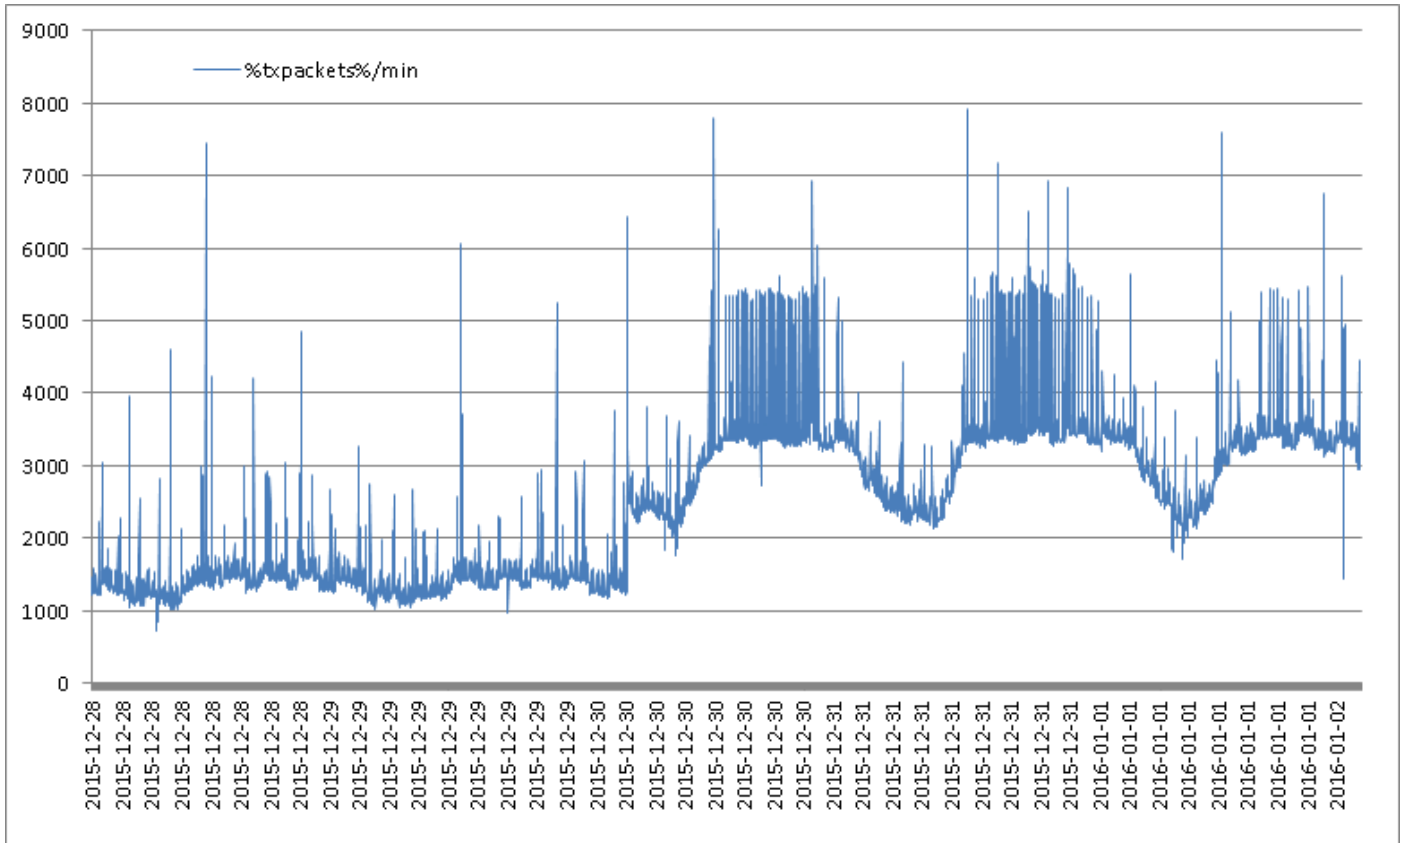
En este ejemplo, los boletos comenzaron a ser abiertos refiriéndose a un aumento en los contadores TX ERR en el puerto 5/1, el puerto de administración en ASR 5500. En un sitio, “no

fue notado” pues un problema hasta después de que una FREGONA fuera ejecutada que implementó la creación y la generación de archivos de registro del evento, una característica del servicio de carga Enhance. Ninguna correlación se podría hacer entre implementar esa característica y un aumento súbito en estos incidentes, excepto de observar que había también un aumento súbito en la producción para el puerto de administración, que debe llevar solamente el tráfico de administración en 12/30 cuando el cambio fue realizado. Aquí los txpackets variables del esquema PORTSch1 se representan gráficamente que muestran el aumento:
