Introducción

Comandos de Troubleshooting

Escenarios de Troubleshooting del ejemplo

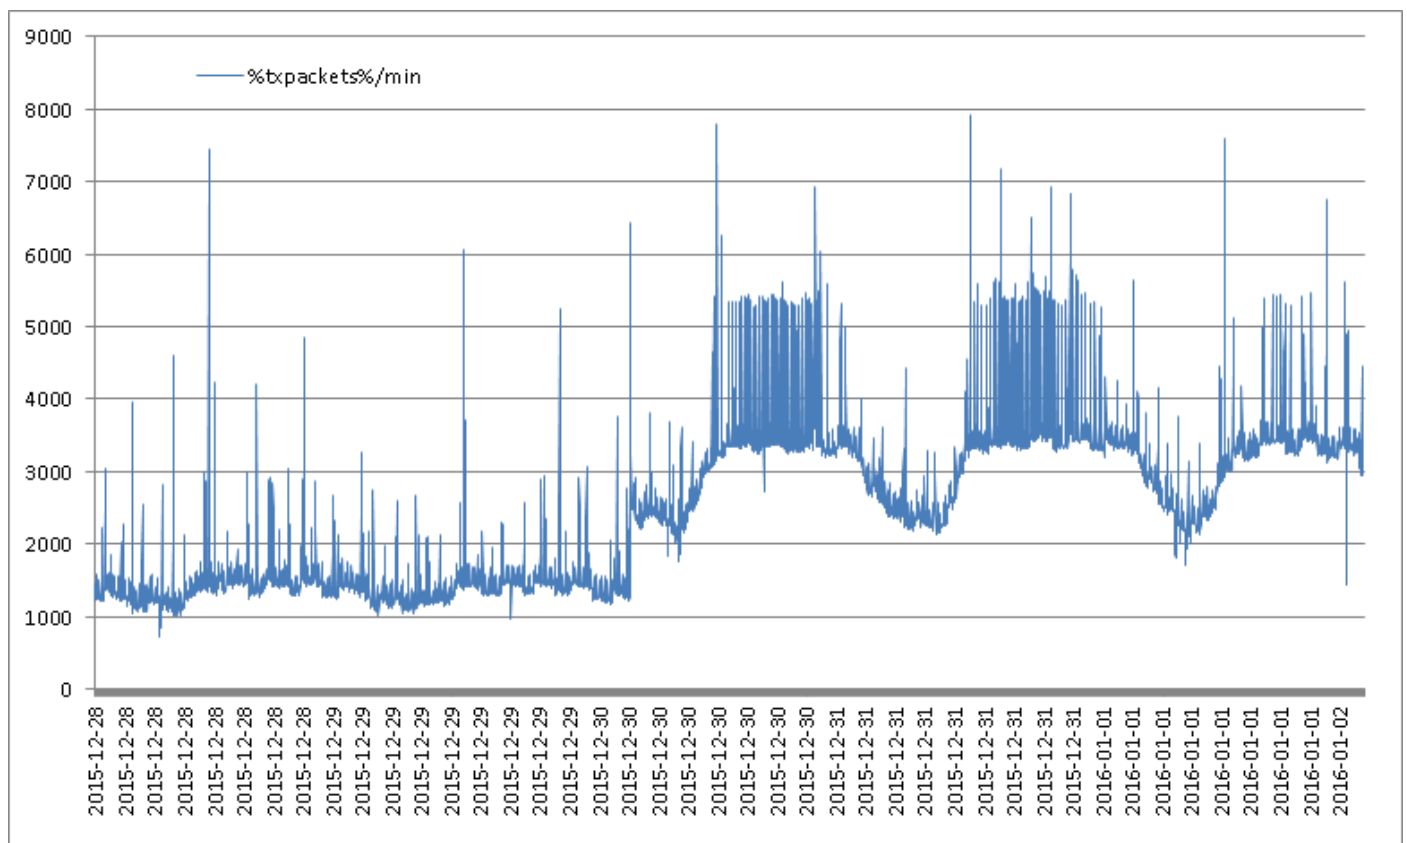
TX cada vez mayor ERR debido a las configuraciones de puerto unidas mal en el puerto de administración ASR 5500

En este ejemplo, los boletos comenzaron a ser abiertos refiriéndose a un aumento en los contadores TX ERR en el puerto 5/1, el puerto de administración en ASR 5500. En un sitio, “no fue notado” pues un problema hasta después de que una FREGONA fuera ejecutada que implementó la creación y la generación de archivos de registro del evento, una característica del servicio de carga Enhance. Ninguna correlación se podría hacer entre implementar esa característica y un aumento súbito en estos incidentes, excepto de observar que había también un aumento súbito en la producción para el puerto de administración, que debe llevar solamente el tráfico de administración en 12/30 cuando el cambio fue realizado. Aquí los txpackets variables del esquema PORTSch1 se representan gráficamente que muestran el aumento:

El problema resultó ser una discordancia en las configuraciones de puerto entre el ASR 5500 y el nuevo Switch con con los cuales conecta, el nexa 7000. El arreglo era fijar los puertos en los ambos extremos al automóvil negocia. El ASR 5500 fue fijado ya al auto, mientras que el nexa fue fijado manualmente a por completo - duplex. El arreglo:

Resulta que el problema ocurría a lo largo de pero nunca fue notado porque el único indicador era el contador TX ERR que no es algo que se puede medir con cualquier información automatizada puesto que no hay variables del bulkstat para cualquier cosa más allá de los contadores de puerto básicos (paquetes del Tx/Rx/bytes, etc.). Pero el problema fue exacerbado seriamente cuando la FREGONA fue funcionada con y puesto que los paquetes del Tx/Rx son capturados por Bulkstats y son KPI medido por el cliente, él entonces fue notado.

```
ASR 5500 (already set to this) port ethernet 5/1 medium speed 1000 duplex full no  
shutdown bind interface 5/1-MGMT local #exitNexus 7K (needed to be set to this)interface  
Ethernet152/1/11 description MGMT-PORT-5/01 switchport switchport access vlan 10 spanning-  
tree port type edge no snmp trap link-status no shutdown
```
