# ASR 5000/gamme 5500 dépannant les questions relatives du port/NPU

## Introduction

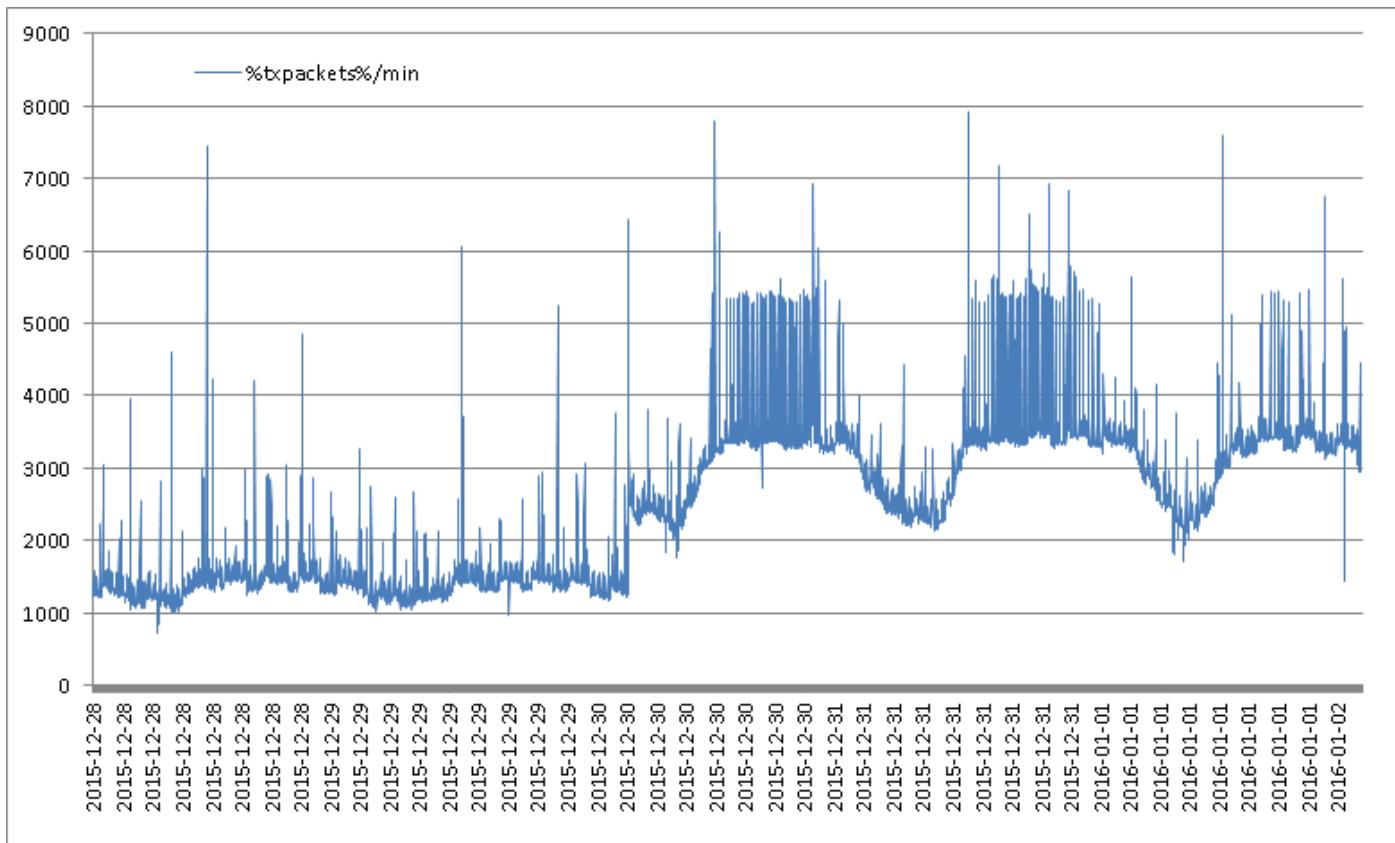
## TX croissants ERRENT en raison des configurations mal adaptées de port sur le port de gestion ASR 5500

Dans cet exemple, les tickets commencés pour être ouvert mettant en référence une augmentation de TX ERRENT des compteurs sur le port 5/1, le port de gestion sur ASR 5500. À un site, « on ne l'a pas noté » car un problème jusqu'après qu'un BALAI a été exécuté qui a mis en application la création et la génération des fichiers record d'événement, une caractéristique de service de remplissage Enhance. Aucune corrélation ne pourrait être faite entre mettre en application cette caractéristique et une augmentation soudaine de ces manques, excepté de noter qu'il y avait également une augmentation soudaine sur le débit pour le port de gestion, qui devrait seulement porter le trafic d'administration sur 12/30 quand la modification a été apportée. Ici des txpackets variables du schéma PORTSch1 est représentés graphiquement affichant l'augmentation :

Allant de retour à vieux SSDs (puisque seulement les compteurs de base sont dépistés par Bulkstats), il peut voir que l'erreur se produisait lentement jusqu'à 12/30, mais d'autre part après que l'exécution de BALAI, l'erreur se soit produite à beaucoup de débit supérieur :

```
***** show port info *****
Tuesday January 05 13:33:07 UTC 2016
Port: 5/1
  Port Type          : 1000 Ethernet
  Configured Duplex : Auto
  Configured Speed  : Auto
  Link State         : Up
  Link Duplex        : Half
  Link Speed         : 100 Mb
```

Issue fixed ...

```
port ethernet 5/1
  medium speed 1000 duplex full
  no shutdown
  bind interface 5/1-MGMT local
#exit
```
