Introduction

This article presents ideas on how to troubleshoot various port related issues ASR 5000 and 5500 platforms including issues related to the Network Processing Unit (NPU), and touches a bit on Link Aggregation (LAG) issues as well. These techniques are not rocket science and in fact are mostly known by engineers, but often one or more may be skipped over in the troubleshooting process simply due to oversight in the rush through the steps towards potential resolution. The article first starts off with the port related health checks. Then it lays out all the approaches in some kind of methodical order. Finally it offers a series of real examples that go beyond basic port troubleshooting for those who want to dig deep.

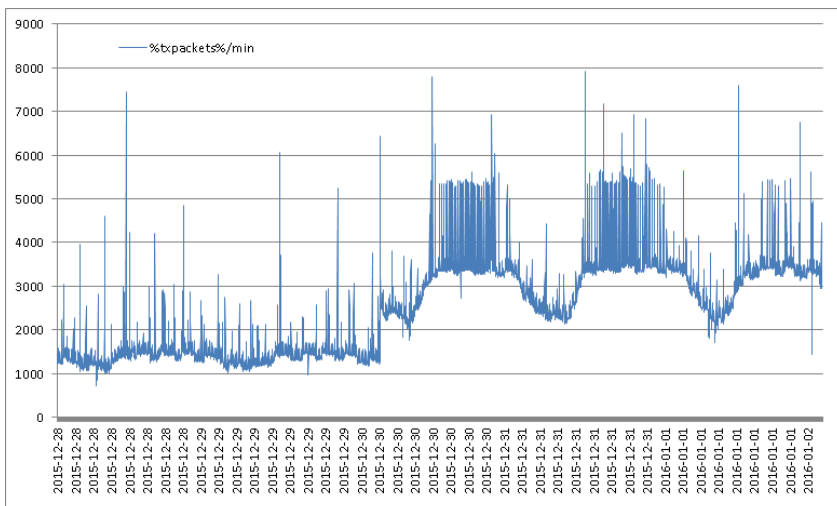
In this example, tickets started to be opened referencing an increase in TX ERR counters on port 5/1, the management port on ASR 5500. At one site, it wasn't "noticed" as a problem until after a MOP was executed that implemented the creation and generation of event record files, a feature of Enhance Charging Service. No correlation could be made between implementing that feature and a sudden increase in these failures, except to note that there was also a sudden increase on throughput for the management port, which should only carry management traffic on 12/30 when the change was made. Here variable txpackets from schema PORTSch1 is graphed showing the increase:

Going back to old SSDs (since only the basic counters are being tracked by Bulkstats), it can be seen that the error was happening slowly up to 12/30, but then after the MOP execution, the error was happening at a much higher rate:

The issue turned out to be a mismatch in the port settings between the ASR 5500 and the new switch to which it connects to, the Nexus 7000. The fix was to set ports on both ends to auto-negotiate. ASR 5500 was already set to auto, while the Nexus was set manually to full duplex. The fix:

It turns out that the issue was occurring all along but was never noticed because the only indicator was the TX ERR counter which is not something that can be measured through any automated reporting since there is no bulkstat variables for anything beyond the basic port counters (Tx/Rx packets/bytes, etc.). But the issue was severely exacerbated when the MOP was run and since Tx/Rx packets is captured by Bulkstats and is a KPI measured by the customer, it was then noticed.

```
port ethernet 5/1
  medium speed 1000 duplex full
  no shutdown
  bind interface 5/1-MGMT local
#exit
```

```
interface Ethernet152/1/11
  description MGMT-PORT-5/01
  switchport
  switchport access vlan 10
  spanning-tree port type edge
  no snmp trap link-status
  no shutdown
```
