ASR 5000/5500 Series que pesquisa defeitos problemas relacionados da porta/NPU

Introdução

Este artigo apresenta ideias em como pesquisar defeitos os vários problemas relacionados as Plataformas ASR 5000 e 5500 da porta que incluem as edições relativas à unidade de processamento da rede (NPU), e toca em um bit em edições da agregação do link (RETARDAÇÃO) também. Estas técnicas não são astronáutica e são sabidas de fato na maior parte por coordenadores, mas frequentemente uns ou vários podem ser saltados sobre no processo de Troubleshooting simplesmente devido ao descuido na precipitação com as etapas para a definição potencial. O artigo parte primeiramente com os exames médicos completos relativos porta. Então apresenta todas as aproximações em algum tipo da ordem metódica. Finalmente oferece uma série de exemplos reais que vão Troubleshooting da porta do além do básico para aquelas que querem escavar profundamente.

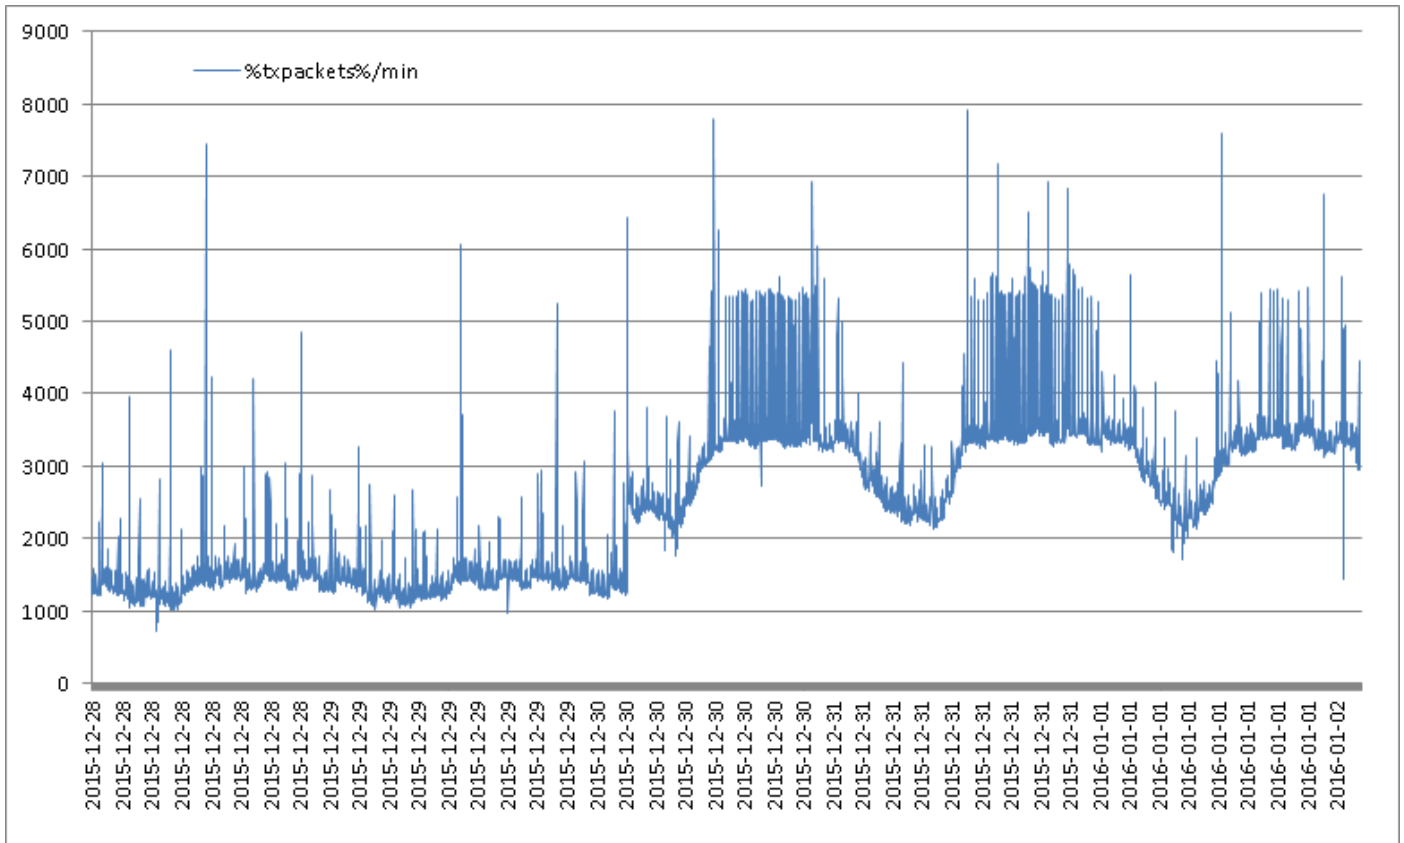
TX crescente ERR devido às configurações de porta combinadas mal na porta de gerenciamento ASR 5500

Neste exemplo, os bilhetes começaram ser abertos provendo um aumento em contadores TX ERR na porta 5/1, a porta de gerenciamento em ASR 5500. Em um local, “não se observou” porque um problema até depois um ESPANADOR foi executado que executasse a criação e a geração de arquivos de registro do evento, uma característica do serviço de carregamento Enhance. Nenhuma correlação poderia ser feita entre a aplicação dessa característica e de um aumento repentino nestas falhas, exceto notar que havia igualmente um aumento repentino na taxa de transferência para a porta de gerenciamento, que deve somente levar o tráfego de gerenciamento em 12/30 quando a mudança foi feita. Os txpackets variáveis do esquema PORTSch1 são representados graficamente aqui que mostram o aumento:

Indo para trás a SSDs velho (desde que somente os contadores básicos estão sendo seguidos por Bulkstats), pode-se ver que o erro estava acontecendo lentamente até 12/30, mas por outro lado depois que a execução do ESPANADOR, o erro estava acontecendo em uma taxa muito mais alta:

A edição despejou ser uma má combinação nas configurações de porta entre o ASR 5500 e o interruptor novo a que conecta, o nexo 7000. O reparo era ajustar portas no ambas as extremidades para negociar automaticamente. O ASR 5500 foi ajustado já ao automóvel, quando o nexo foi ajustado manualmente a completamente - duplex. O reparo:

```
ASR 5500 (already set to this)
port ethernet 5/1
  medium speed 1000 duplex full
  no shutdown
  bind interface 5/1-MGMT local
#exit
```

```
Nexus 7K (needed to be set to this)
interface Ethernet152/1/11
  description MGMT-PORT-5/01
  switchport
  switchport access vlan 10
  spanning-tree port type edge
  no snmp trap link-status
  no shutdown
```
