# 在Intersight管理模式下排除本徵VLAN問題

本檔案介紹Cisco Intersight管理模式環境中的本徵VLAN配置選項，突出顯示常見方案。

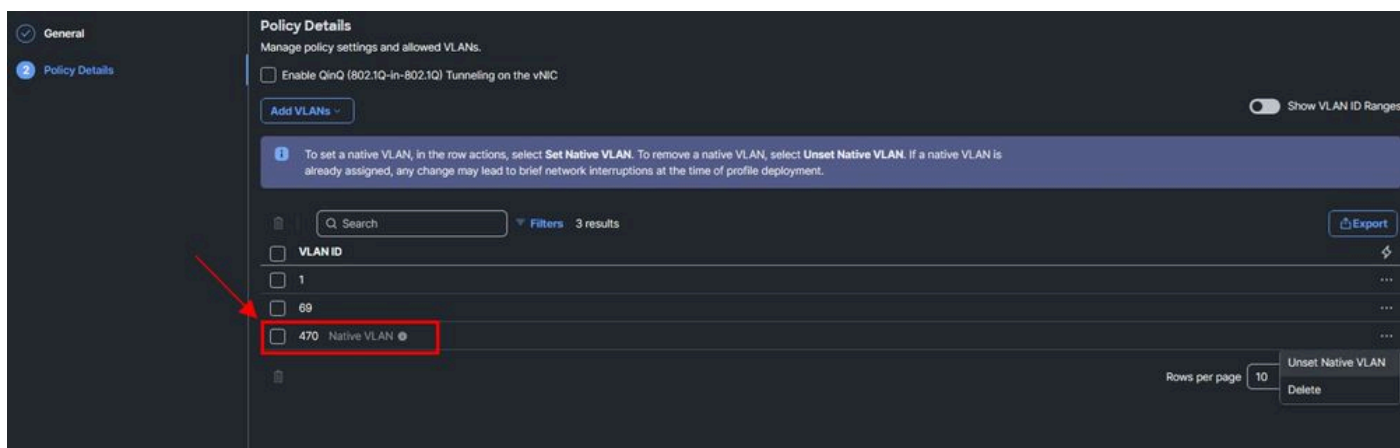
## 場景1.本徵VLAN配置在vNIC級別

如果在乙太網路組中將VLAN配置為Native，則可能會由於VLAN標籤問題而導致網路連線丟失。

- 乙太網路組中的配置：

附註：一旦從網路組中刪除本徵VLAN，連線就會恢復。

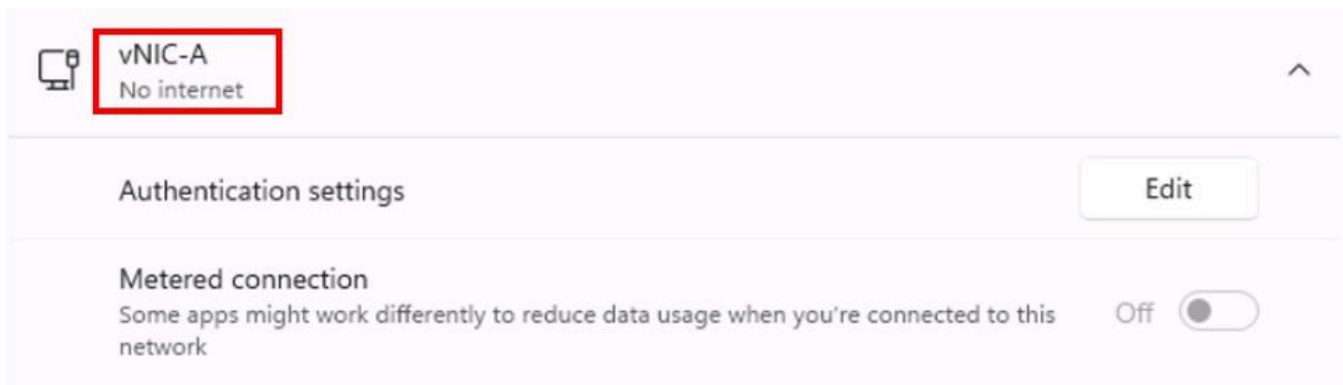
## 案例1.本徵VLAN在FI上行鏈路中配置，但未在vNIC中配置

在Windows中未連線使用的vNIC:

如果嘗試執行ping，則預期此操作無法正常工作。

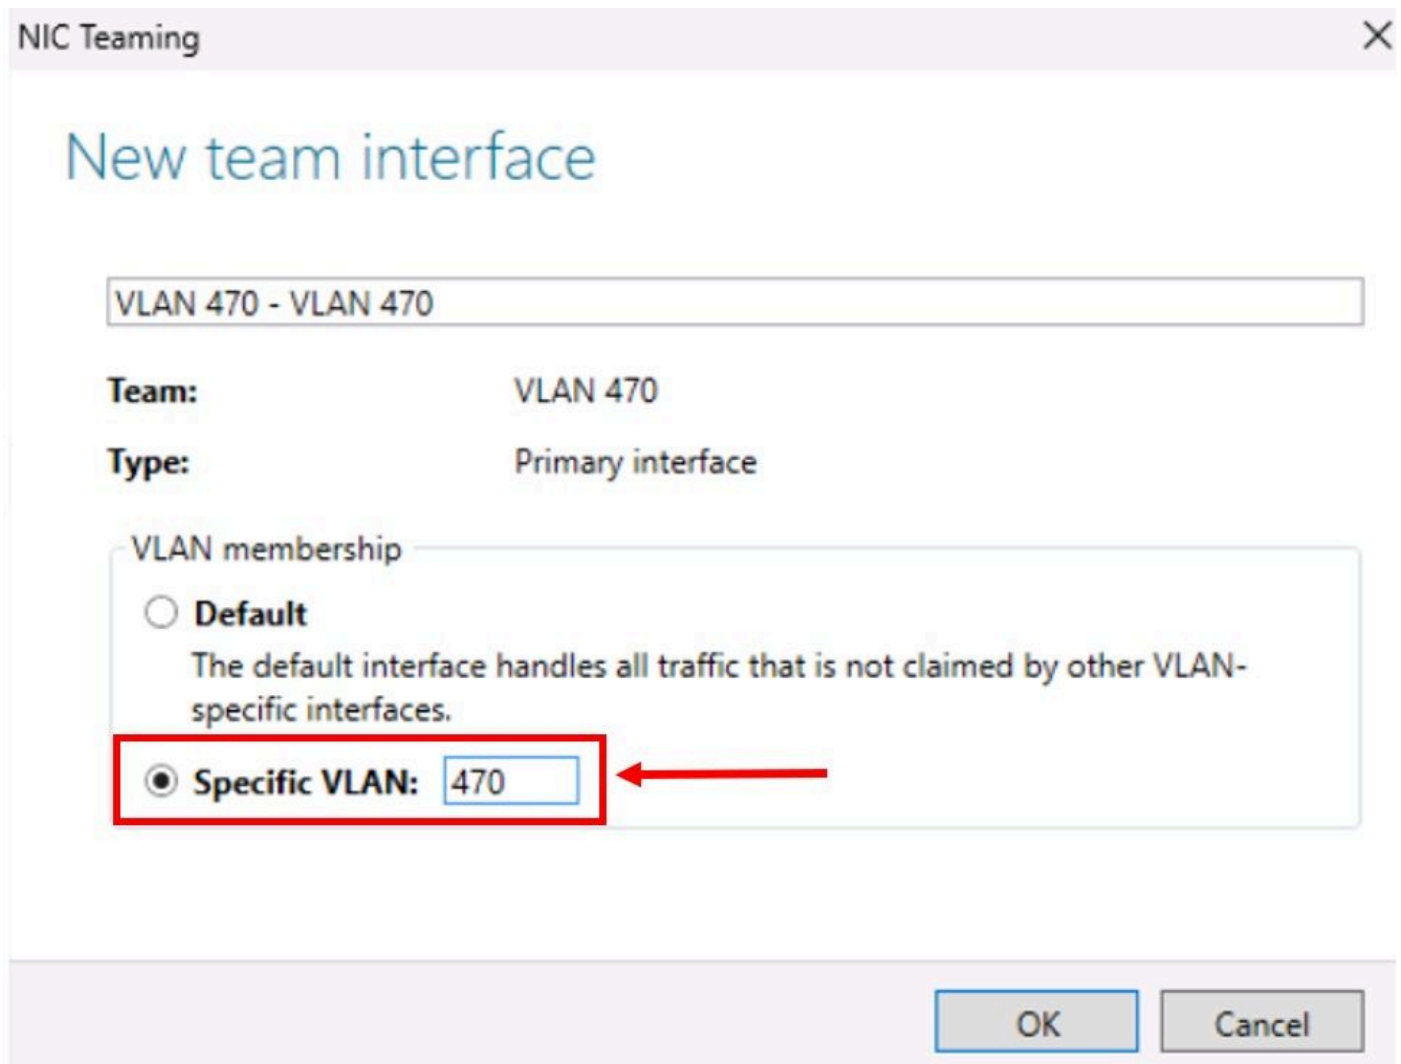
### 場景3.本地VLAN在作業系統和vNIC級別配置

- 作業系統端：

- ping測試不起作用，並且您沒有連線。
