排除UCCX Finesse插入功能故障

本文描述如何解決由於Cisco Unified Communications Manager(CUCM)上的某些配置設定而導致Cisco Unified Contact Center Express(UCCX)Finesse中的插入功能遇到的問題。

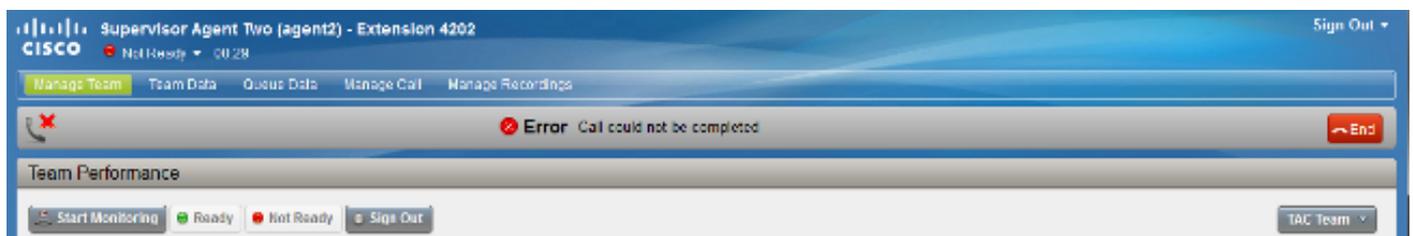
Supervisor按一下**插入**時，Supervisor Finesse會話上會有幾秒鐘的延遲，然後出現以下錯誤消息：

出現錯誤後，插入操作的諮詢部分可能仍顯示為非自動應答的常規入站呼叫。但是，Supervisor案頭上未清除錯誤消息。

當代理裝置無法在撥號計畫中立即找到嘗試加入呼叫的Supervisor目錄號碼(DN)的單個匹配項時，經常會出現此問題。例如，如果Supervisor DN為4202，並且代理DN搜尋的分割槽(如42022或4202X)中存在更長的潛在匹配項，則代理電話不會嘗試連線到Supervisor電話，直到數字間超時到期。此時，由於座席電話呼叫的等待時間延長，Finesse主管超時，並顯示「Error - Call cannot be completed (錯誤 — 呼叫無法完成)」消息。

為了解決此問題，請確保將主管DN的最後一位輸入座席電話時，主管DN觸發唯一匹配。

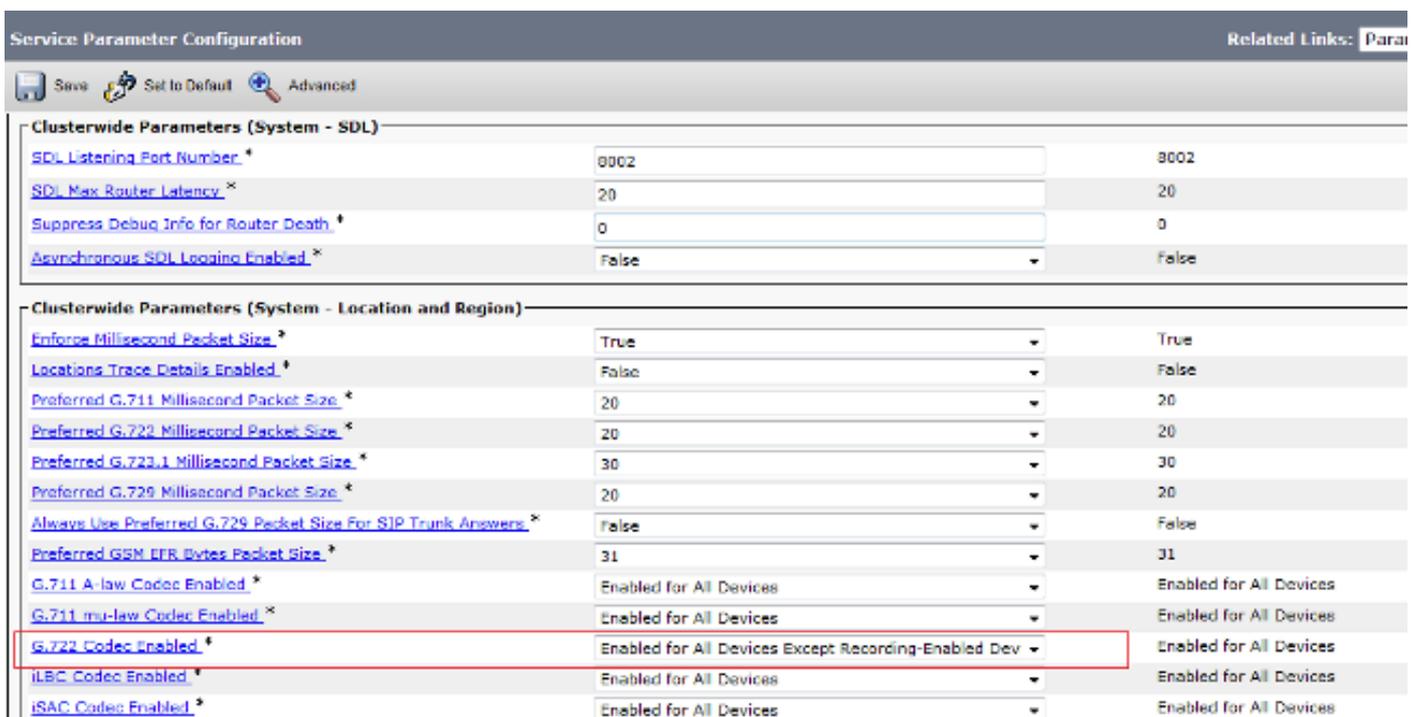
當Supervisor電話啟用錄製時，由於缺少媒體資源，電話無法設定強插式會議時，可能出現此問題。這是因為Supervisor電話可能會將G.711中的監控流傳送到記錄伺服器（如MediaSense），而插入功能會嘗試使用G.722。Cisco CallManager(CCM)日誌顯示功能不匹配，這表示需要轉碼器：

如果轉碼器不可用，則服務引數可以避免需要。在CCM Administration頁中，導航到System > Service Parameters。選擇CUCM節點和Call Manager服務，然後向下滾動至Clusterwide Parameters (系統 — 本地化和區域)。對於G.722 Codec Enabled設定，選擇Enabled for All Devices except-Enabled Devices except-Enabled Devices:
