疑難排解FTD無法對ARP專案所在的上游裝置執行Ping操作

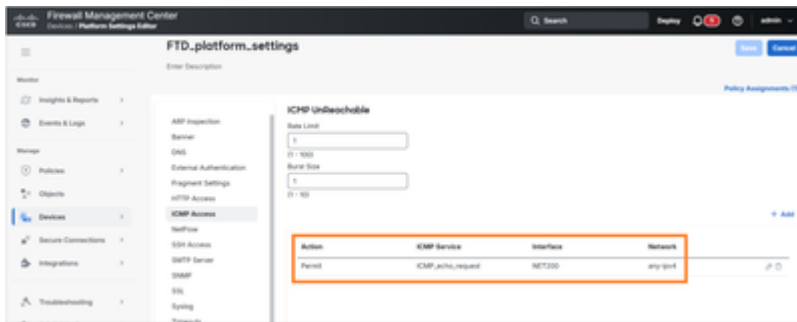
在配置為拒絕ping流量的平台設定中找到ICMP規則。

在本範例中，ICMP規則僅允許FTD介面接受ICMP回應要求。

此問題的根本原因是平台設定中配置的ICMP規則明確拒絕ICMP回應應答流量。雖然防火牆維持了正確的第2層連線（以可見的ARP條目為證據），但平台級ICMP規則阻塞了第3層ICMP回應應答資料包，阻止對上游IP地址成功執行ping操作。當實施安全策略以限制ICMP流量但可能無意中影響合法網路連線測試和監控時，可能會發生此類配置。

步驟4.更新ICMP規則配置

根據網路安全要求和運行需要，修改識別的ICMP規則以允許ping流量或刪除阻塞配置。
