排除UCS刀片發現問題

本文檔介紹對刀片式伺服器因伺服器電源狀態 — MC錯誤而無法發現的問題進行故障排除的步驟。

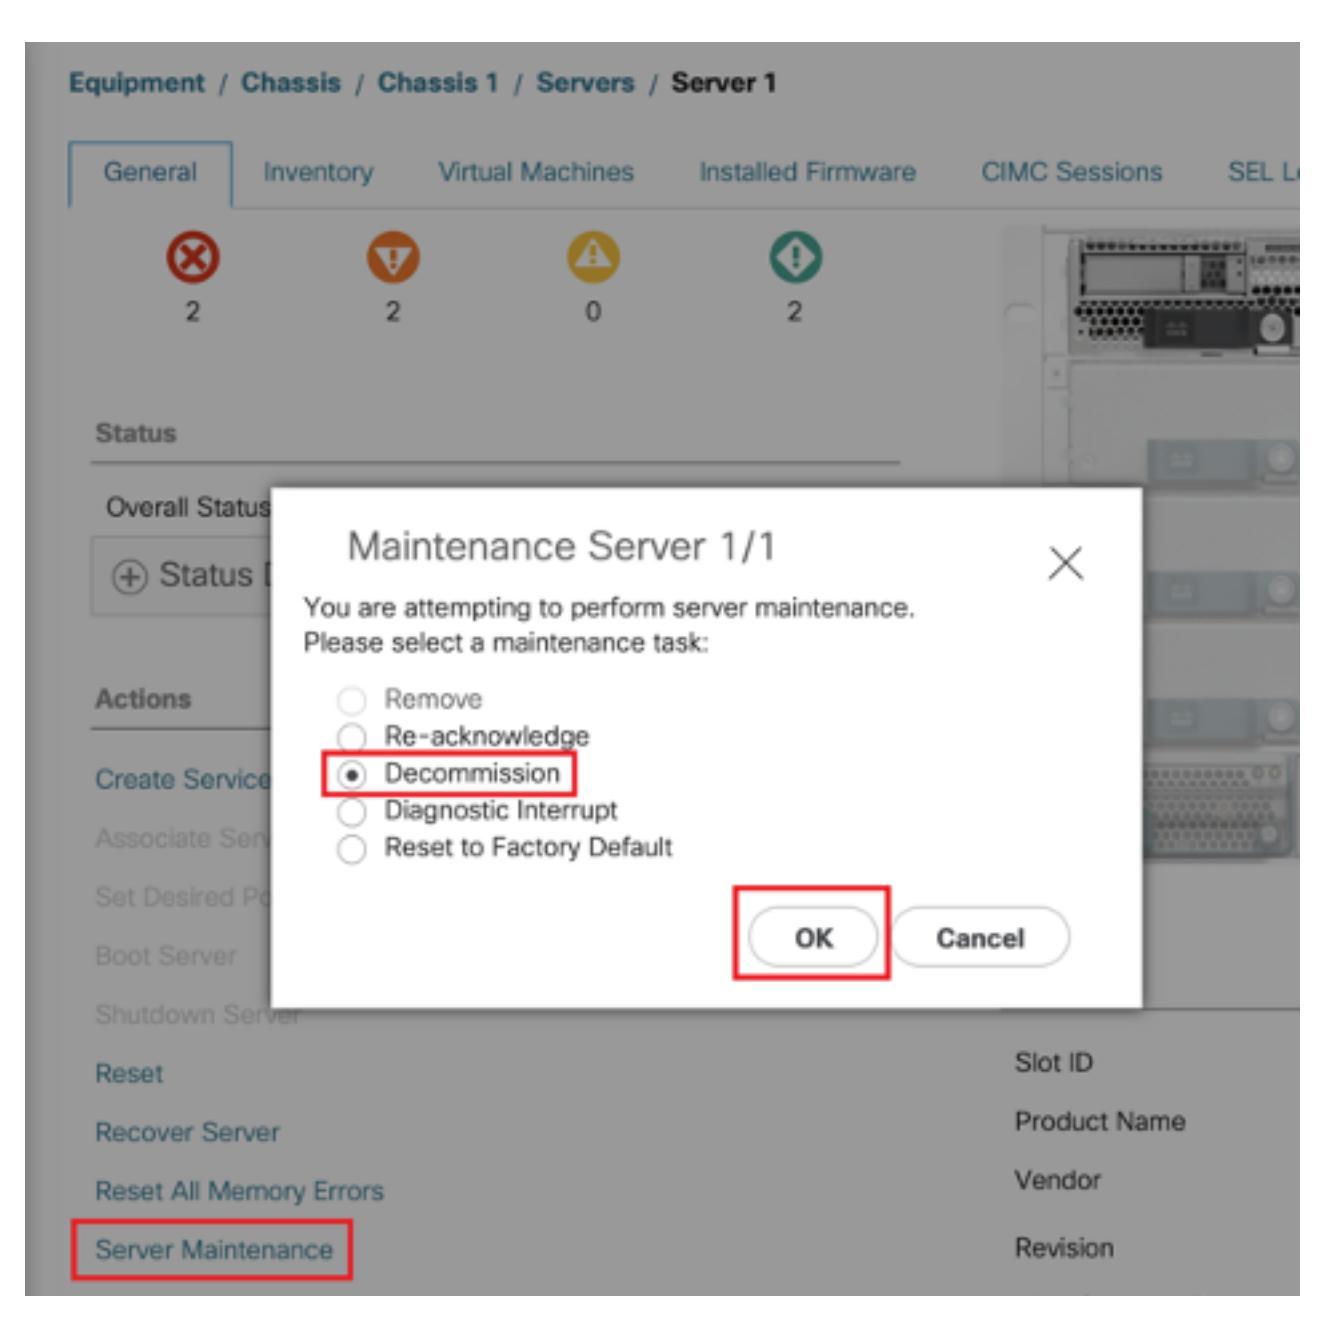
第2步:記下受影響的刀片序列號並停用刀片。

導航至Equipment > Chassis X > Server Y > General > Server Maintenance > Decommission > Ok。
