Troubleshoot Fragmentation Issues: Affecting c9800 Wireless Controller with Azure

This document describes a known problem with the Azure platform leading to packet loss due to the mishandling of out-of-sequence fragments.

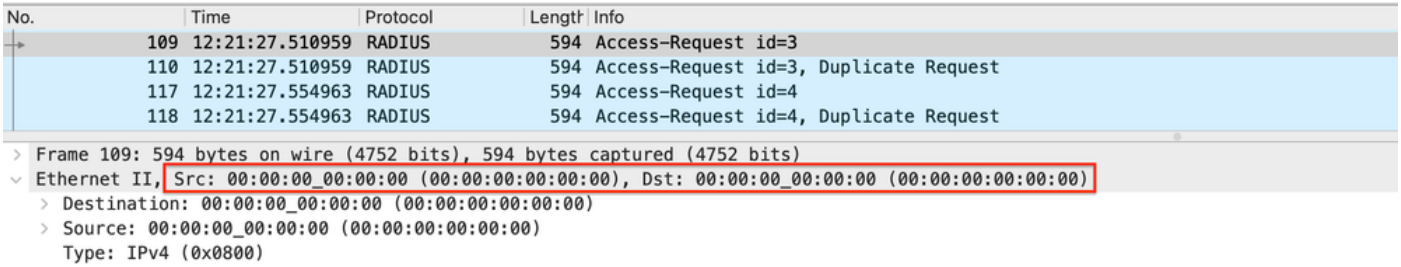
Radius Access-Request Punted to CPU on WLC

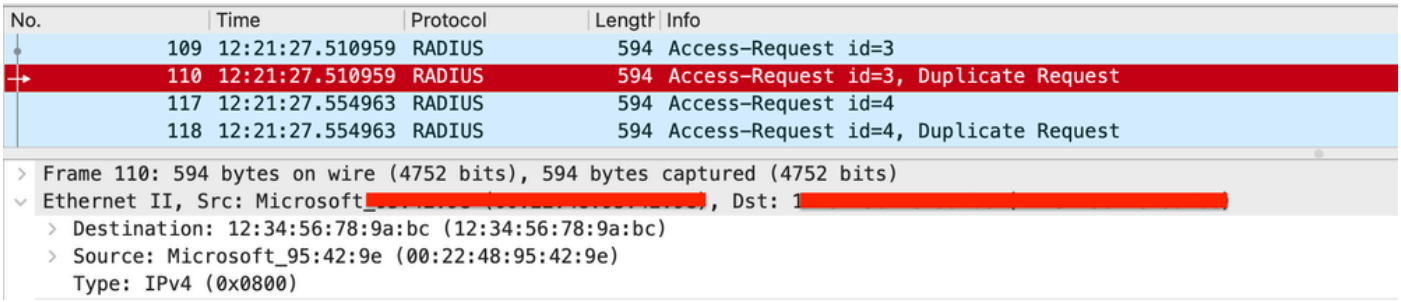
Radius Access-Request Sent to AAA Server

The Access requests in question, identified by ID = 8, which are sent out multiple times and for which no response was seen from AAA server. Upon further investigation, we observed that for Access-request ID=8, UDP fragmentation is occurring due to the size surpassing the MTU, as illustrated below:

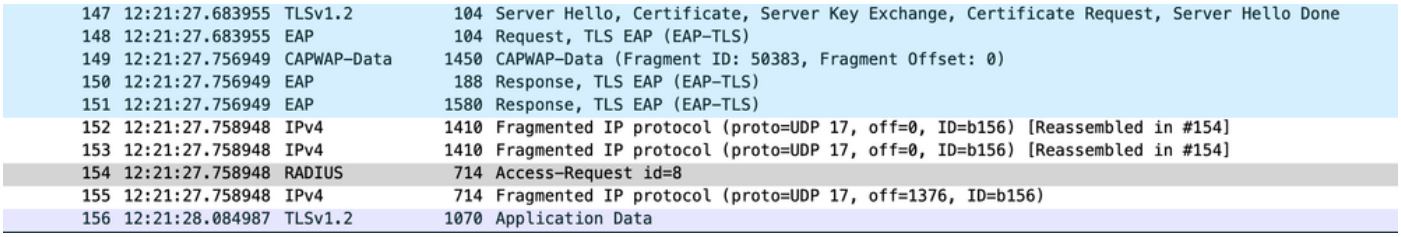
Fragmentation taking Place on WLC Packet Capture

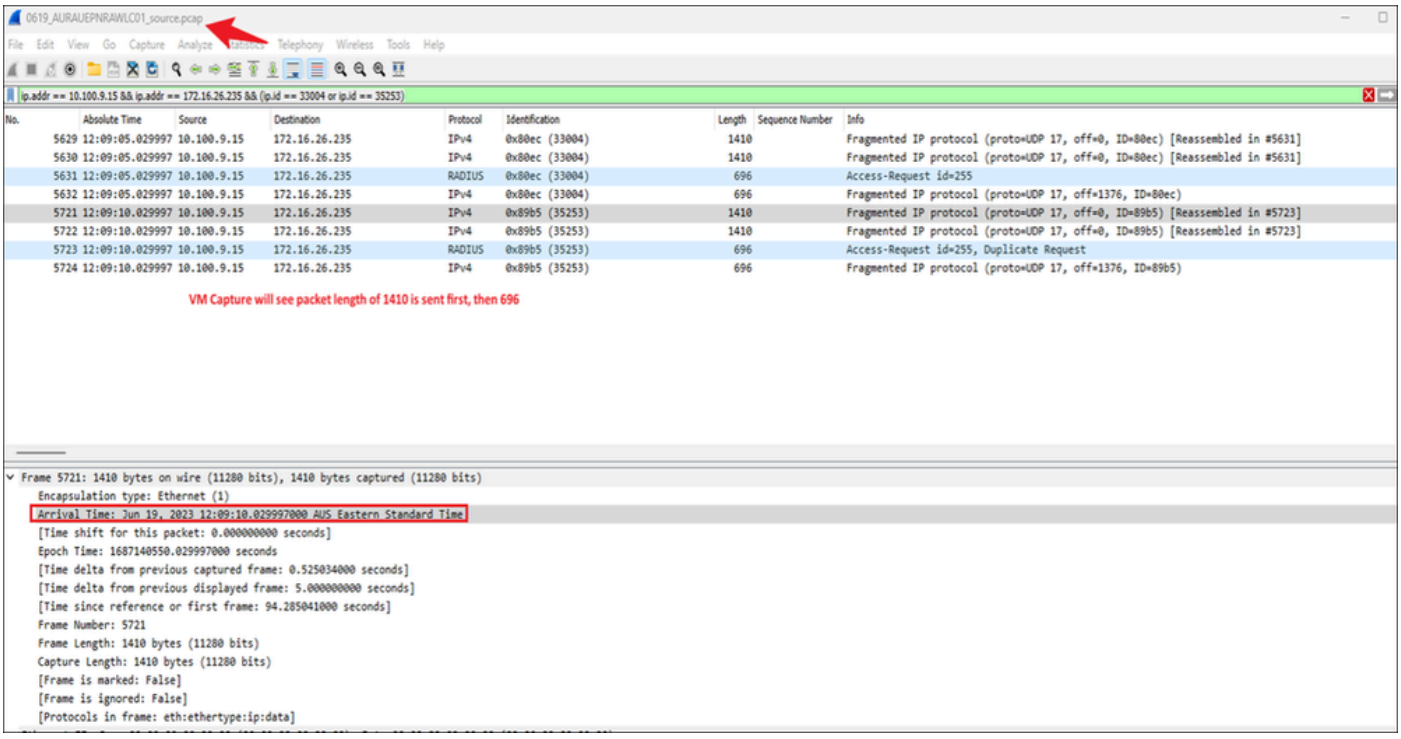
Sequence of Fragmented Packets on WLC

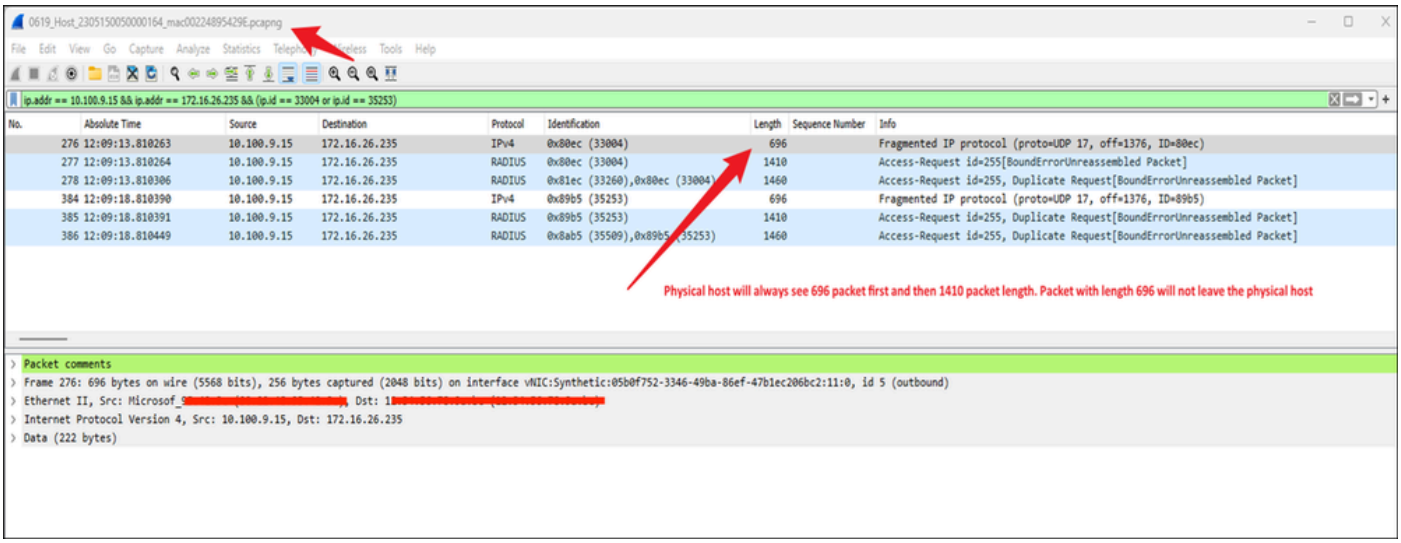
Captures on Azure End

On the physical host, the packets are not arriving in the proper sequence

Since the packets are arriving in the wrong order, and the physical node is programmed to reject any out-of-order frames, the packets gets dropped immediately. This disruption causes the authentication process to fail, leaving the client unable to progress beyond the authentication phase.

- From the Wireless controller's Encapsulated Packet Capture (EPC), we observed that the packets are being sent in the correct order. It is then the responsibility of the receiving host to reassemble them properly and continue with processing, which, in this case, is not occurring on the Azure side.
- To address the issue of out-of-order UDP packets, the`enable-udp-fragment-reordering` option needs to be activated on Azure.
- You must reach out to Azure support team for assistance with this matter. Microsoft has acknowledged this problem.
