Troubleshoot Analog FXO GroundStart Outbound Call Failures

Document ID: 61947

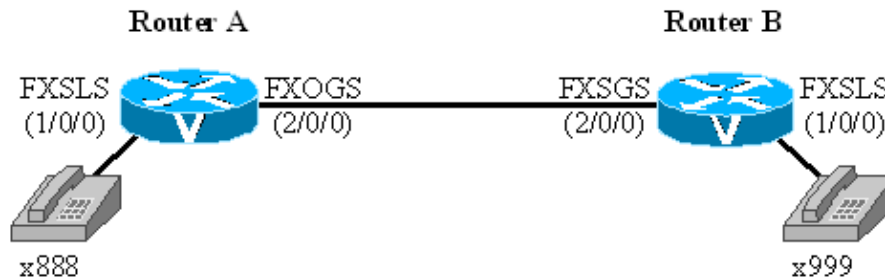
The easiest empirical way to do this is to connect the FXO port to a known functioning FXS port, such as a VIC-2FXS, VIC2-2FXS, VIC-2DID (in FXS mode), VIC-4FXS/DID (in FXS mode), NM-HDA FXS, or EVM-HD FXS port on another (or even same) Cisco voice gateway. In this case, a straight-through, two-wire RJ-11 connection should be used. The aim here is to verify that one voice gateway can signal the other over the connection and draw a dial tone from the peer gateway. A complete testing scenario for this could be:

A successful test would enable a user to pick up either analog phone and get a dial tone from the local router, dial the far-end extension to go offhook over the GS line, hear a dial tone from the peer gateway, then dial the far-end extension once again to complete the call to the far-end phone. If this works fine in both directions, then the FXO voice-port functions as expected. Be sure to check the phone call for two-way audio from both parties.

If the call attempts continue to fail or an audio problem such as one-way or no-way audio is experienced, then there may be an actual hardware problem. Check the RJ-11 cabling again, and test with another FXS or FXO voice card, if available.
