# CTI Data Fails to Reach Cisco Agent Desktop

Document ID: 66278

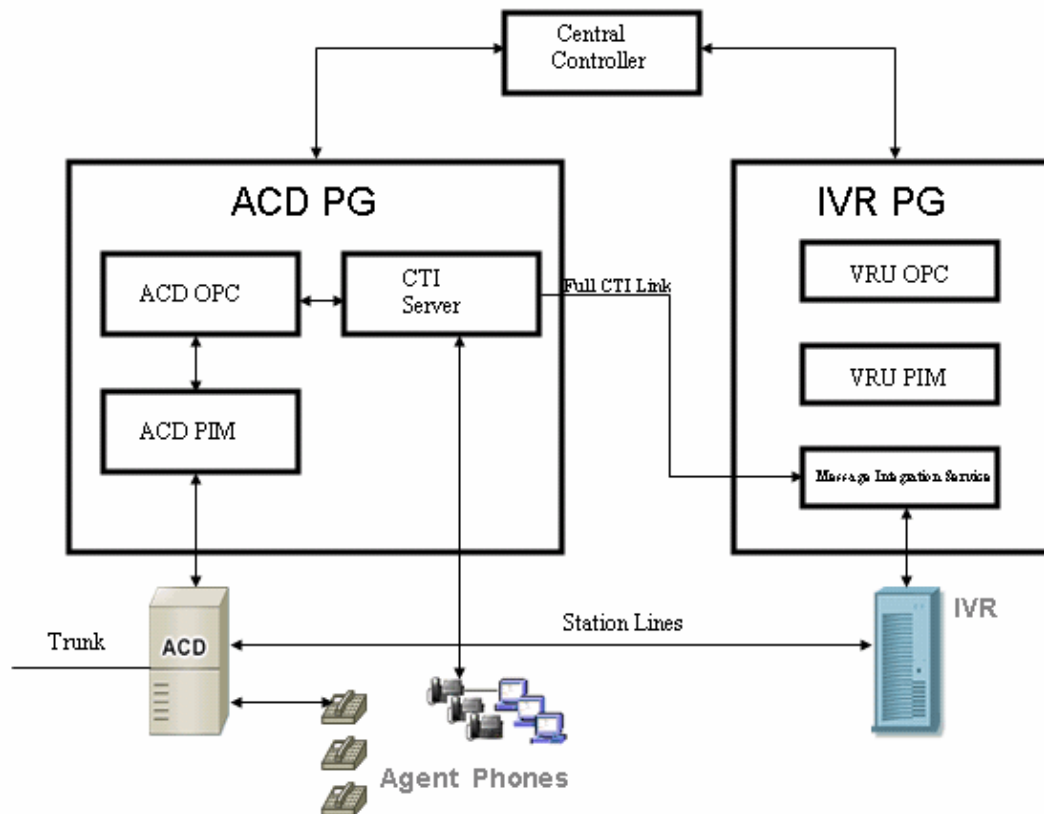
**Figure 1 A Sample CTI Configuration**

Figure 1 represents a sample CTI configuration to demonstrate the high-level data flow. This data flow enables you to understand the problem and develop a diagnostic approach.
