Release Notes for Cisco Aironet 350, 1100, and 1200 Series Access Points for Cisco IOS Release 12.2(13)JA2

February 5, 2004

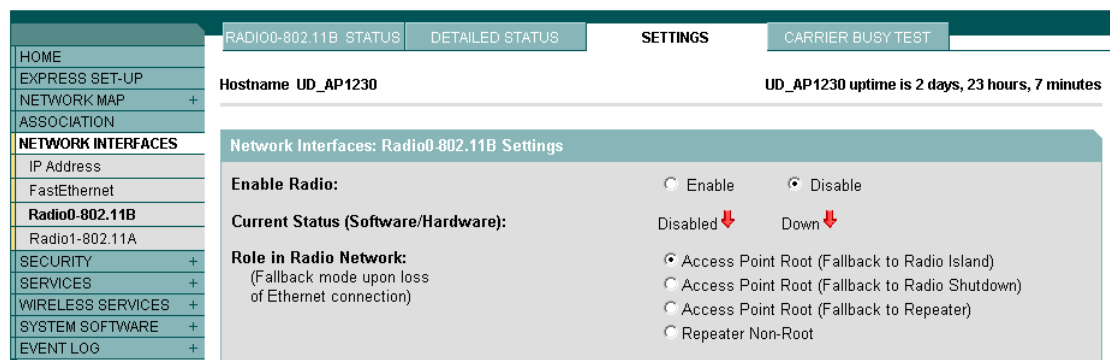
Figure 2 Network Interfaces: Radio Settings Page

If your access point runs Cisco IOS Release 12.2(11)JA or 12.2(11)JA1 the access point might reboot immediately after you upgrade to Cisco IOS Release 12.2(13)JA2. Because of a rare timing condition that affects the radios, the access point sometimes reboots immediately after the upgrade when the radios are enabled. However, when the access point reboots after the crash, the upgrade is complete and the access point operates normally. To prevent the access point from rebooting unexpectedly, disable the radio interfaces before upgrading to Cisco IOS Release 12.2(13)JA2.

- Step 1** Browse to the Network Interfaces: Radio Settings page. [Figure 2](#) shows the top portion of the Network Interfaces: Radio Settings page.

- Step 2** Select **Disable** to disable the radio.
- Step 3** Click **Apply** at the bottom of the page.
- Step 4** If your access point has two radios, repeat these steps for the second radio.
