Troubleshoot Unknown Protocol Drops in Catalyst 9000 Switches

This document describes common causes for unknown protocol drops in Catalyst 9000 series switches.

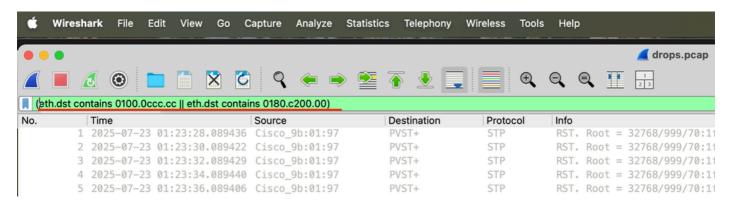
Step 7. Open the packet capture in Wireshark and use this filter (eth.dst contains 0100.0ccc.cc || eth.dst contains 0180.c200.00) to focus on CPU multicast addresses.

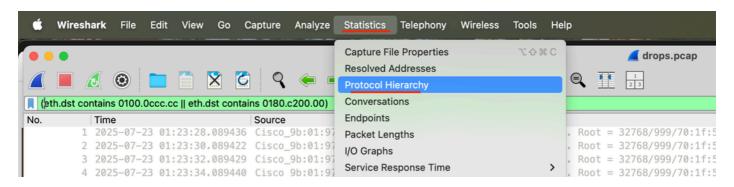
Step 8. Go to **Statistics** and then click **Protocol Hierarchy**.

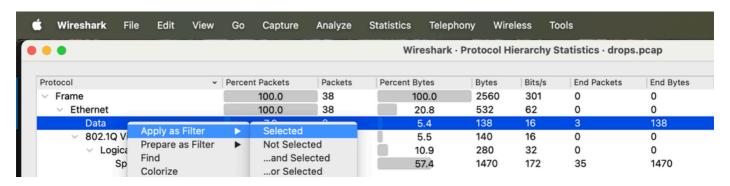
Step 10. Right-click **Data**, navigate to **Apply as Filter** and click **Selected** to filter unknown protocol frames.
