This document describes how to troubleshoot the corrupted ethernet packet on Cisco Nexus 9000 when a padding information is corrupted or malfomed.

Padding Modified with Tagged VLANs when Traffic traverses N9K

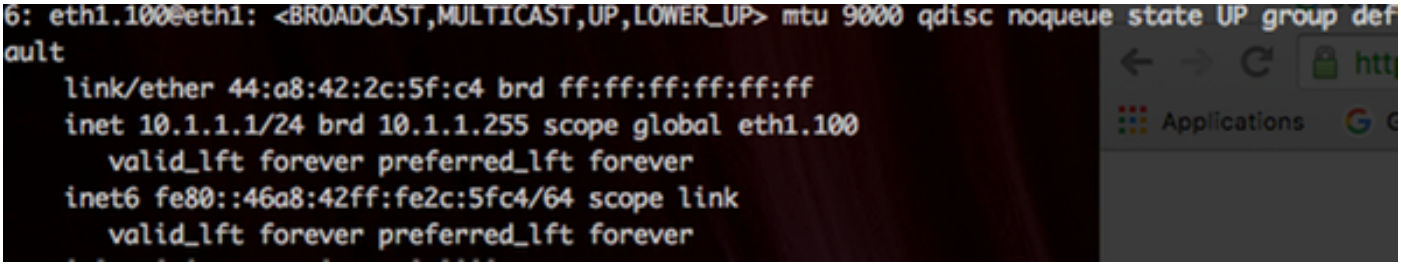
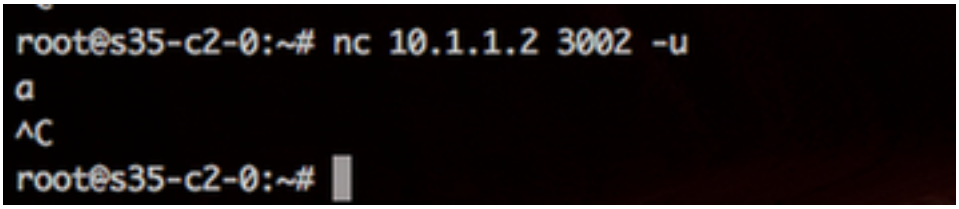
As shown in the image, it sends Side (VLAN 100 tagged), port e1/59 on the switch

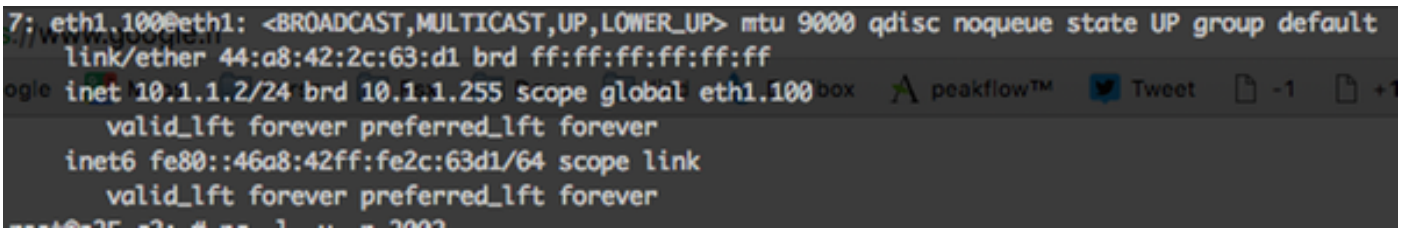
It receives Side (VLAN 100 tagged), port e1/60 on the switch, as shown in the image:

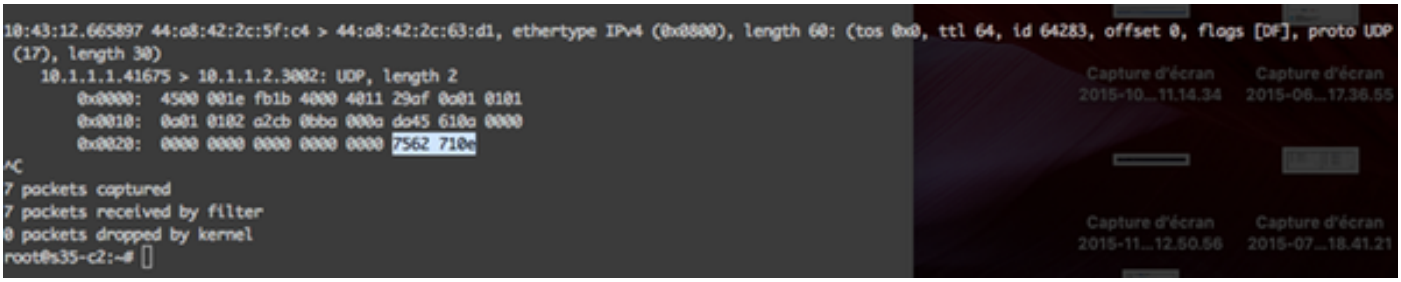
The packet is received, as shown in the image:

The work around is to [buffer-boost](#)on interface where we have this server connected.

C9396PX-1(config)# int et 1/7

C9396PX-1(config-if)# no buffer-boost

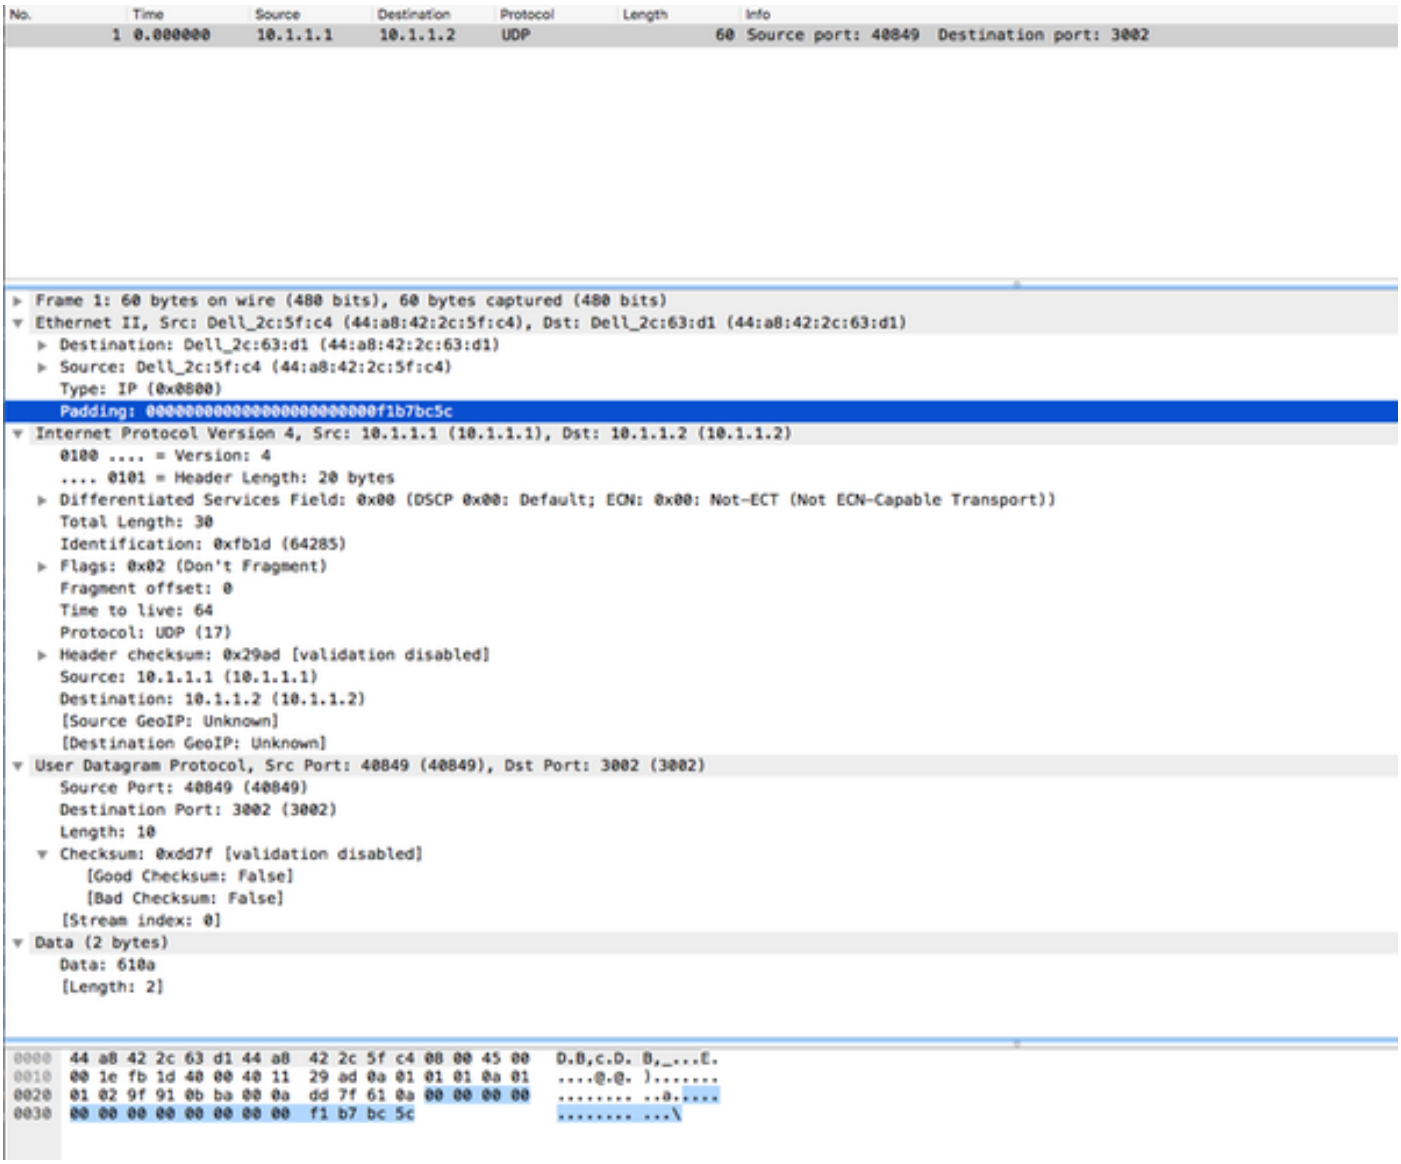
Instead of padding with zeroes, the packet is padded with garbish characters, in most of the cases it has no impact because checksums are not modified and so nobody uses these datas. However, if customers have a special usage and need to recompute checksums, these garbish datas leads to corruption of checksums in the end (I believe other appliances, like NAT/load-balancers might see the issue too)

As shown in the image, the wrong padding is hilighted.

This is also displayed with a packet analyzer (another packet, data is different than previous screenshots but test and bug is identical),
