Understanding and Troubleshooting HSRP Problems in Catalyst Switch Networks

Document ID: 10583

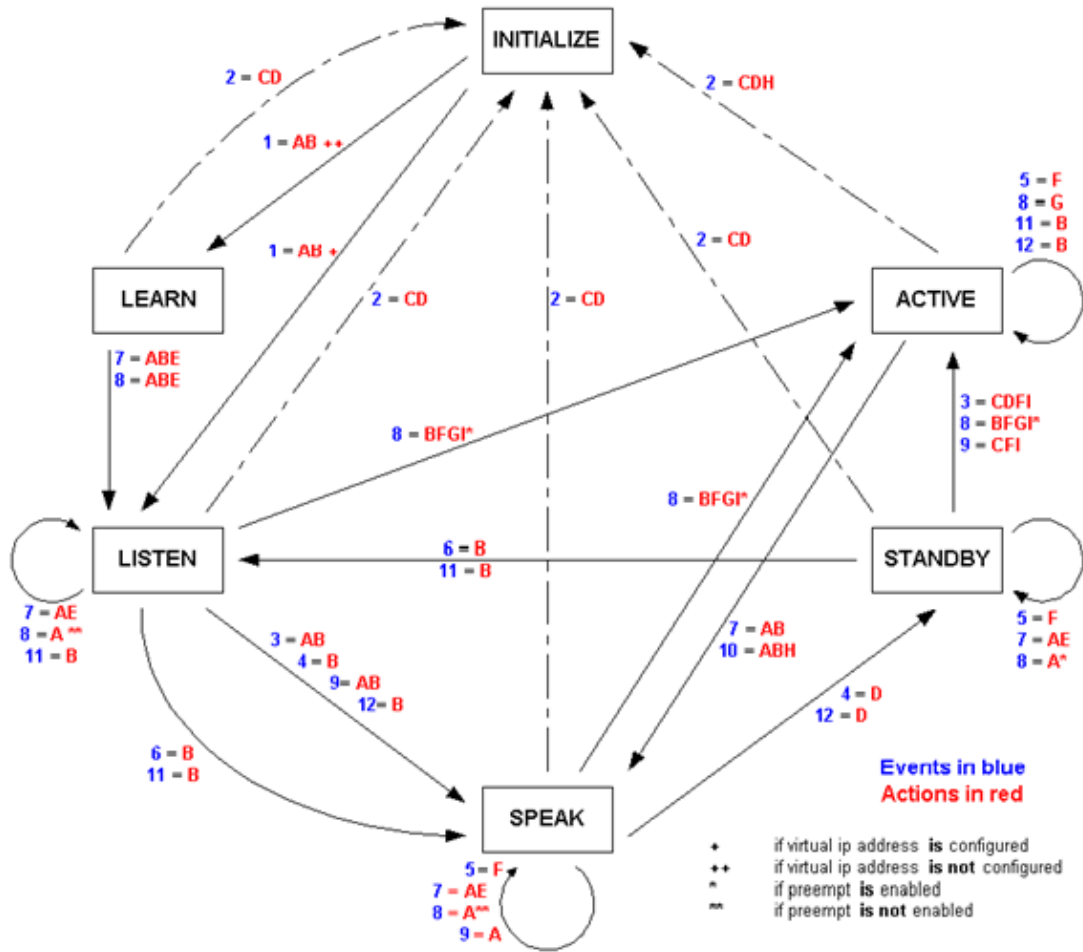
HSRP State Table

The diagram in this section shows the state transitions of the HSRP state machine. Each time that an event occurs, the associated action results, and the router transitions to the next HSRP state. In the diagram, numbers designate events, and letters designate the associated action. The table in the section HSRP Events defines the numbers, and the table in the section HSRP Actions defines the letters. Use this diagram only as a reference. The diagram is detailed and is not necessary for general troubleshooting purposes.

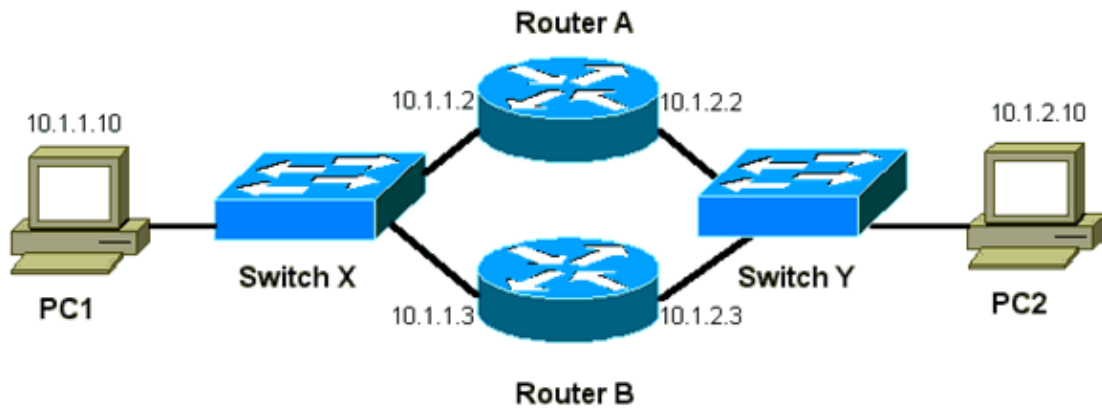
Packet Flow

Device	MAC Address	IP Address	Subnet Mask	Default Gateway
PC1	0000.0c00.0001	10.1.1.10	255.255.255.0	10.1.1.1
PC2	0000.0c00.1110	10.1.2.10	255.255.255.0	10.1.2.1

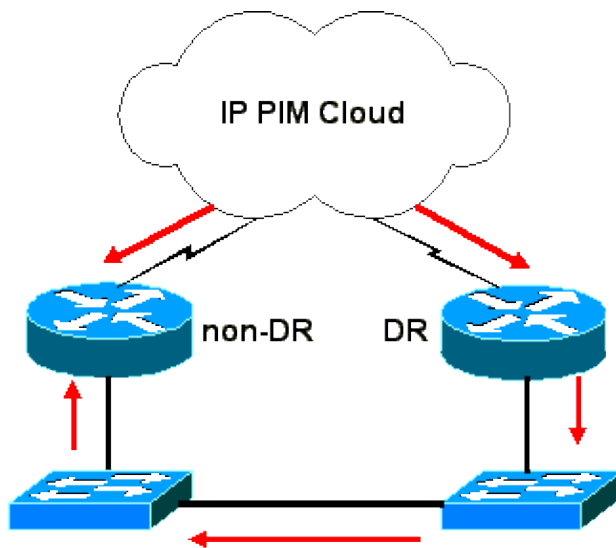
This diagram provides an example. The red lines indicate multicast feed.

The redundant router, which is the router that does not forward the multicast traffic stream, sees this data on the outbound interface for the LAN. The redundant router must drop this traffic because the traffic arrived on the wrong interface and, therefore, fails the RPF check. This traffic is referred to as non-RPF traffic because it is reflected backward against the flow from the source. For this non-RPF traffic, there is usually no (*,G) or (S,G) state in the redundant router. Therefore, no hardware or software shortcuts can be created in order to drop the packet. The processor must examine each multicast packet individually. This requirement can cause the CPU on these routers to spike or run at a very high processing rate. Often, a high rate of multicast traffic on the redundant router causes HSRP to lose hello packets from its peer and change states.

IP multicast uses one router to forward data onto a LAN in redundant topologies. If multiple routers have interfaces onto a LAN or VLAN, only one router forwards the data. There is no load balancing for multicast traffic on LANs. All multicast traffic is always visible by every router on a LAN. This is also the case if Cisco Group Management Protocol (CGMP) or Internet Group Management Protocol (IGMP) snooping is configured. Both routers need to see the multicast traffic in order to make a forwarding decision.

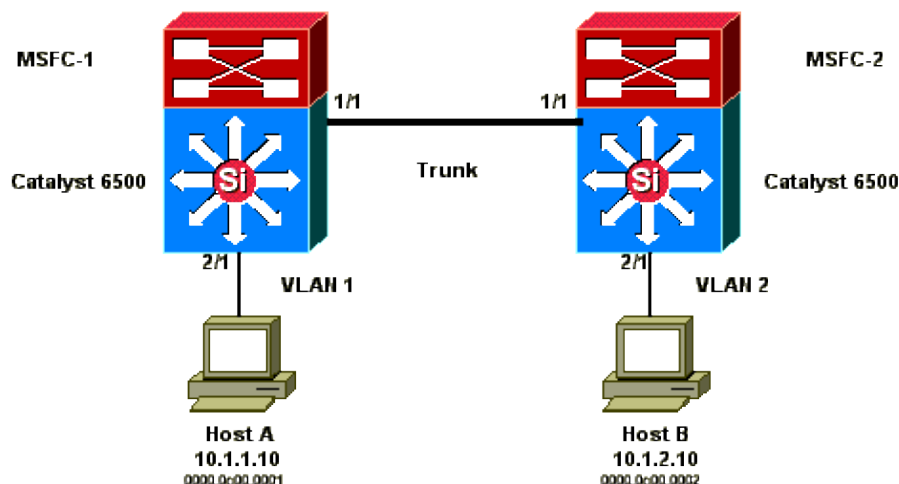
This diagram illustrates this issue. This topology example includes Catalyst 6500s with Multilayer Switch Feature Cards (MSFCs) in each switch. Although this example uses MSFCs, you can use any router instead of the MSFC. Example routers that you can use include the Route Switch Module (RSM), Gigabit Switch Router (GSR), and Cisco 7500. The hosts are directly connected to ports on the switch. The switches are interconnected through a trunk which carries traffic for VLAN 1 and VLAN 2.

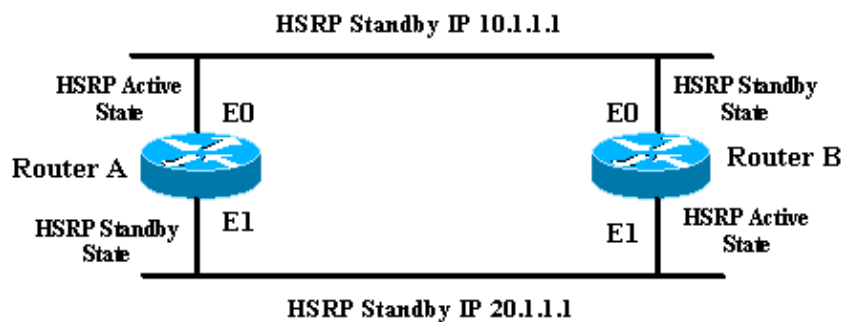
Unable to Ping HSRP Standby Address on Cisco 2500 and 4500 Series Routers

In this diagram, Router A represents a Cisco 2500 series router, and Router B represents a Cisco 4500 series router. If Router A pings the virtual IP address on LAN 1, 10.1.1.1, the router first sends out an ARP request.

Router B responds with an ARP reply that contains the virtual MAC address. Router B ignores this ARP reply because the virtual MAC address is the same as the Router B E1 interface address.
