Understanding and Troubleshooting HSRP Problems in Catalyst Switch Networks

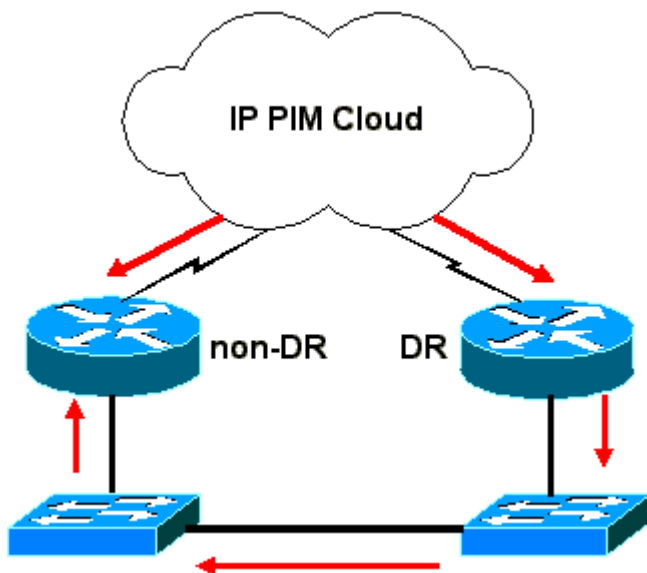
This diagram provides an example. The red lines indicate multicast feed.

The redundant router, which is the router that does not forward the multicast traffic stream, sees this data on the outbound interface for the LAN. The redundant router must drop this traffic because the traffic arrived on the wrong interface and, therefore, fails the RPF check. This traffic is referred to as non-RPF traffic because it is reflected backward against the flow from the source. For this non-RPF traffic, there is usually no (*,G) or (S,G) state in the redundant router. Therefore, no hardware or software shortcuts can be created in order to drop the packet. The processor must examine each

multicast packet individually. This requirement can cause the CPU on these routers to spike or run at a very high processing rate. Often, a high rate of multicast traffic on the redundant router causes HSRP to lose hello packets from its peer and change states.

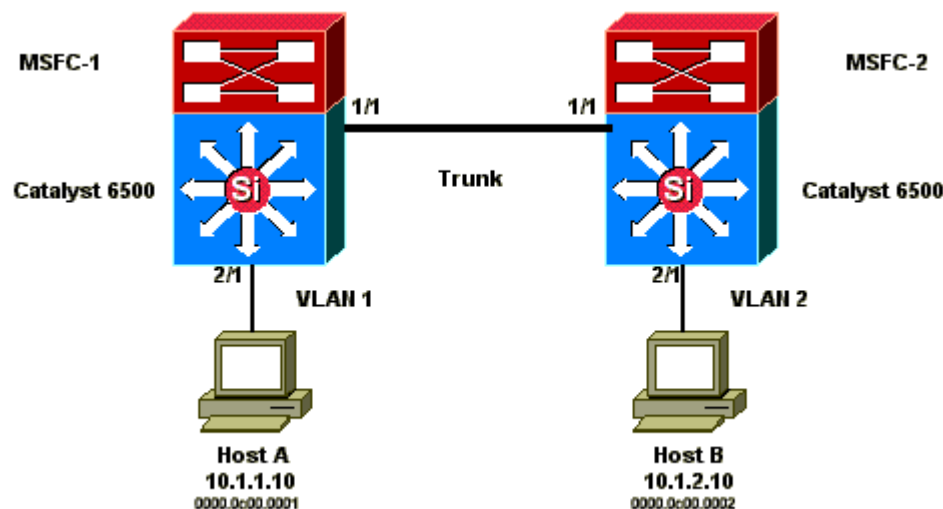
This diagram illustrates this issue. This topology example includes Catalyst 6500s with Multilayer Switch Feature Cards (MSFCs) in each switch. Although this example uses MSFCs, you can use any router instead of the MSFC. Example routers that you can use include the Route Switch Module (RSM), Gigabit Switch Router (GSR), and Cisco 7500. The hosts are directly connected to ports on the switch. The switches are interconnected through a trunk which carries traffic for VLAN 1 and VLAN 2.

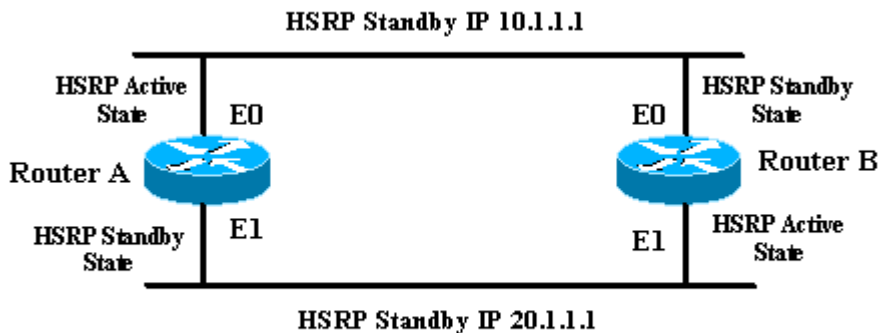
Unable to Ping HSRP Standby Address on Cisco 2500 and 4500 Series Routers

In this diagram, Router A represents a Cisco 2500 series router, and Router B represents a Cisco 4500 series router. If Router A pings the virtual IP address on LAN 1, 10.1.1.1, the router first sends out an ARP request. Router B responds with an ARP reply that contains the virtual MAC address. Router B ignores this ARP reply because the virtual MAC address is the same as the Router B E1 interface address.

There is a known restriction with the 10 MB Ethernet controller on the Cisco 2500 and 4500 series routers. The Ethernet controller only supports a single MAC address in its address filter. As a result, only one HSRP group can be configured in an interface. The HSRP MAC address is also used as the interface MAC address. This causes problems when the same HSRP group is configured on different Ethernets on the same router. The [show standby](#) command shows use of the MAC address as the HSRP MAC address.
