ONS 15454 Release 2.2.x to 2.2.2 and 3.0 Software Upgrades

Document ID: 109594

With the Optical Network System (ONS) 15454 running release 2.2.x software, it is now possible for users to perform their own software upgrades to either release 2.2.2 or 3.0. This top issue documents a lab setup, which walks the reader through all of the necessary steps to complete these software upgrades.

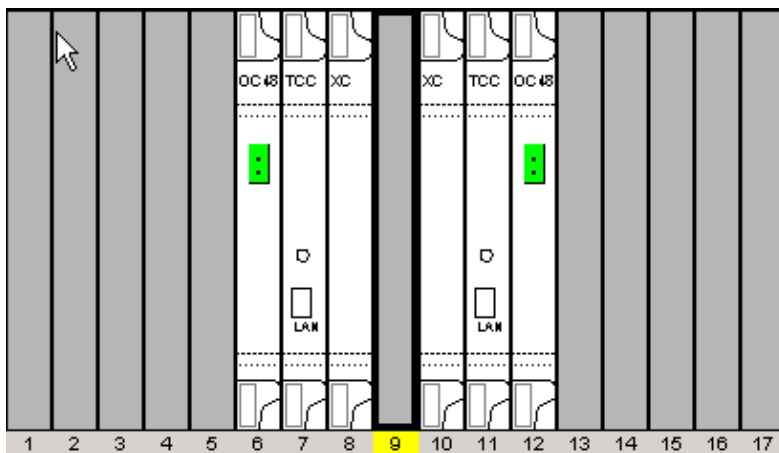
1. Log into the node.
2. Ensure that slots 7, 8, 10, and 11 have duplicate TCC+ and Cross Connect (XC) or Cross Connect Virtual Tributary (XC-VT) cards installed. Release 2.2.x does not support simplex operation.

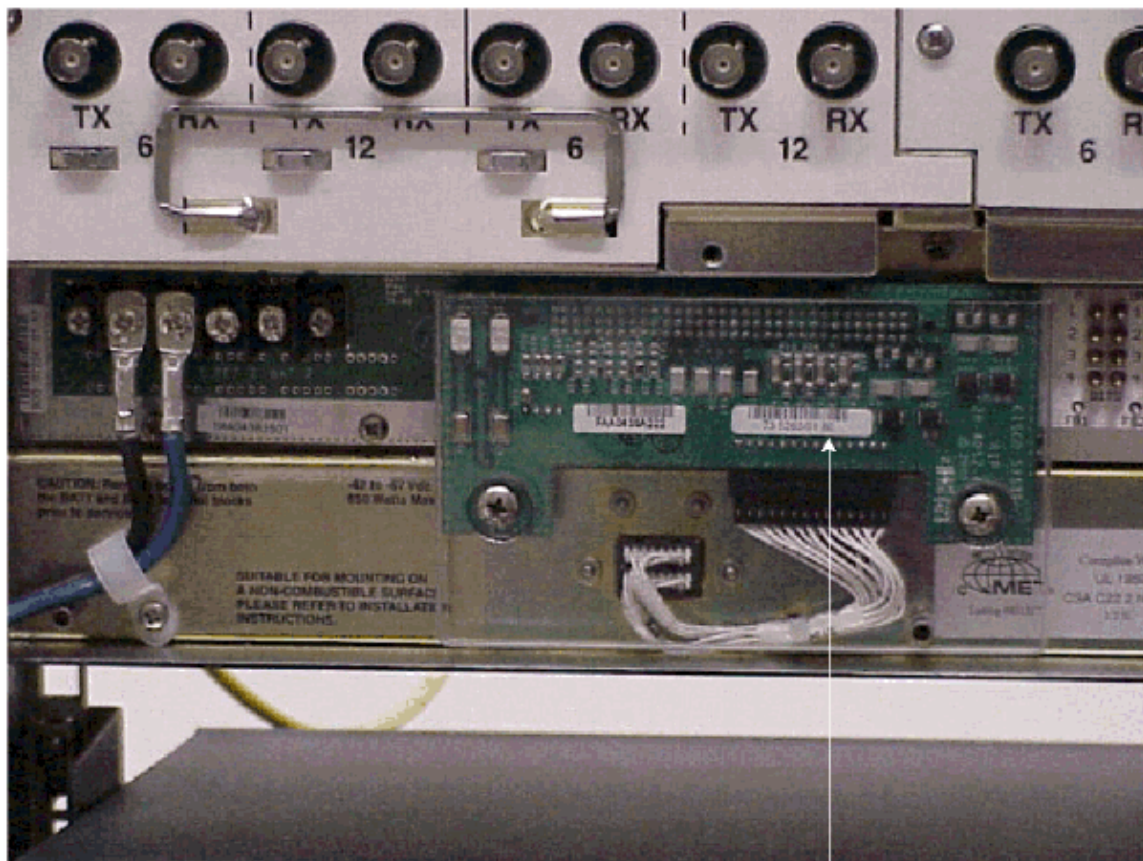
1. Look at the back of your ONS 15454 node and locate the green board with ATM Interface Processor (AIP) stamped into the right hand side (the writing will be sideways as you face the board).
2. Locate the sticker with the part number. The number should be preceded by P/N on the sticker.

3. If the part number is 67-11-00015, the AIP board should be replaced. Otherwise, the AIP board will support the software upgrade.
4. Repeat steps 1-3 for all nodes in the network.

If the part number is 67-11-00015 then the AIP board needs to be replaced before the software upgrade. Any other part number on the AIP board will support both the release 2.2.2 and 3.0 software upgrades

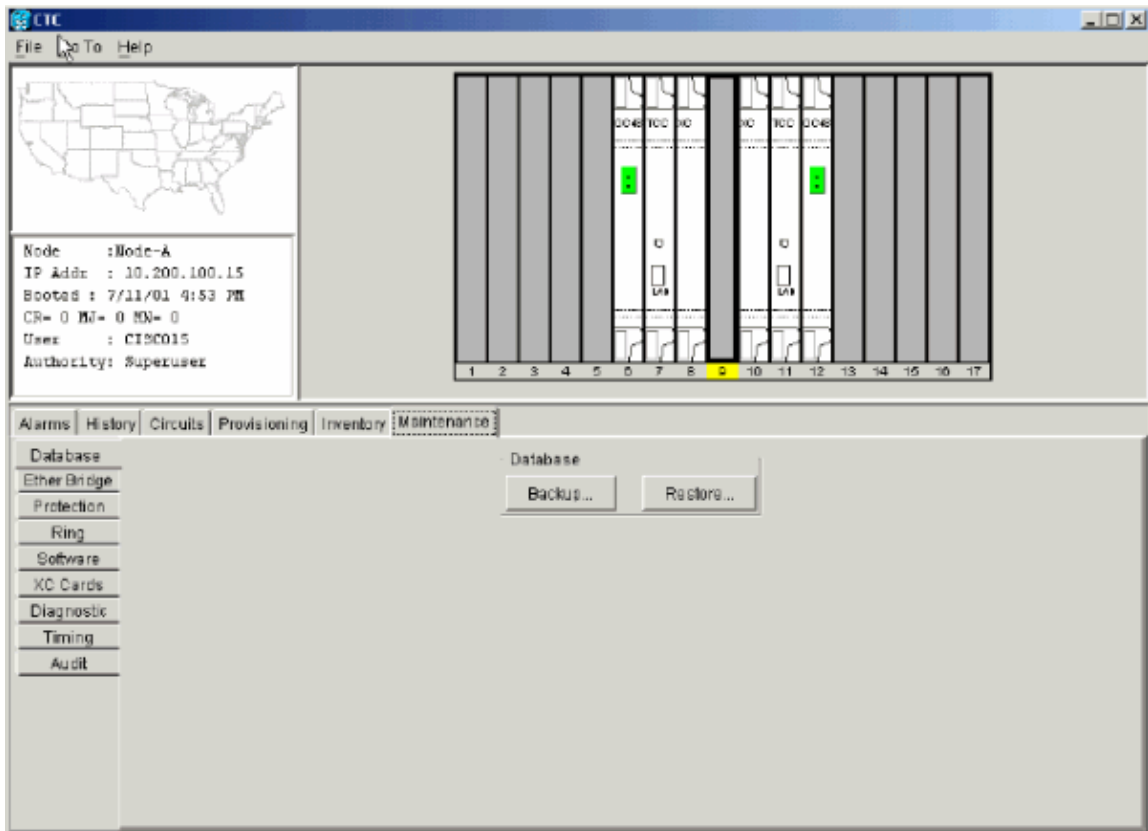
1. Log into CTC.
2. From the Node view, click the **Maintenance > Database** tabs, as shown below:

Before upgrading from release 2.2.x to release 2.2.2 or 3.0 software, it is necessary to back up the current database for each node in the network.

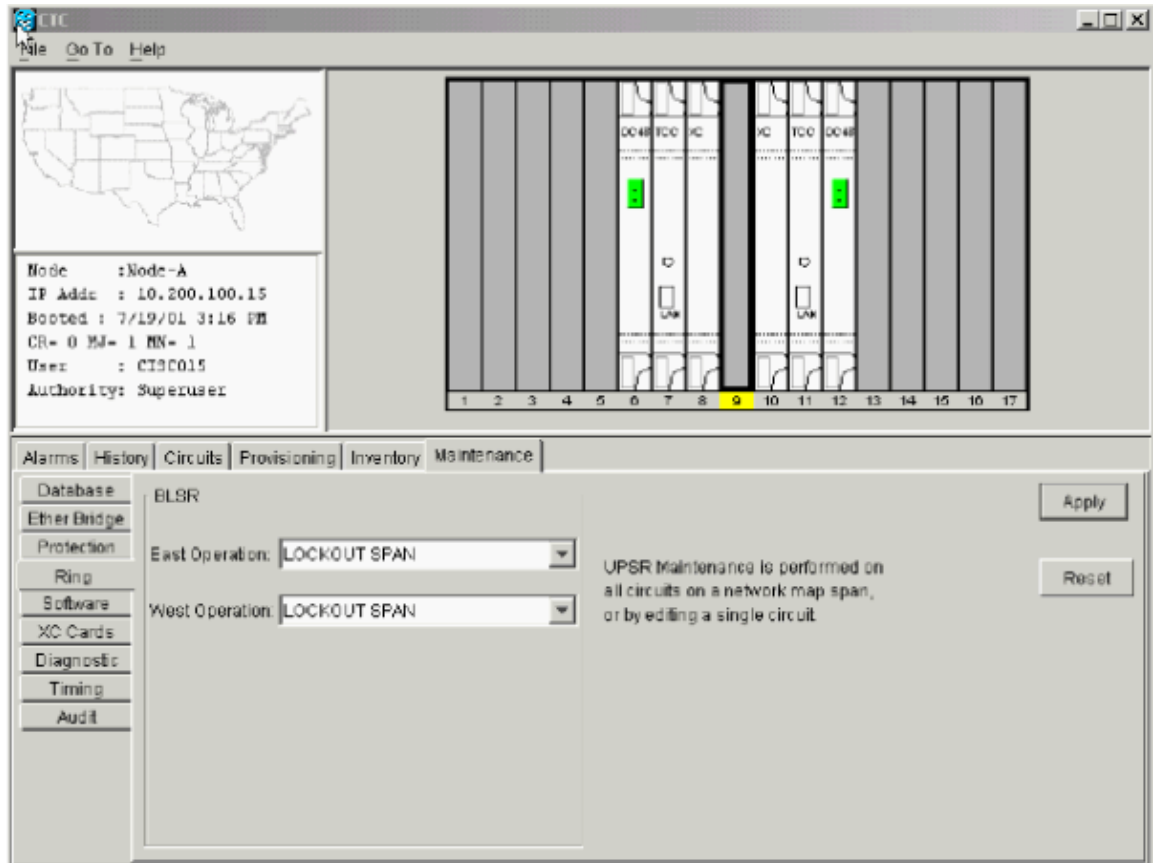
Note: To prevent ring or span switching, perform the lockout on both the East and West spans of each node.

1. Perform a ring lockout to prevent switches from occurring during the upgrade by following the steps below:
 - a. Click the **Maintenance > Ring** tabs.
 - b. Choose **Lockout Span** from the pull-down menus for both West and East side operation, as shown below:

If the node is in a BLSR configuration, it is necessary to perform a ring lockout before activating the new software level. The ring lockout keeps the ring from switching (routing traffic on protect Synchronous Transport Signals (STs)) due to bit errors caused by cards in the shelf booting during the upgrade. You must perform the ring lockout for all nodes in the BLSR ring. Complete the steps below for the ring lockout.

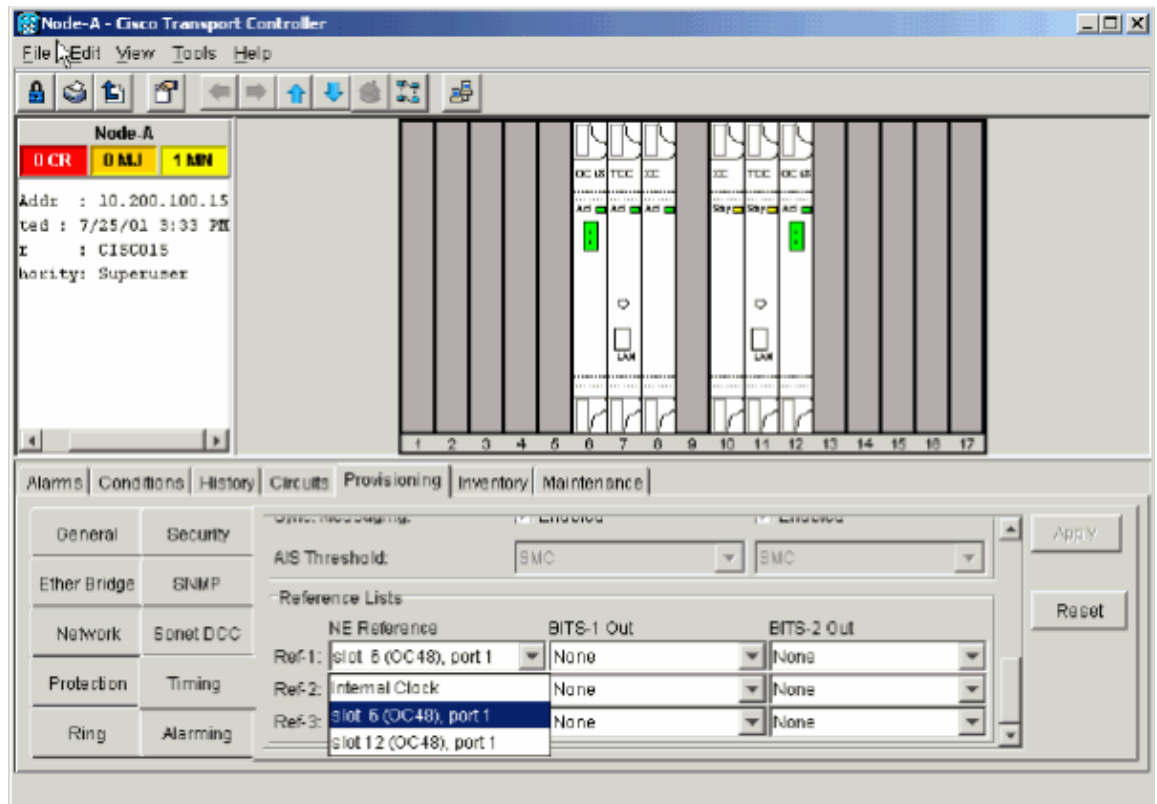
- a. In the Node view, click the **Provisioning** > **Timing** tabs, as shown below:

- b. In the Reference Lists pane, change one of the NE References and click **Apply**.
- c. Wait one minute, then change the same NE Reference back again, and click **Apply**.

To ensure that your upgrade activation has succeeded, Cisco recommends that you execute a provisioning change to the node, as shown in the steps below:

If the problem exists, a 30 minute timer will be set in motion allowing the node reset to occur during the maintenance window, or while personnel are onsite. Look for a SYSBOOT alarm in the alarms panel for the node. If the node does not reset 30 minutes after the provisioning change and there is no SYSBOOT alarm present in the CTC alarms panel for the node, the software activation was successful.

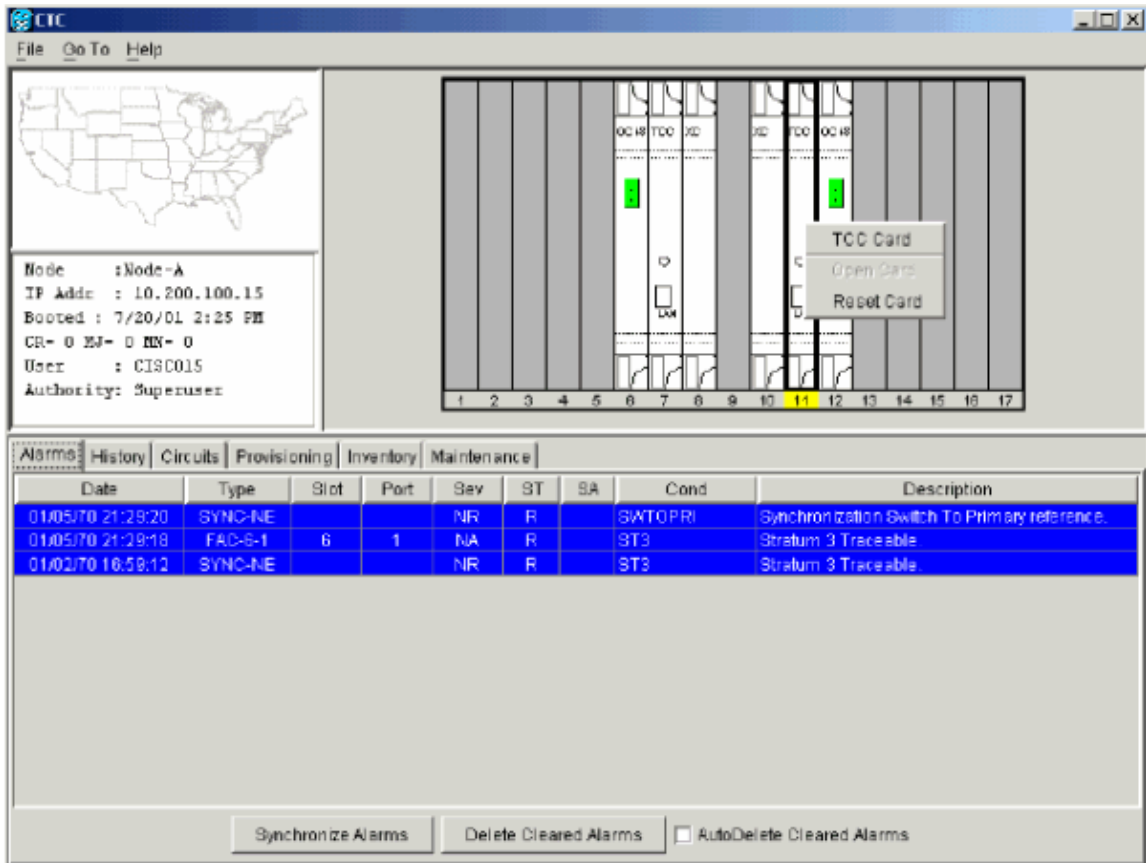
1. Record the IP address of the node.
2. From the Node view, right–click the **standby TCC+** and choose the **Reset Card** option, as shown below:

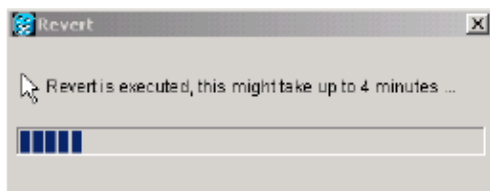
8. Click **OK**. This drops the connection to the node and begins the revert. During the revert the panel below is displayed:

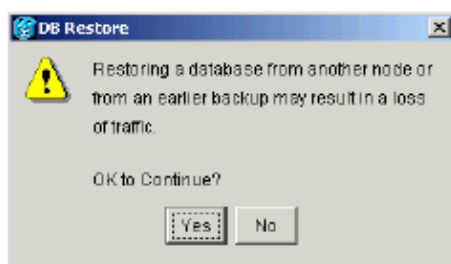
The warning panel below appears, telling you that the restore may cause a loss of traffic is displayed. Click on **Yes** to continue, as shown below:
