Hardware Troubleshooting the Cisco uBR72xx / uBR7246 VXR Universal Broadband Router

Document ID: 12446

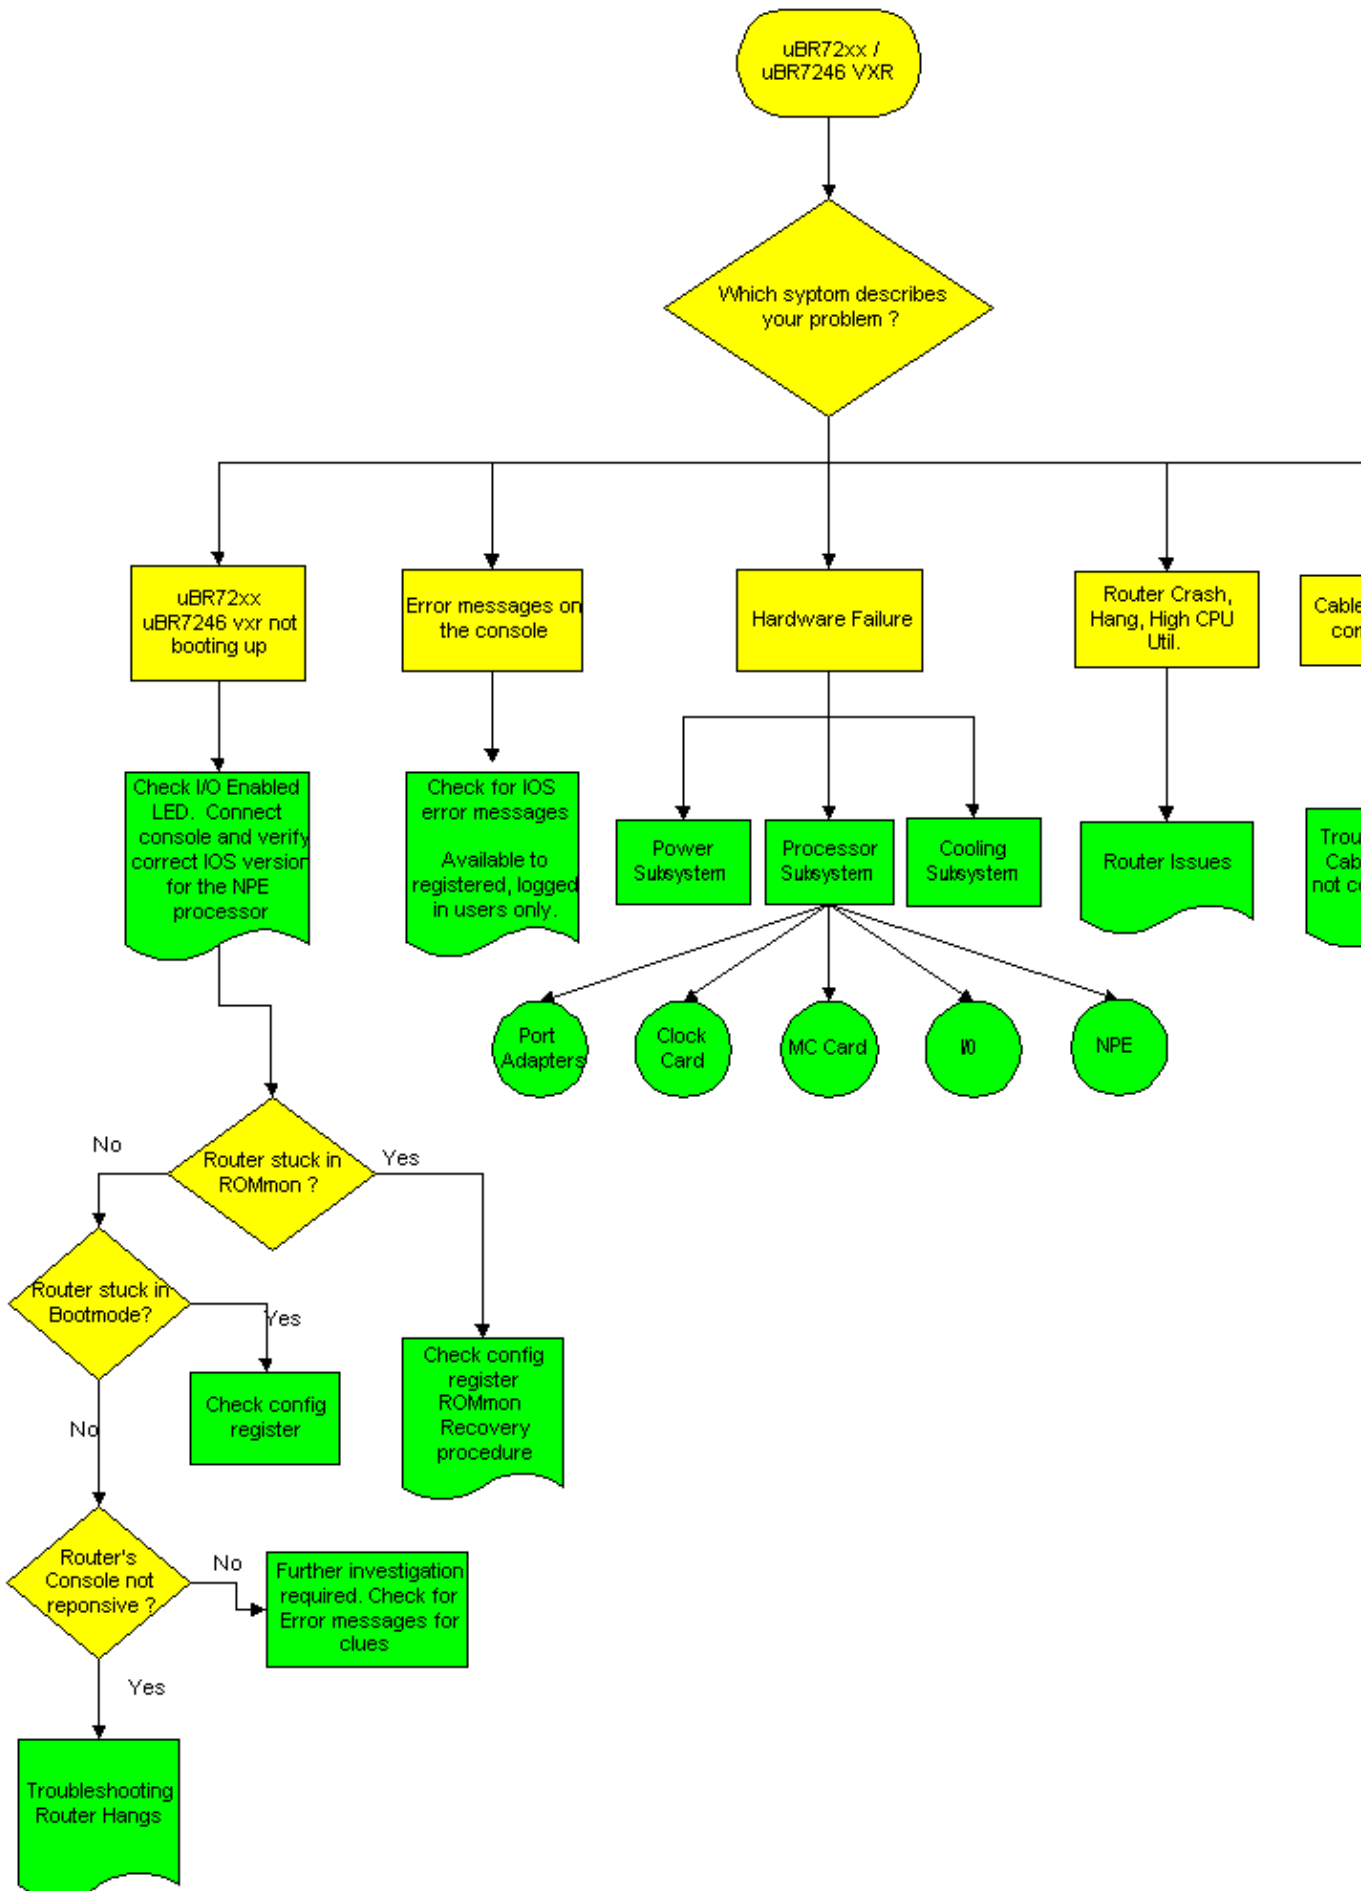
Referring to the flowchart below, there are five common failures the Cisco uBR72xx / uBR7246 VXR Universal Broadband Router can encounter:

- uBR72xx / uBR7246 VXR Not Booting Up
- Error Messages Appearing on the Console
- Hardware Failure
- Router Crash, Hang or High CPU Utilization
- Cable Modems Not Coming Online

All green symbols are linked to different sections in this document to assist the reader in getting quickly to the right troubleshooting area.
