Troubleshooting Versatile Interface Processor (VIP) Crashes

Document ID: 12811

This document provides information to troubleshoot a Versatile Interface Processor (VIP) crash.

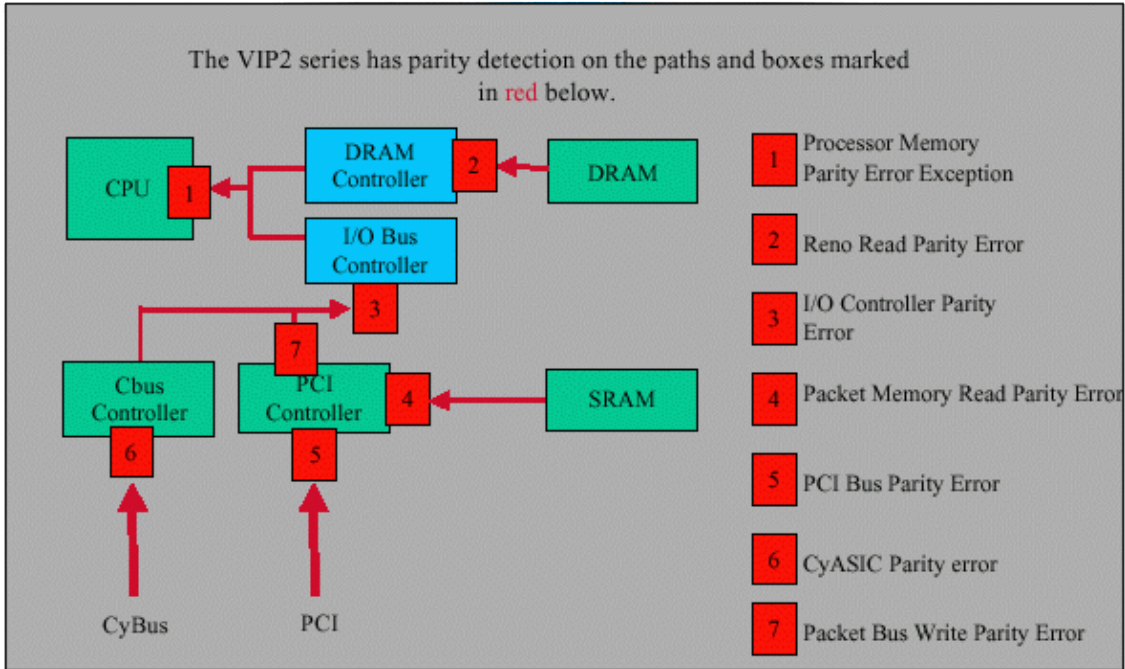
VIP2 Parity Error Detection

Parity errors occur on a VIP when the hardware attempts to check the validity of data by comparing computed parity values to previous parity values for the same data. A single bit flip in the data can result in a parity error. When you diagnose parity errors on a VIP, it is important to understand each location at which parity is checked and at which parity errors can potentially occur. This diagram outlines this information. In addition, refer to Cisco 7500 VIP Fault Tree Analysis for more information about parity errors.

As shown in this diagram, there are seven different types of parity errors that can occur on a VIP. Note that errors can be received from another source and might not have originated within the VIP itself. The source of the parity error can be from the Route/Switch Processor (RSP), another VIP, or from poorly seated or faulty port adapters. In order to properly understand a VIP crash, it is important to diagnose the source of the crash.

It is also important to understand that data with bad parity can be reported by several of the parity checking devices on the VIP and Cisco 7500 Series Router for any single read or write operation. For example, if the VIP reads a packet on a transmit queue on the RSP into its own SRAM, and there is a parity error in the SRAM of the RSP, then you see error messages from the MD ASIC on the RSP, the CYA ASIC on the VIP, and also the PCI/packet memory ASIC on the VIP.
