Upgrading the VPN 3002 Hardware Client from a VPN 3000 Series Concentrator

Document ID: 14098

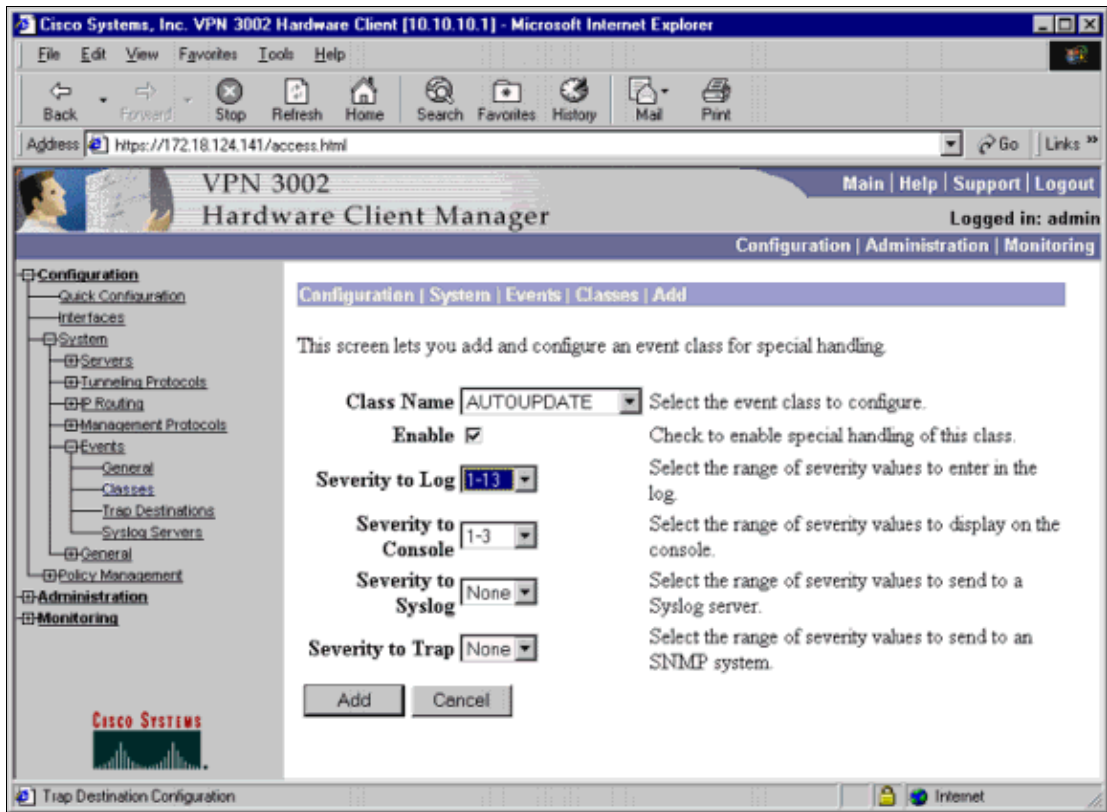
1. Add the debug by selecting **Configuration > System > Events > Classes**. Add these settings.
 - ◆ Class Name: **AUTOUPDATE**
 - ◆ Severity to Log: **1-13**
 - ◆ Severity to Console: **1-3**
