Upgrading VxWorks Firmware from the Console

Document ID: 14235

Introduction

This document illustrates the methods used to upgrade an Access Point (AP) that runs VxWorks firmware through a console connection. This method is useful when the user does not have an FTP server or the AP is not configured with an IP address where a browser can connect. Refer to the Updating Firmware section of Managing Firmware and Configurations for directions on how to perform a firmware upgrade through a web browser or from a file server.

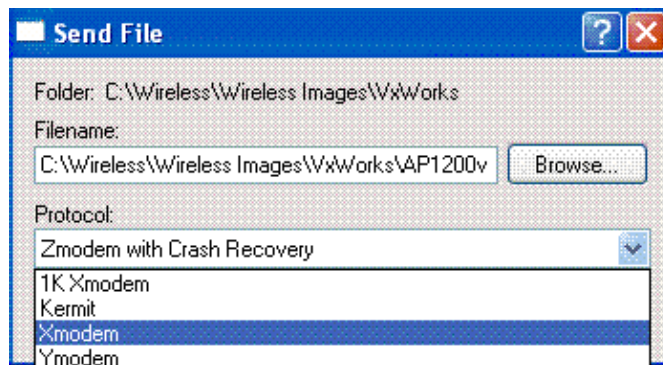
- a. Click the **Transfer** tab on the Menu bar in the Hyper Terminal window.
- b. Choose the **Send File** tab on the pop-up window.
- c. Under the Send File window, browse and choose the appropriate Uncompressed Image file (img) to which this AP needs to be upgraded. You should have already downloaded this uncompressed image file on your PC.
- d. Choose **Xmodem** as your Protocol used to send the file to the AP.

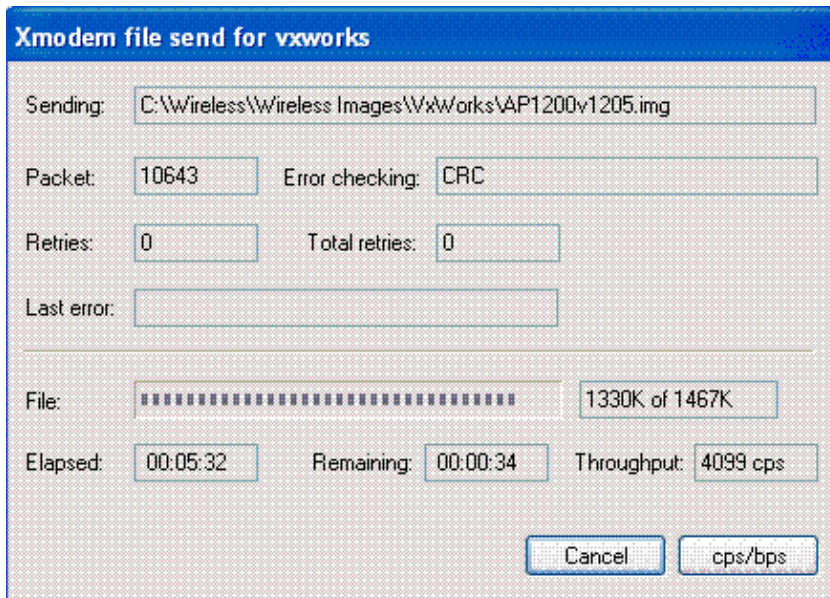
13. Now, the file transfer via Xmodem protocol initiates. This is how the Xmodem file transfer window looks:
