Troubleshooting Dial Technology Connectivity – Callin

Document ID: 14951

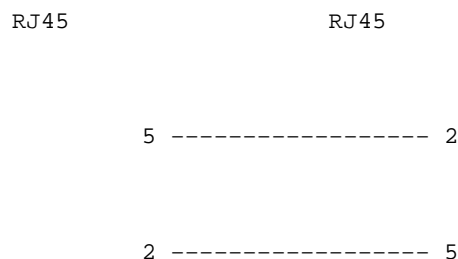
RJ45 to RJ45 crossover cable:

- ◆ If the order of the colored pins is the same at each end, the cable is straight.
- ◆ If the order of the colors is reversed at each end, the cable is rolled.
- ◆ The cable is a crossover cable if colors indicate the following:

4 ----- 1

1 ----- 4

4. If an external modem is not answering, check the cabling between the modem and the access server or router. Confirm that the modem is connected to the TTY or auxiliary port on the router with a rolled RJ-45 cable and an MMOD DB-25 adapter. Cisco recommends and supports this cable configuration for RJ-45 ports. Note that these connectors are typically labeled: Modem.
