Troubleshooting Hardware and Related Issues on the MSFC, MSFC2, and MSFC2a

Document ID: 18000

This document helps to troubleshoot issues with the Multilayer Switch Feature Card (MSFC) and the MSFC2 for the Cisco Catalyst 6500/6000 series switches and the Cisco 7600 series routers.

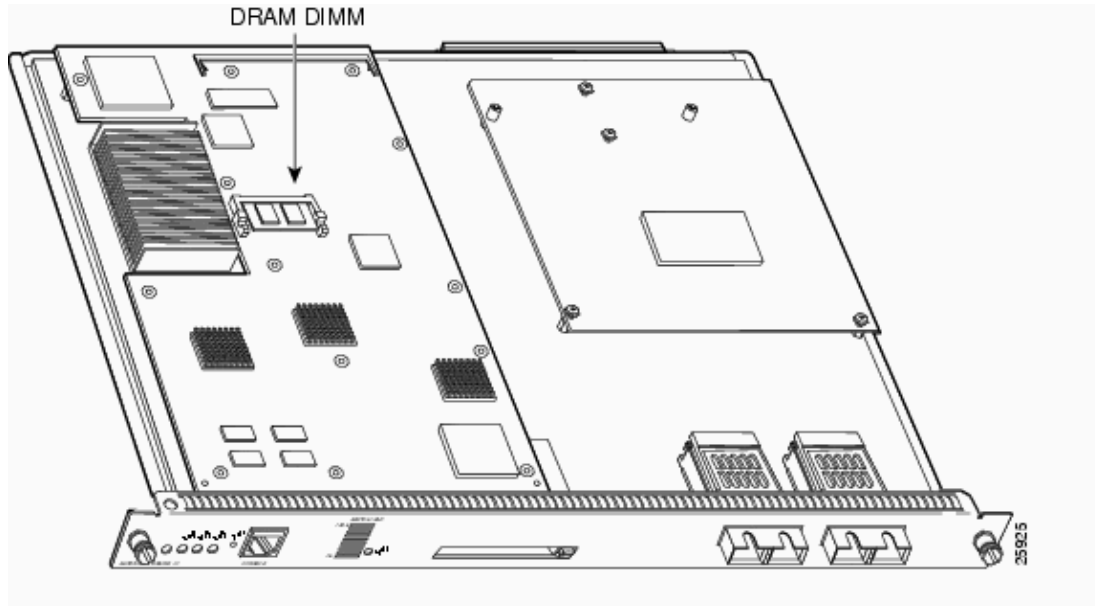
Two DRAM slots are stacked on top of one another on the MSFC.

Note: This image does not show the stacked slots.

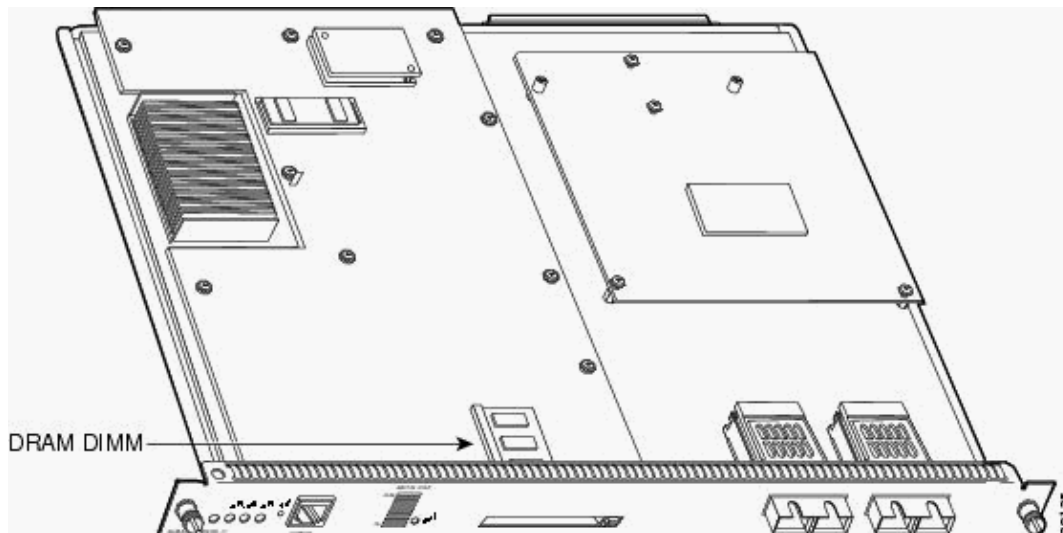
MSFC2 That Shipped Before November 2001 DRAM DIMM Location

The MSFC2 has only one DRAM slot.
