Troubleshooting Hardware and Related Issues on the MSFC, MSFC2, and MSFC2a

Document ID: 18000

This document helps to troubleshoot issues with the Multilayer Switch Feature Card (MSFC) and the MSFC2 for the Cisco Catalyst 6500/6000 series switches and the Cisco 7600 series routers.

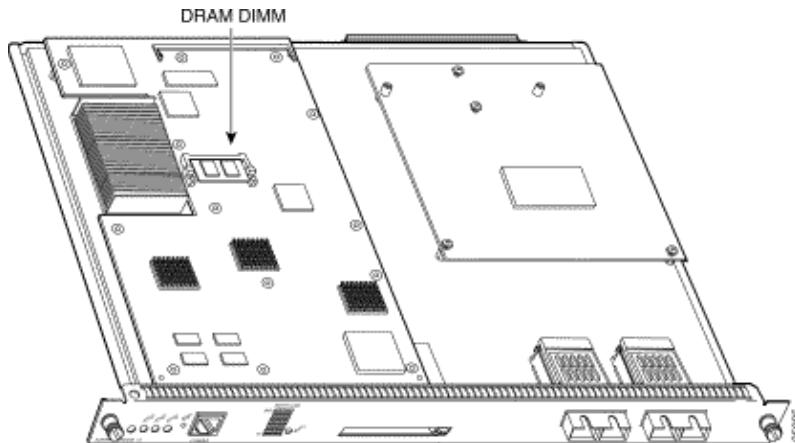
Two DRAM slots are stacked on top of one another on the MSFC.

Note: This image does not show the stacked slots.

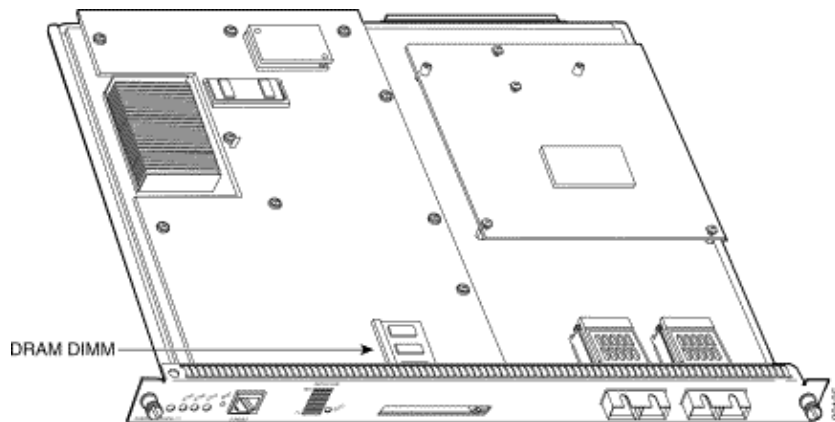
MSFC2 That Shipped Before November 2001 DRAM DIMM Location

The MSFC2 has only one DRAM slot.

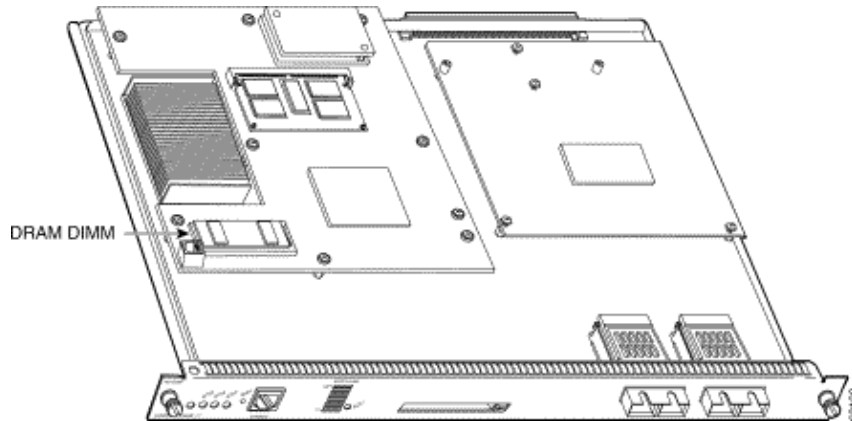
MSFC2 That Shipped After November 2001 DRAM DIMM Location

The MSFC2 has only one DRAM slot.
