# Hardware Troubleshooting for the AS5800

Document ID: 18899

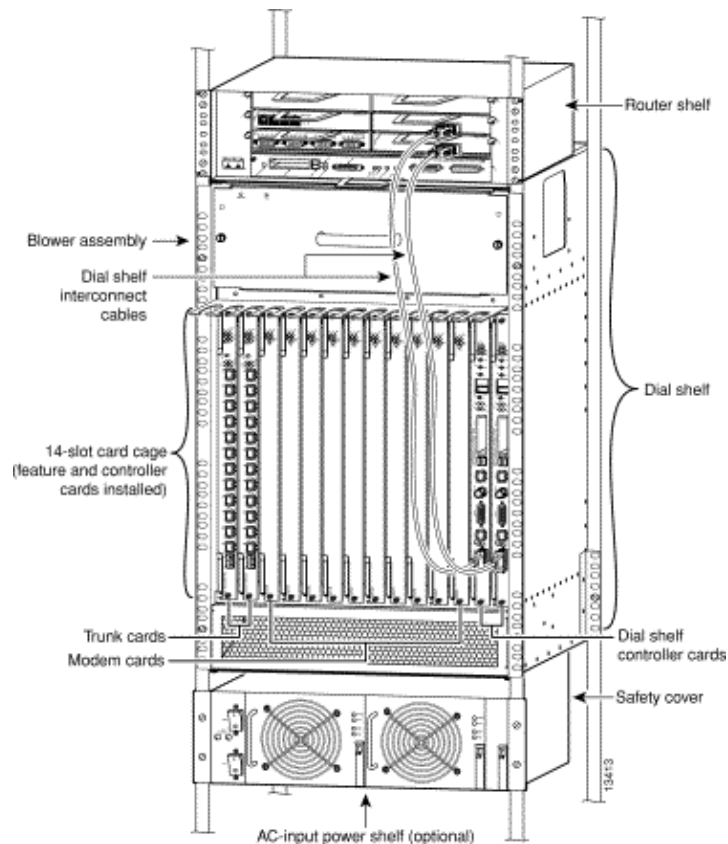
This diagram shows the various components of the AS5800:

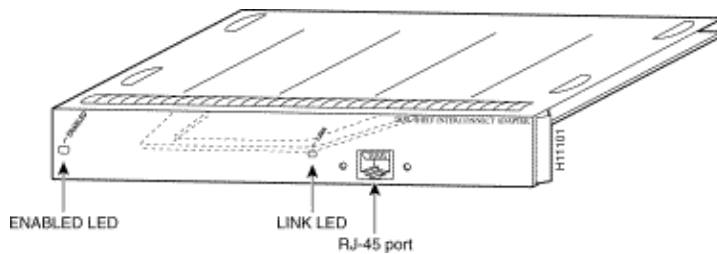
5. Does the Dial Shelf Interconnect (DSI) port adapter Link LED (on the router–shelf) stay on?

The link status LED indicates an active connection to the dial shelf and lights up when the interconnect port adapter is receiving a carrier signal from the dial shelf controller card. This LED should light up and remain green when the access server is operating.

If the interconnect port adapter link LED does not light up, refer to the **Troubleshooting the Dial Shelf Interconnect Port Adapter** section of the AS5800 Hardware Troubleshooting document.
