Fax Relay Troubleshooting Guide

Document ID: 20227

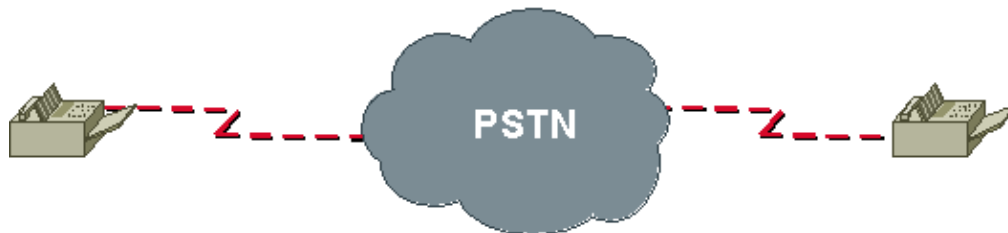
The half-duplex fax negotiation occurs at the start of a fax call. V.21 modulated High-level Data Link Control (HDLC) data frames are passed at a speed of 300 bps. These data frames are sent in a standard sequence between the origination and termination fax devices. In this exchange, each fax device exchanges its capabilities, and both fax devices agree on the fax session characteristics before the page transmission takes place. This illustration shows a traditional fax call over PSTN.

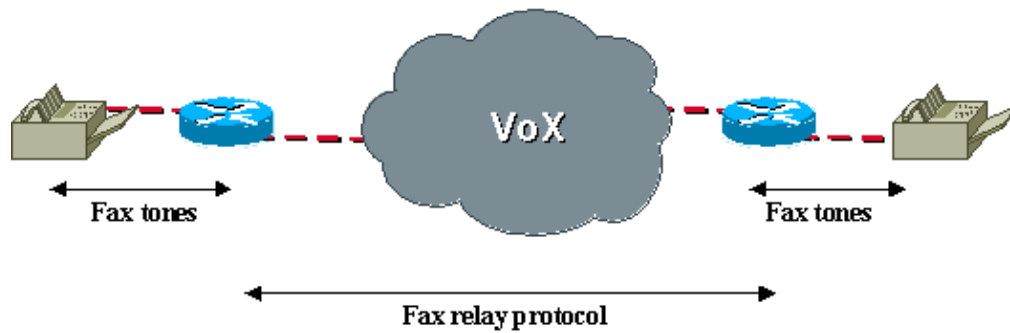
This diagram illustrates fax relay over a VoX network. The fax connection to the origination and termination gateways can be directly into FXS ports on the gateway, or can be via a PBX or the PSTN into an E1, Basic Rate Interface (BRI), FXO, or E&M port on the gateway.

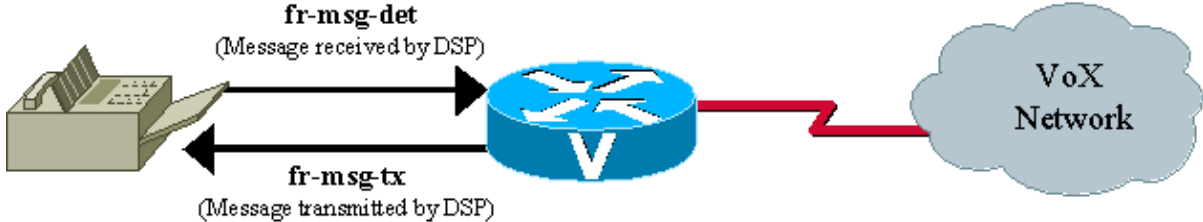
This debug shows the T.30 events that take place in the DSP within fax relay. It is important to remember that the debugs that take place from the perspective of the DSP interact with the fax device, so any "Fr-MSG-TX" or transmit message is transmitted from the DSP to the connected fax device. Any message that the DSP says that it detects, or "fr-msg-det" message, is a message that it received from the connected fax device. This graphic illustrates the directional flow of the DSP messages when the **debug fax relay t30 all** command is issued.

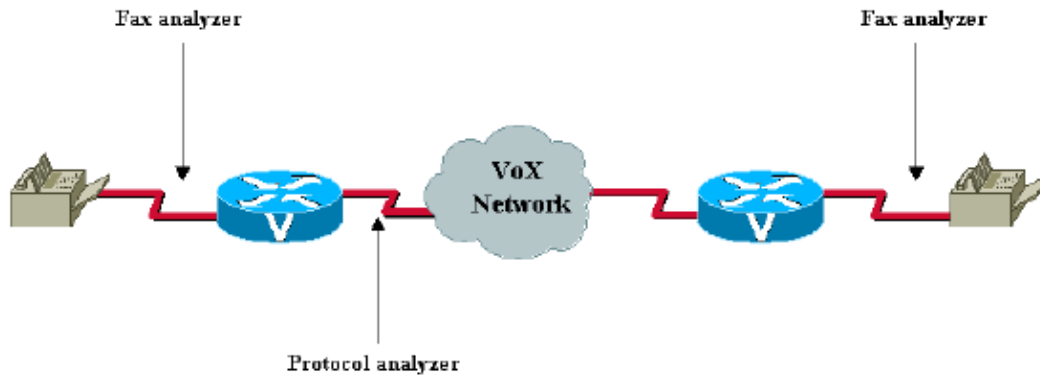
The ability to resolve a complex problem sometimes requires a combination of equipment an analyzer to capture the fax traffic at each fax machine and a protocol analyzer to capture the fax relay packets. A single fax call is placed to reproduce the problem, and then the information is captured from the attached devices for analysis. This diagram shows where in the network this test equipment is placed.

Sometimes it is necessary to go beyond the debugging capabilities of the Cisco voice gateways to resolve fax relay problems. Tools such as protocol analyzers and fax analyzers are used to see what occurs in fax relay operation. Fax analyzers such as the Genoa ChannelProbe/FaxProbe by QualityLogic or the HP Telegra can be positioned between the fax device and the Cisco gateway to capture what occurs. Protocol analyzers such as Sniffer and Domino can be helpful when you need to view the fax relay packets that are exchanged between the routers.
