Fax Relay Troubleshooting Guide

Document ID: 20227

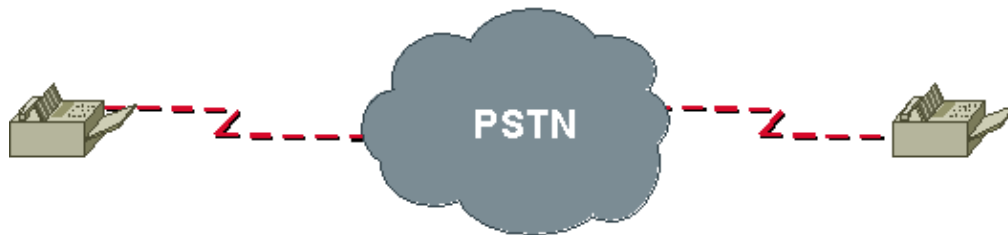
The half-duplex fax negotiation occurs at the start of a fax call. V.21 modulated High-level Data Link Control (HDLC) data frames are passed at a speed of 300 bps. These data frames are sent in a standard sequence between the origination and termination fax devices. In this exchange, each fax device exchanges its capabilities, and both fax devices agree on the fax session characteristics before the page transmission takes place. This illustration shows a traditional fax call over PSTN.

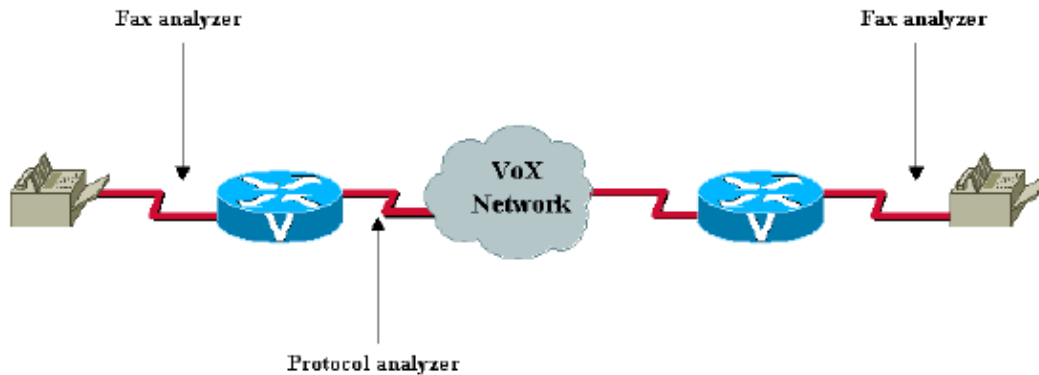
The ability to resolve a complex problem sometimes requires a combination of equipment an analyzer to capture the fax traffic at each fax machine and a protocol analyzer to capture the fax relay packets. A single fax call is placed to reproduce the problem, and then the information is captured from the attached devices for analysis. This diagram shows where in the network this test equipment is placed.

Sometimes it is necessary to go beyond the debugging capabilities of the Cisco voice gateways to resolve fax relay problems. Tools such as protocol analyzers and fax analyzers are used to see what occurs in fax relay operation. Fax analyzers such as the Genoa ChannelProbe/FaxProbe by QualityLogic or the HP Telegra can be positioned between the fax device and the Cisco gateway to capture what occurs. Protocol analyzers such as Sniffer and Domino can be helpful when you need to view the fax relay packets that are exchanged between the routers.

Most of the fax analyzers have adequate help screens and documentation to help you determine what happens. The T.30 specification is also very helpful. For the protocol analyzers, decoding can be a little more difficult since sometimes the encodings are proprietary, or the analyzer software does not have the specific decode needed. For fax relay that uses VoFR and VoATM, Cisco gateways use standards-based Annex D from the FRF11 specification. If the protocol analyzer is not able to decode the frame, the frame can be manually decoded with this specification. With fax relay and VoIP, a Cisco proprietary format is used for the fax relay packets.
