Understanding EtherChannel Inconsistency Detection

Document ID: 20625

This document provides information on EtherChannel inconsistency and how it is detected in Cisco Catalyst switches.

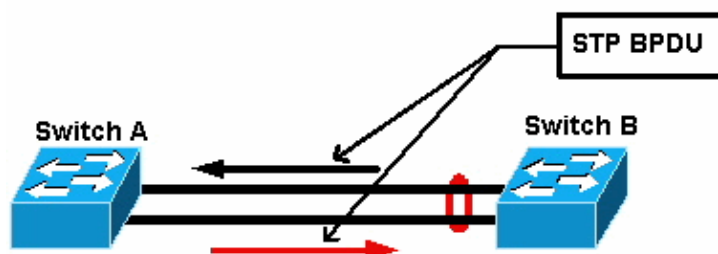
This is not the case if one switch considers the links to be a channel and a neighbor switch considers those links to be separate connections, that is, inconsistent. Consider this example:

In the diagram, switch A does not channel, while switch B channels. Assume that the STP designated port for the channel is on the switch B side. This means that switch B is supposed to send BPDUs. As long as the channel is regarded as a single STP port, only one BPDU is sent for each VLAN on the channel. This BPDU is physically transmitted by one of the links in the channel. Therefore, only one of the ports on switch A receives it. This is represented with a black arrow in the diagram.

After switch A receives the BPDU, the other port on switch A becomes the STP designated port. This is because the port is not bundled as a channel with the port that received the BPDU, and it does not receive BPDUs directly from switch B. As the STP designated port on switch A, it now transmits BPDUs, which are represented by the red arrow in the diagram, back to switch B. Switch B receives BPDUs from switch A, and an inconsistency is detected.

As mentioned in the Background section, an EtherChannel is seen as a single port by STP. All the ports in the channel share the same STP state and only one STP bridge protocol data unit (BPDU) can be sent or received for each VLAN and for each hello interval.
