Troubleshooting PVC Failures When Using OAM Cells and PVC Management

Document ID: 21424

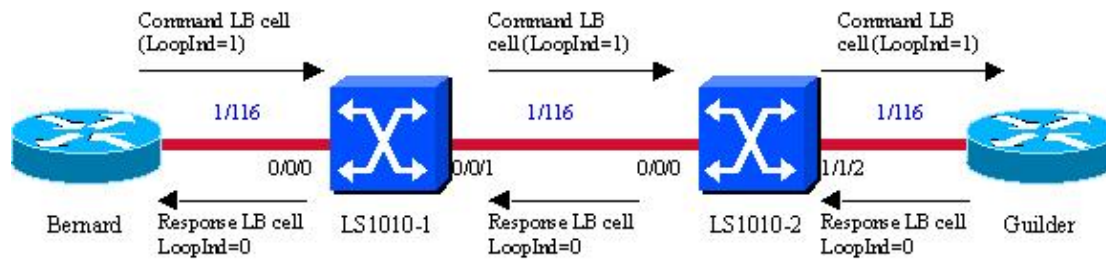
Identifiers in the loopback cell indicate which device(s) should loop the cell. A Cisco device that terminates a VC when receiving such a cell on a PVC will loop it even if it is not configured for OAM. Also, each of these cells will contain a "direction" indicator (to identify if it is a command or response cell) and a sequence number (called *Correlation tag* or *CTag* in the debugs). The "command" loopback cell and the "response" loopback cell will have the same sequence number.

The following diagram illustrates loopback (LB) cells:

As you can see, F5 loopbacks were sent, but not answered (**18 F5 OutEndloop but only 9 F5 InEndloop; therefore, 9 F5 looped loopback cells were lost.**). This caused the PVC to go down (as PVC management is configured). F5 OutEndloop represents the number of loopback cells sent and F5 InEndloop represents the number of F5 loopback cells received.
