Replacing the Alarm Interface Panel on a Cisco ONS 15454

Document ID: 23153

This document describes how to change the alarm interface panel (AIP) board on a Cisco ONS 15454 shelf.

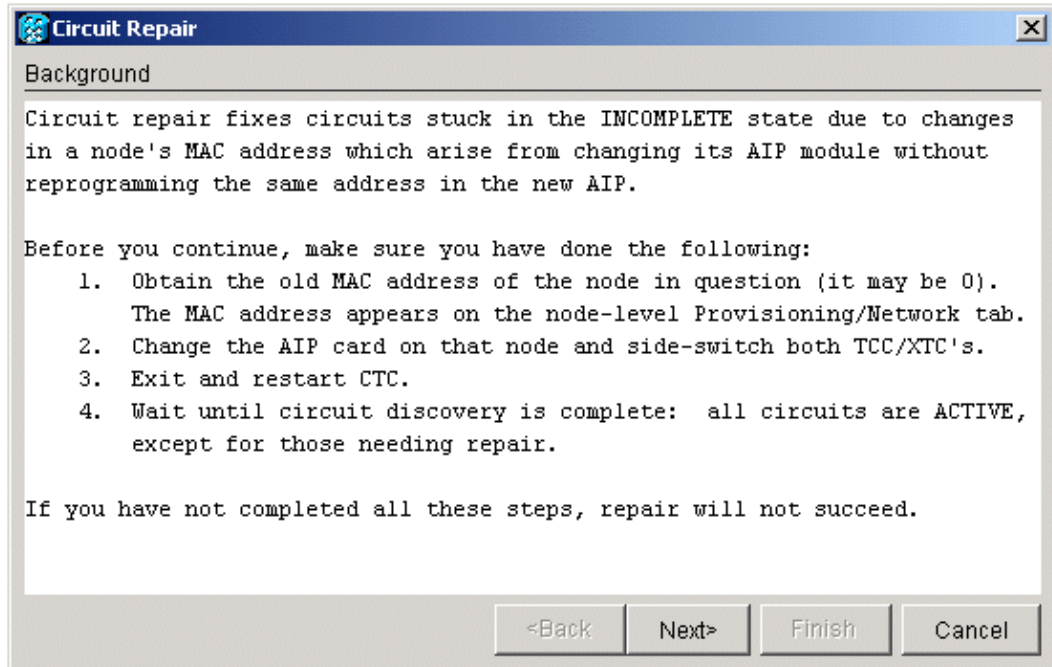
6. Repair the circuits. In the CTC menu, select **Tools > Repair Circuits**. This window displays:
