# Understanding and Troubleshooting Astro/Lemans/NiceR Timeouts on Catalyst 4000/4500 Series Switches

Document ID: 45640

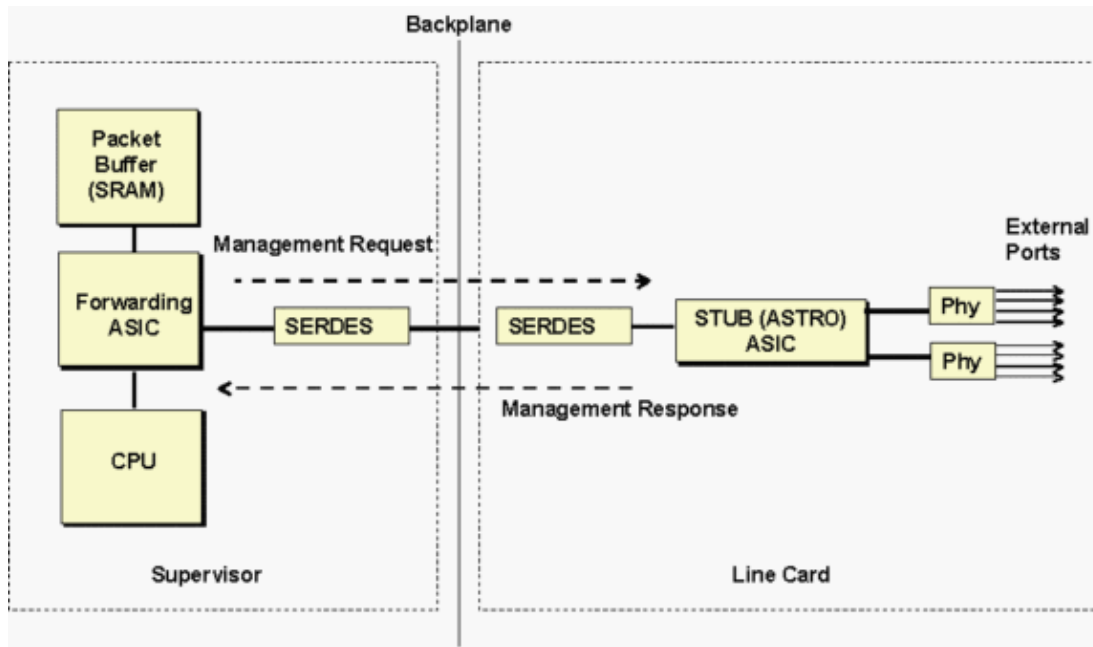
Astro stub ASIC refers to the 10/100 stub ASICs controls a group of eight adjacent 10/100 ports communicating to the Supervisor through a Gigabit bandwidth connection to the backplane, as shown in Figure below.

The Supervisors communicate to the Line Card stub ASIC through the SERDES (SERIALIZER–DESERIALIZER) component. There is a SERDES component on the Supervisor side connecting to the backplane and another SERDES on the line card for each stub ASIC for connecting to the backplane.

The above diagram can be used in general to troubleshoot different type of line cards. The stub ASIC referred in the timeout messages would be different depending on the type of line card. See the table below for a list of ASIC names and their description.
