# Troubleshooting Unrecognized Voice Interface Cards on Cisco 1750, 1751, and 1760 Routers

Document ID: 5711

This document explains how to troubleshoot a Cisco 1750, Cisco 1751, or Cisco 1760 router that does not recognize Voice Interface Cards (VICs).

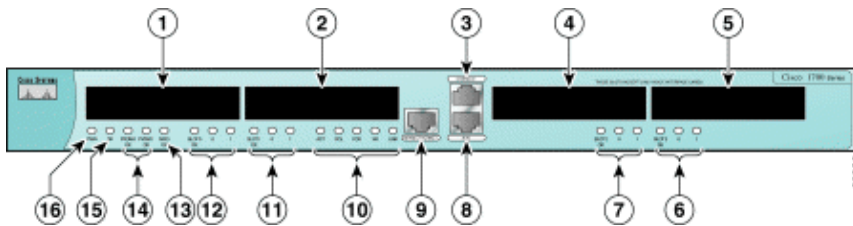
The Cisco 1760 has two PVDM OK LEDs, 0 and 1. There is one for each PVDM card slot. These LEDs are on the front panel. The number 14 indicates them in this diagram:

This table describes the other numbers in this diagram:

Location	Function
1	WIC/VIC Slot 0
2	WIC/VIC Slot 1
3	Console Port
4	VIC Slot 2
5	VIC Slot 3
6	Slot 3 LEDs
7	Slot 2 LEDs
8	Auxiliary Port
9	Ethernet Port
10	Ethernet LEDs
11	Slot 1 LEDs
12	Slot 0 LEDs
13	MOD OK LED
14	PVDM 0/1 OK LEDs
15	Router OK LED
16	Power LED
