Cisco ONS 15454 ML Card Troubleshooting

Document ID: 59863

This document uses a simple test topology to describe how to troubleshoot Multi-Layer (ML) cards on Cisco ONS 15454. The Appendix section provides some basic configuration commands, and detailed topology information.

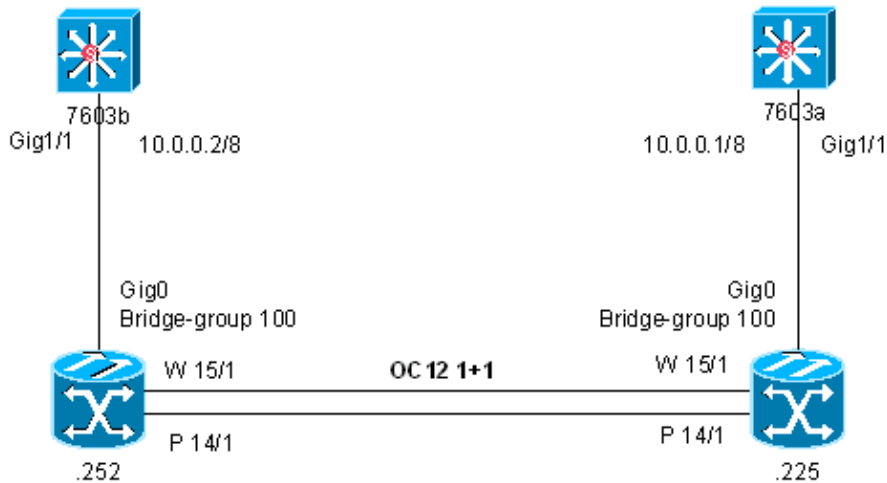
Figure 1 Test Topology

Figure 1 represents the test topology:

1. Connect two Cisco 7603 routers to ONS nodes over Gigabit Ethernet, and ensure that both ports on the two routers are on the same IP subnet. Here, each ONS node has one ML1000-2 card in slot 12.
2. Configure a bridge-group 100 for Gig0 and POS0 on both ONS nodes.

3. Disable IP routing on ML cards.
4. Provision OC12 1+1 protection between the two ONS nodes. See Figure 1 for the relevant information.
