# Replace the ML Series Card for Cisco ONS 15454

Document ID: 66131

This document describes the procedure to replace a Cisco Multi-Layer (ML) Series card for the ONS 15454 platform.

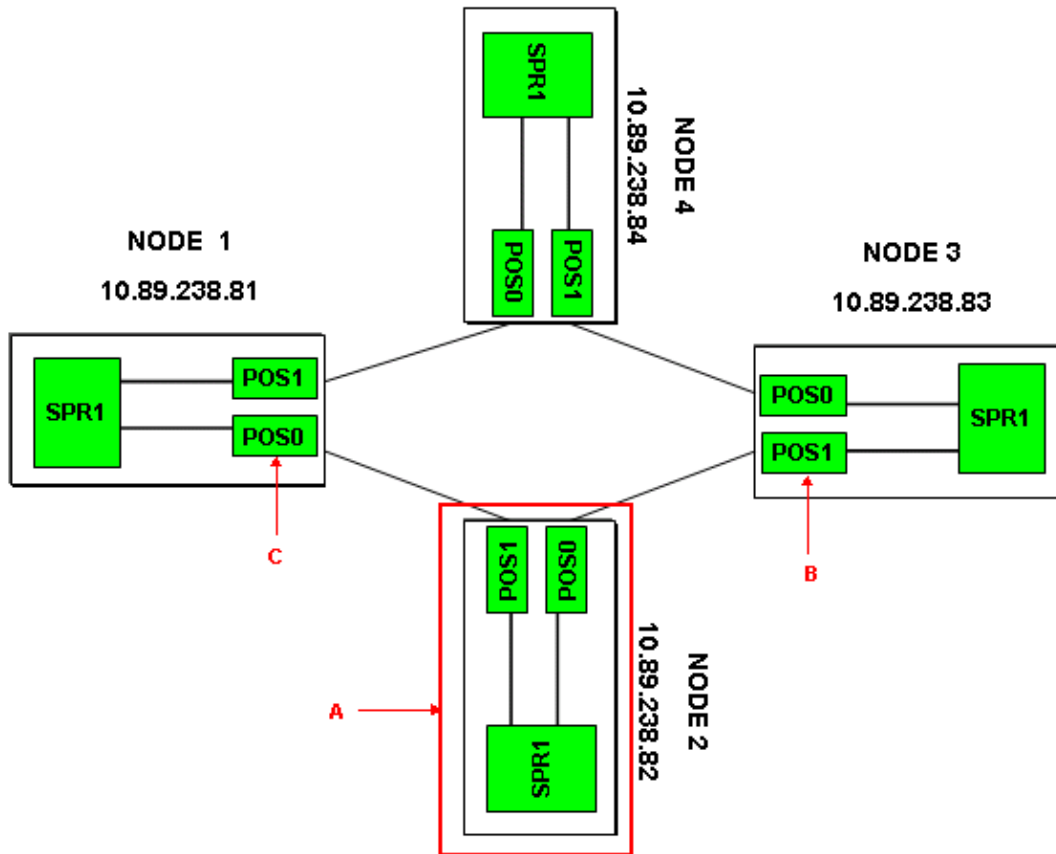
**Figure 2 RPR Ring Topology**

Each node has one ML 1000 card installed. These four ML cards form one Resilient Packet Ring (RPR). Figure 2 displays the configuration.

This procedure explains how to replace the ML Series card on node 2 with a new card (see arrow A in Figure 2). The two POS interfaces on the two adjacent ML cards are:

- POS 0 on node1 (see arrow C in Figure 2).
- POS 1 on node 3 (see arrow B in Figure 2).

11. Pull out the ML card on node 2 (see arrow A in Figure 2).
