MWI Failure on Phones Attached to Avaya G3 PBX Integrated with Cisco Unity

Document ID: 70357

This document describes one reason why the Message Waiting Indicator (MWI) on phones attached to the Avaya Definity G3 phone system fails to function in an integrated environment with Cisco Unity and Intel PBX–IP Media Gateway (PIMG).

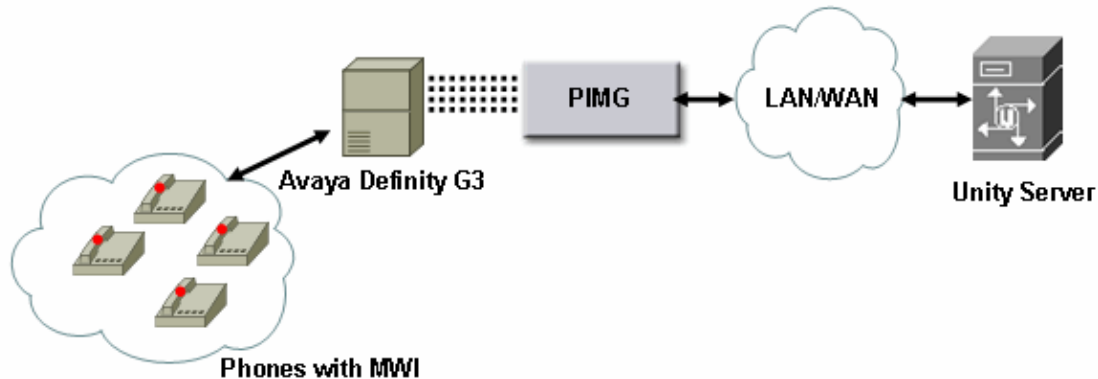
Figure 1 Topology

Types of hardware involved are:

- Cisco Unity server
- Microsoft Exchange server
- Intel PBX–IP Media Gateway
- Avaya Definity G3 phone system

Figure 1 shows the topology:
