Troubleshooting Cisco Express Forwarding–Related Error Messages

Document ID: 7603

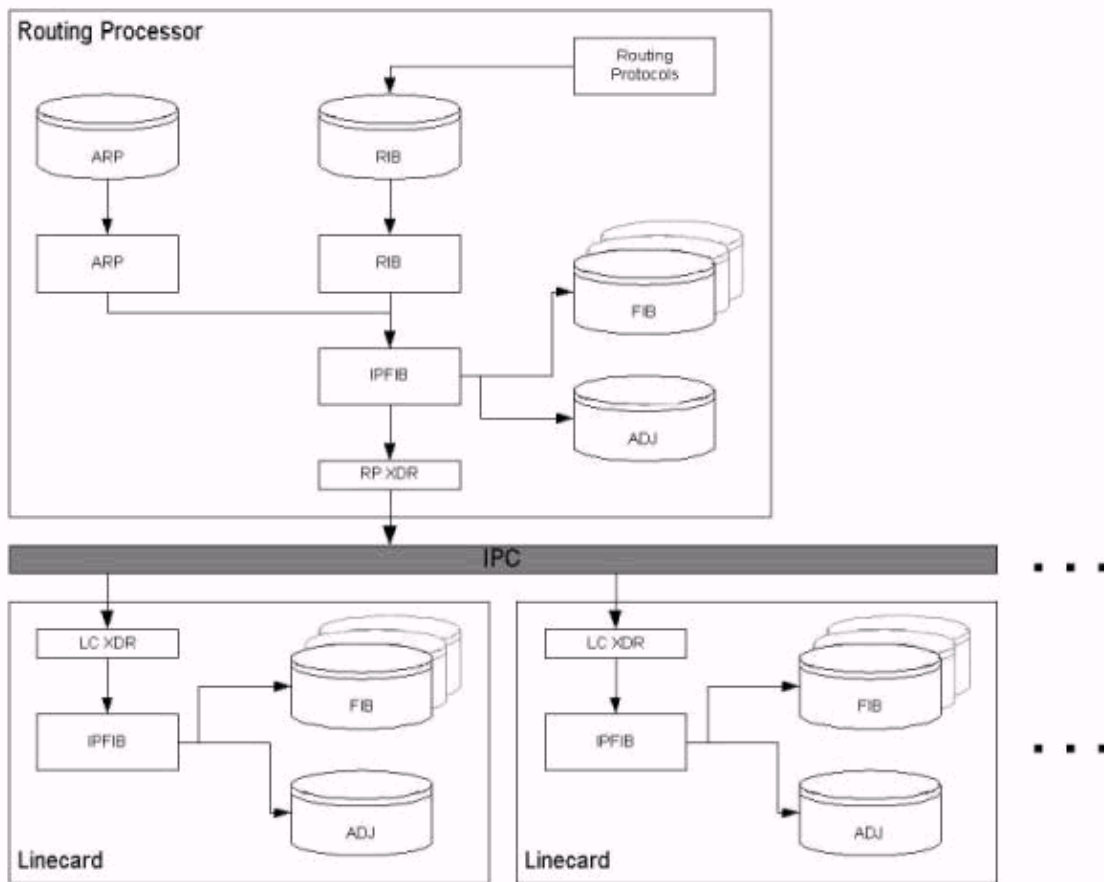
Here is an overview of the XDR architecture:

As explained in the Background section of this document, IPC messages transport the FIB and adjacency tables from the RP to the LCs. In other words, the IPC mechanism synchronizes both sets of tables on the RP and the LCs. Any data structure used by a feature must be transported to the LC through the FIB IPC, and the statistics must be sent back to the RP. When Distributed Cisco Express Forwarding is enabled, the LC makes the forwarding decision using the locally stored, replicated databases.

XDR is referred to as an IPC overlay mechanism. XDR messages are used exclusively with the Distributed Cisco Express Forwarding implementation.
