Cisco AssureWave Wireless LAN Controller

Release 7.4.110.0 Test Results

Executive Summary

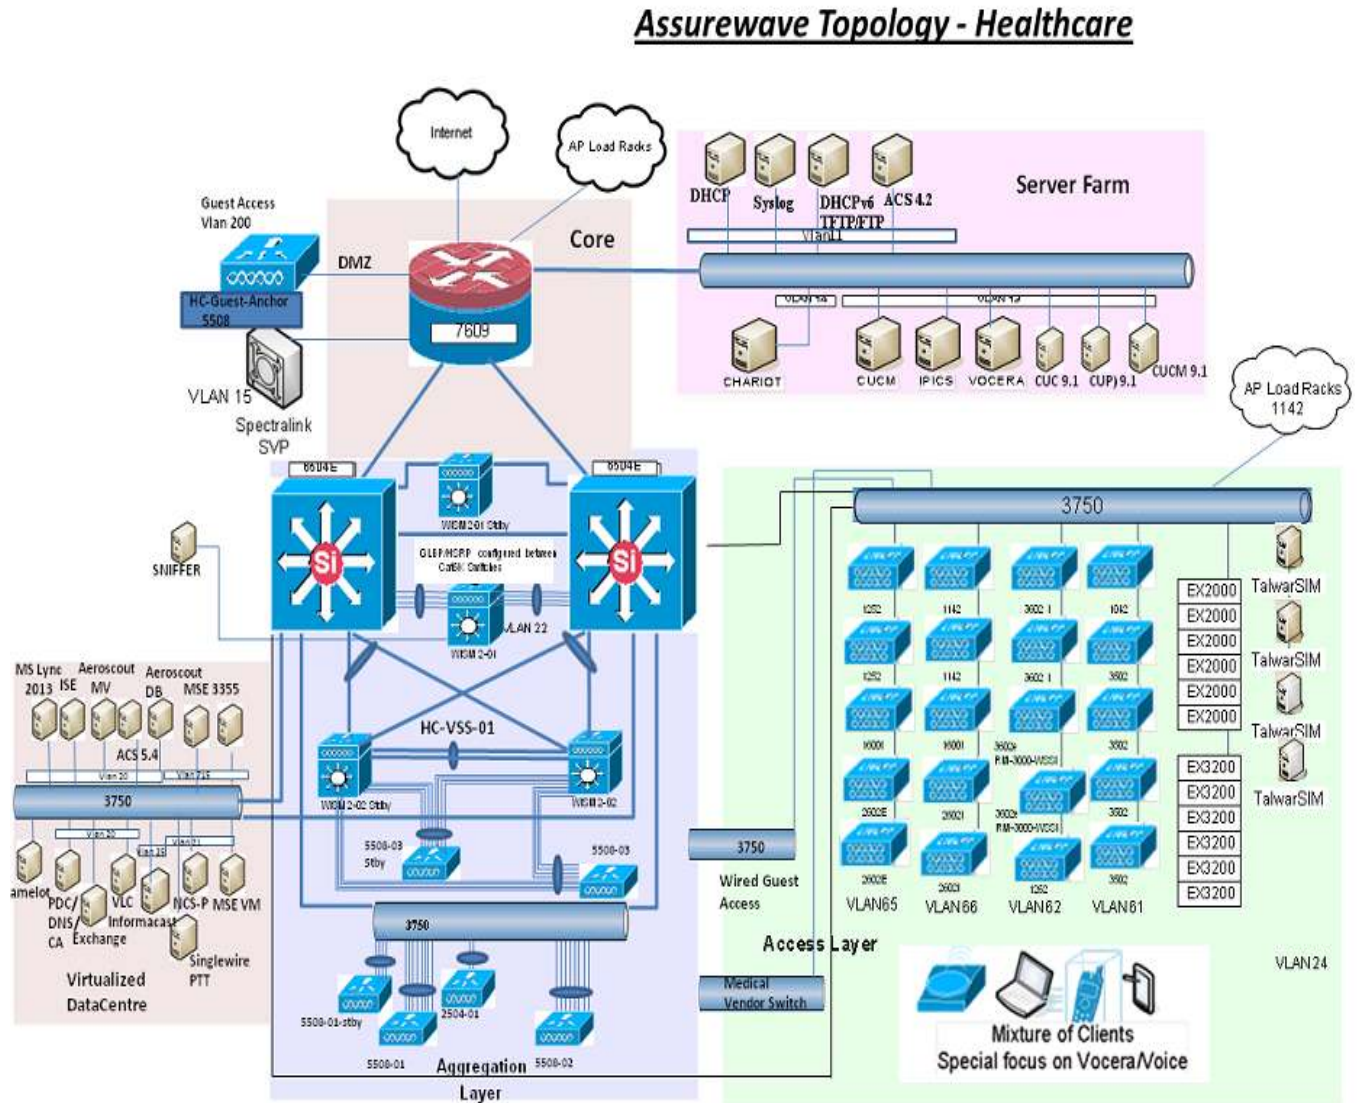
Healthcare Test Topology

Figure 1 shows the test topology for the Healthcare vertical market.
