Nexus Validation Test

Phase 3.2

1. Introduction

This is an addendum to the NVT Phase 3.0 report. Please reference the NVT Phase 3 report for network topology and feature descriptions (located at the following link):

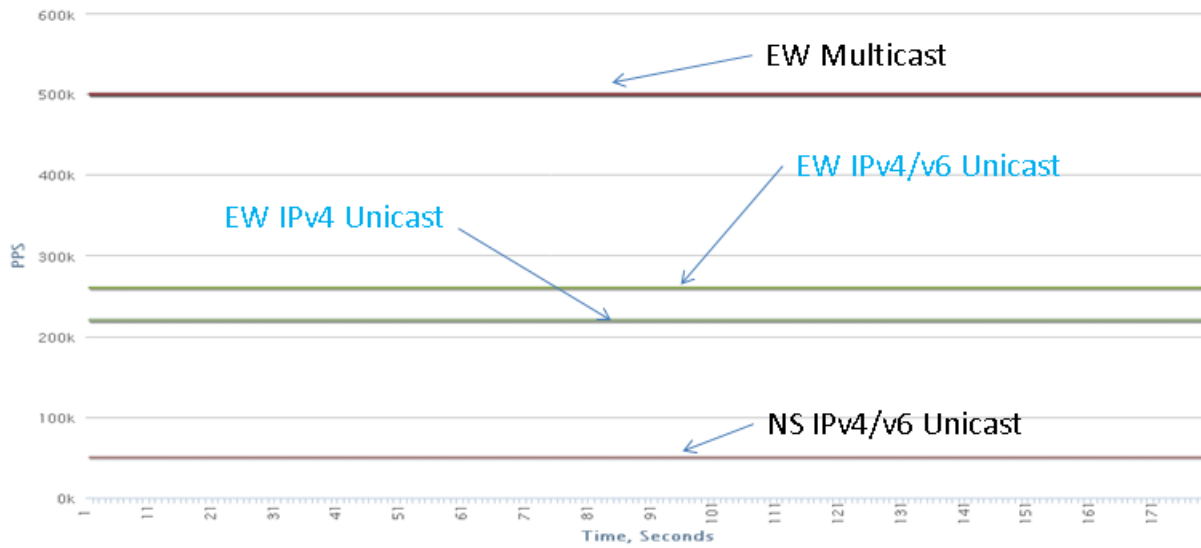
Figure 1 Legend

NS: North South traffic from upstream core switches towards leaf switches.

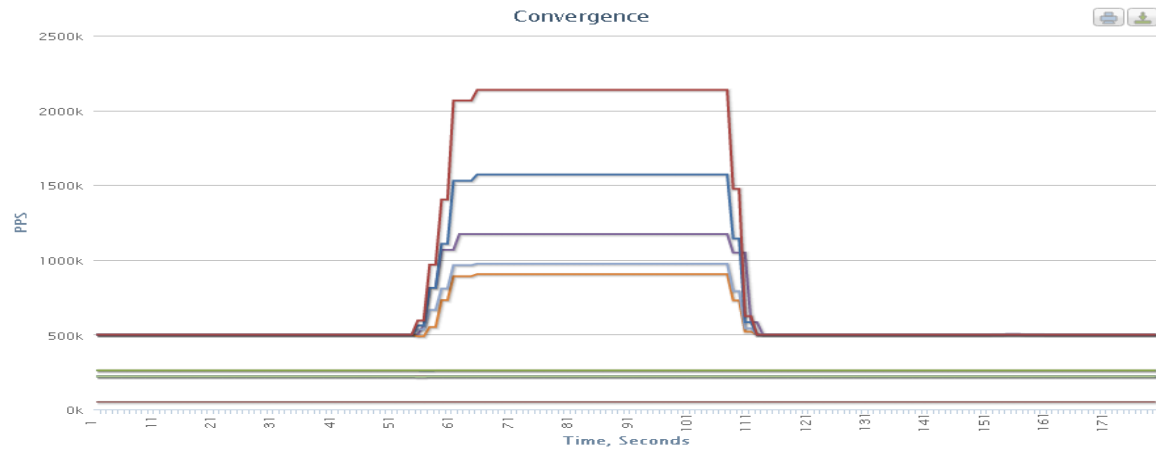
Figure 4 Software Version 6.0(2)U3(1) without Eternity command (Link NO shut)

Link NO Shut (No Eternity vs Eternity)

As seen in the convergence graphs below, packet duplication is eliminated for certain test cases such as local and remote link failure and recovery. The graphs shown below are for link failure and recovery between a spine switch and one of the leaf switches. Figure 4 & Figure 6 show network convergence for 6.0(2)U3(1) without *hardware profile multicast prefer-source-tree eternity* command whereas Figure 5 & Figure 7 show convergence with *hardware profile multicast prefer-source-tree eternity* command configured.

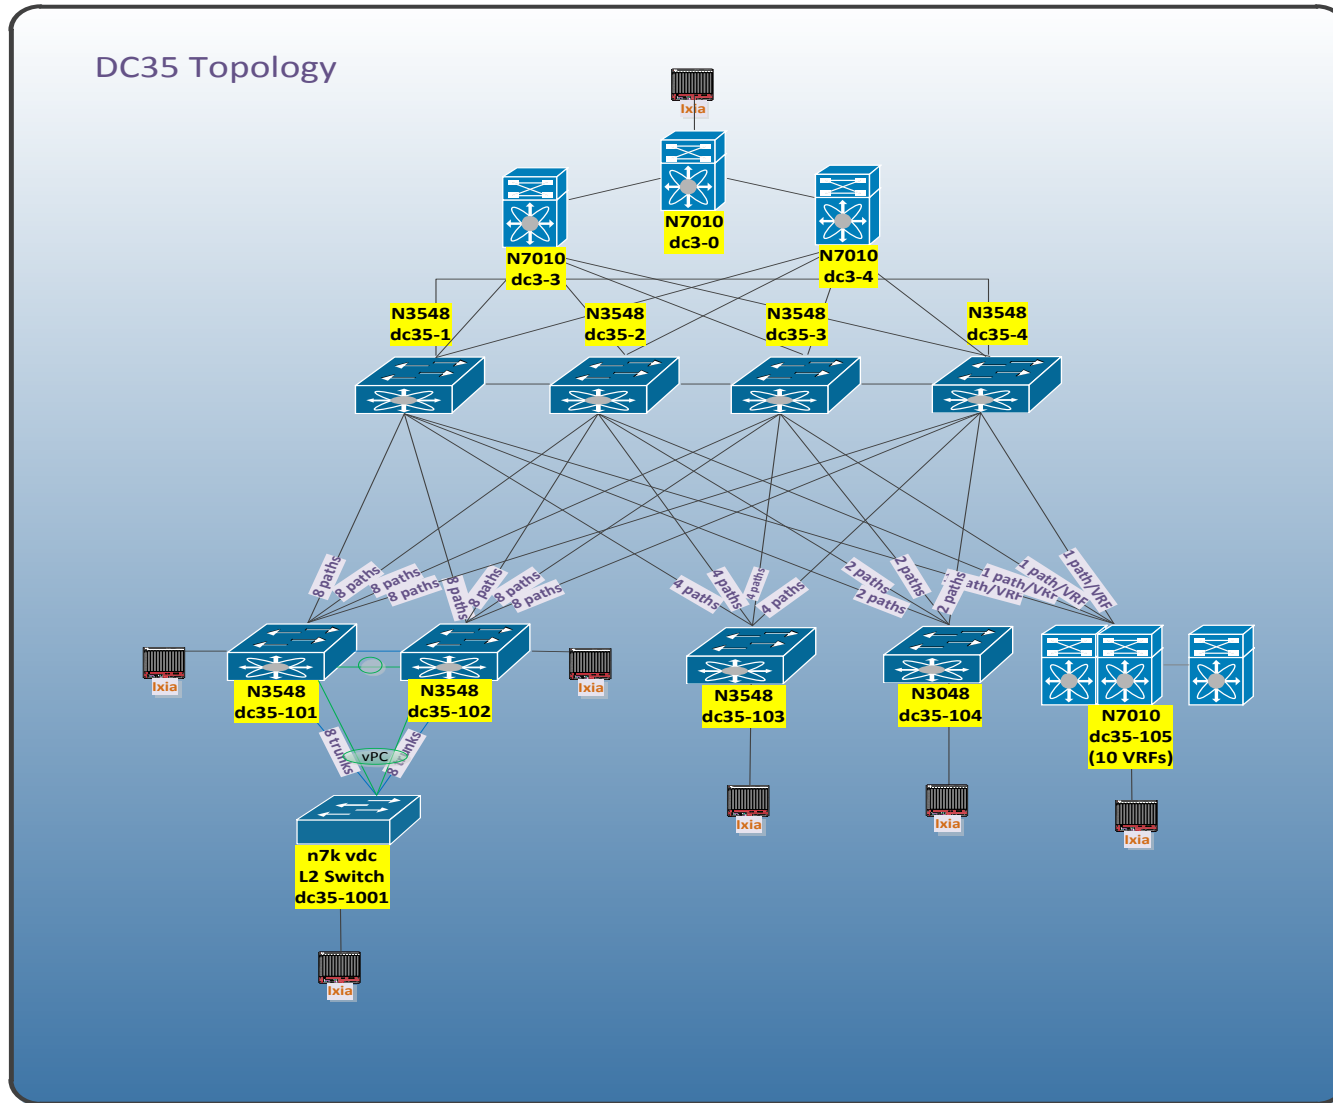
Figure 6 DC35 Topology

NVT has added a new topology based on the N3548 in Phase 3.2. The physical and logical designs are similar to DC32, except that it uses OSPF instead of BGP for unicast routing. VPC is a new feature for the N3548 and is covered as part of this topology.

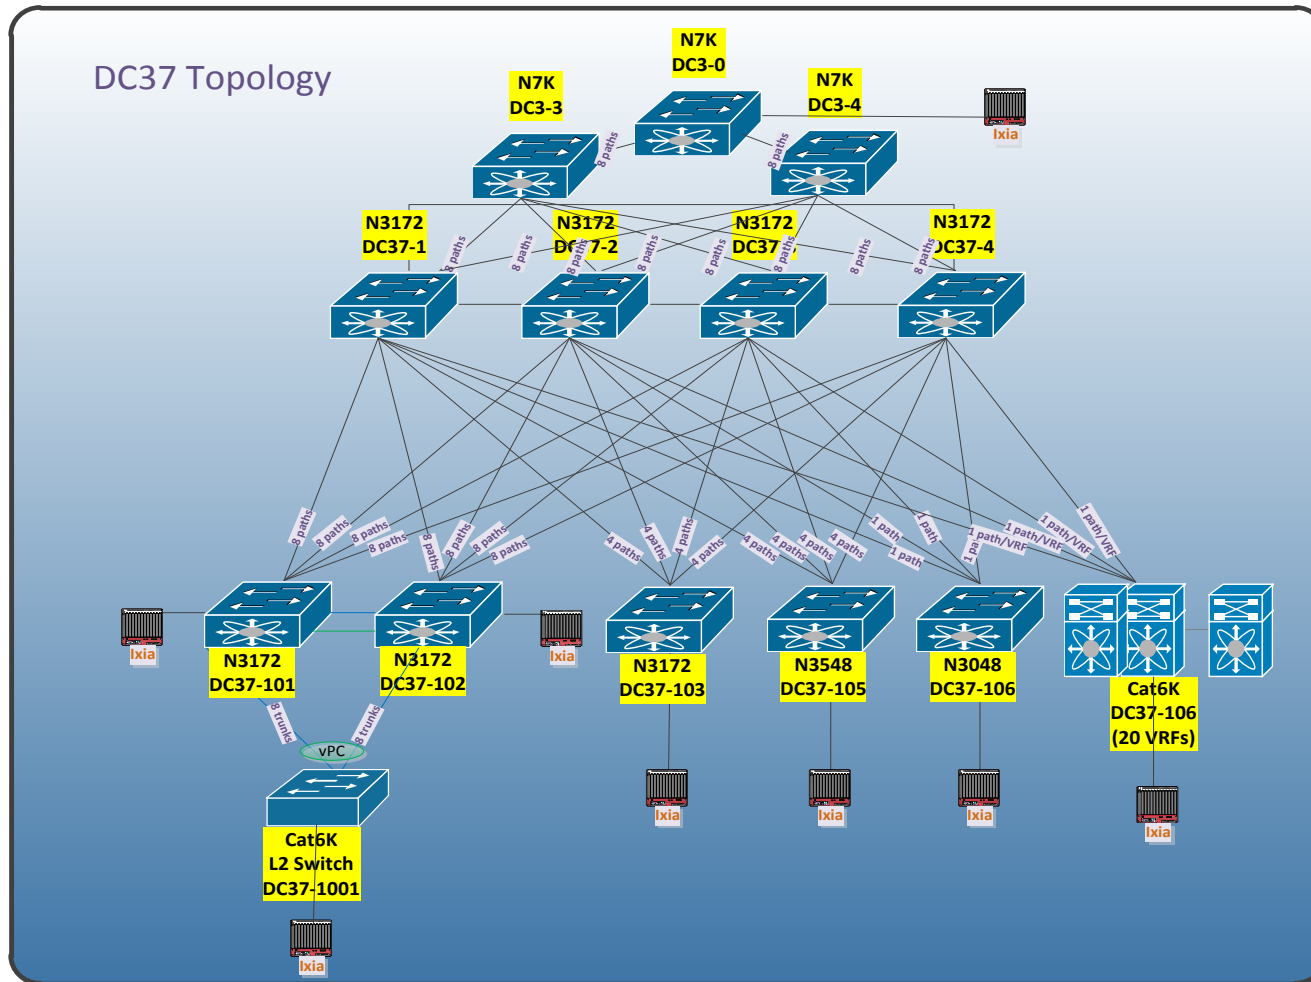
Figure 7 DC37 Topology

NVT has added a new topology as part of Phase 3.2 to cover the Nexus 3172. The logical topology is similar to the other phase 3 spine/leaf topologies discussed in the Phase 3.0 document. Interoperability with the N7K, N3548, N30xx, and Cat6K series of switches are also covered. Because the topology is logically similar to DC33 from Phase 3.0, the test cases are also similar.
