Cisco TelePresence SX, MX, and DX Series

Collaboration Endpoint Software 8

D15314.15

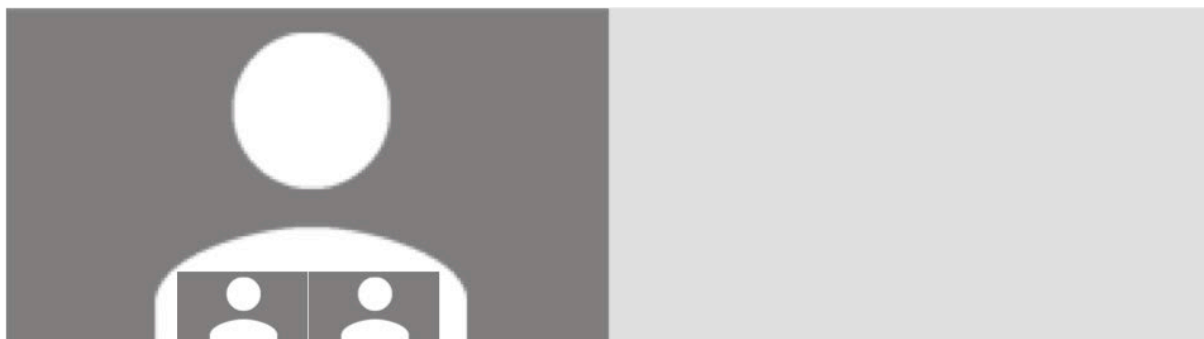
The above example shows a two-screen system in a conference where Multistream is not enabled. The endpoint is receiving only one transcoded stream from the Cisco TelePresence Server.

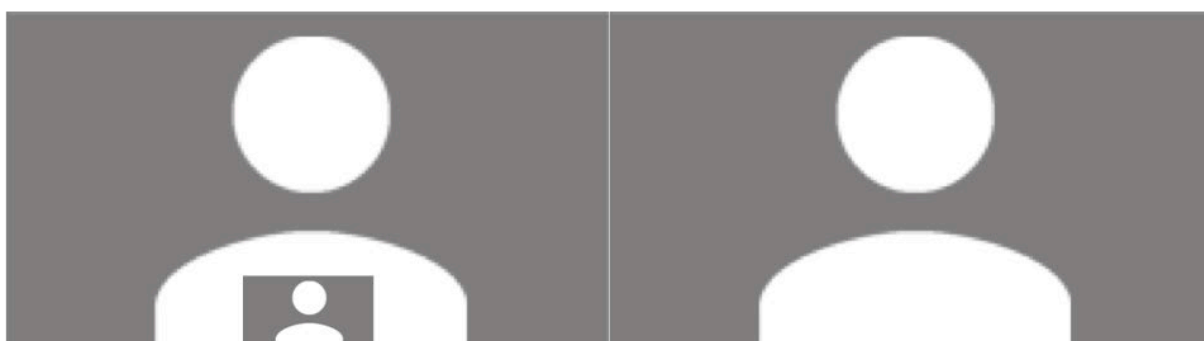
The above example shows the same conference with Multistream enabled.
