Configure and Verify Ethernet 10/100/1000Mb Half/Full Duplex Auto-Negotiation

This document describes the guidelines to troubleshoot, as well as isolate and resolve, Ethernet auto-negotiation issues.

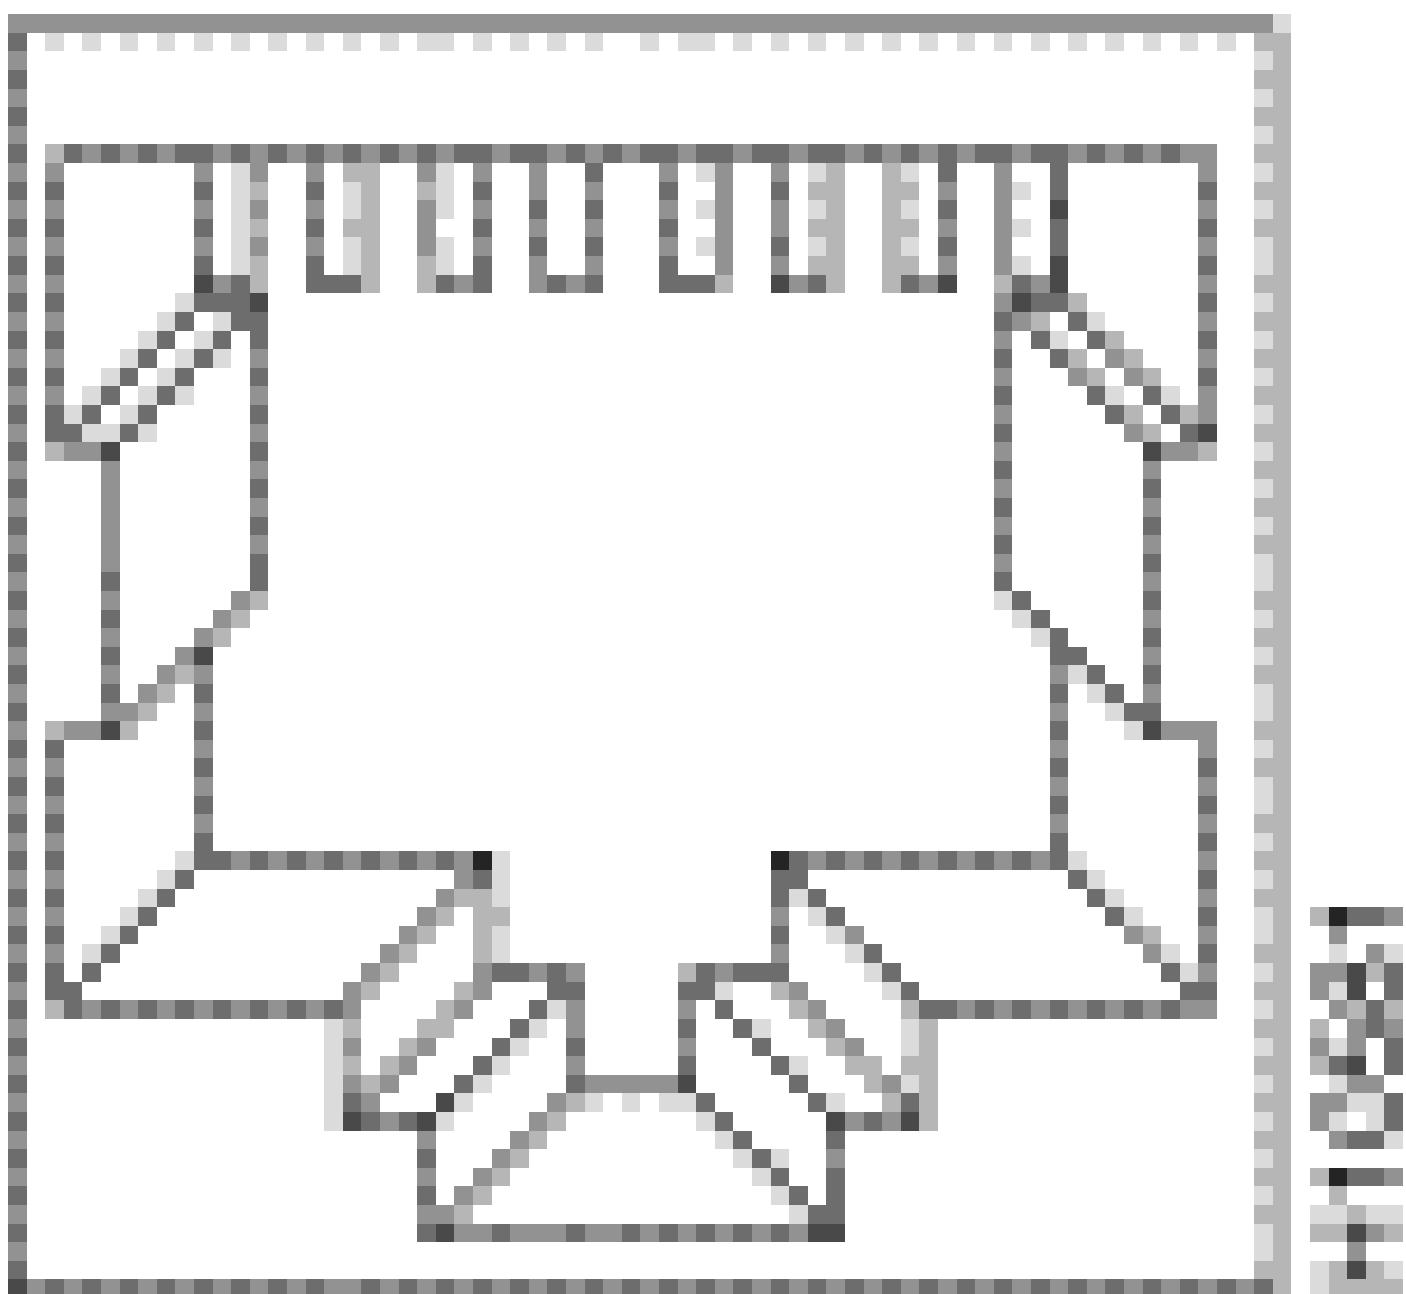
Note: Use a crossover cable when you connect two ports in the same layer of the OSI model, such as router to router (Layer 3) or switch to switch (Layer 2). Use a straight-through cable if the two ports are in different layers, such as router to switch (Layer 3 to 2) or PC to switch (Layer 3 to 2). For this rule, treat a PC as a Layer 3 device.

Ethernet Crossover Cables

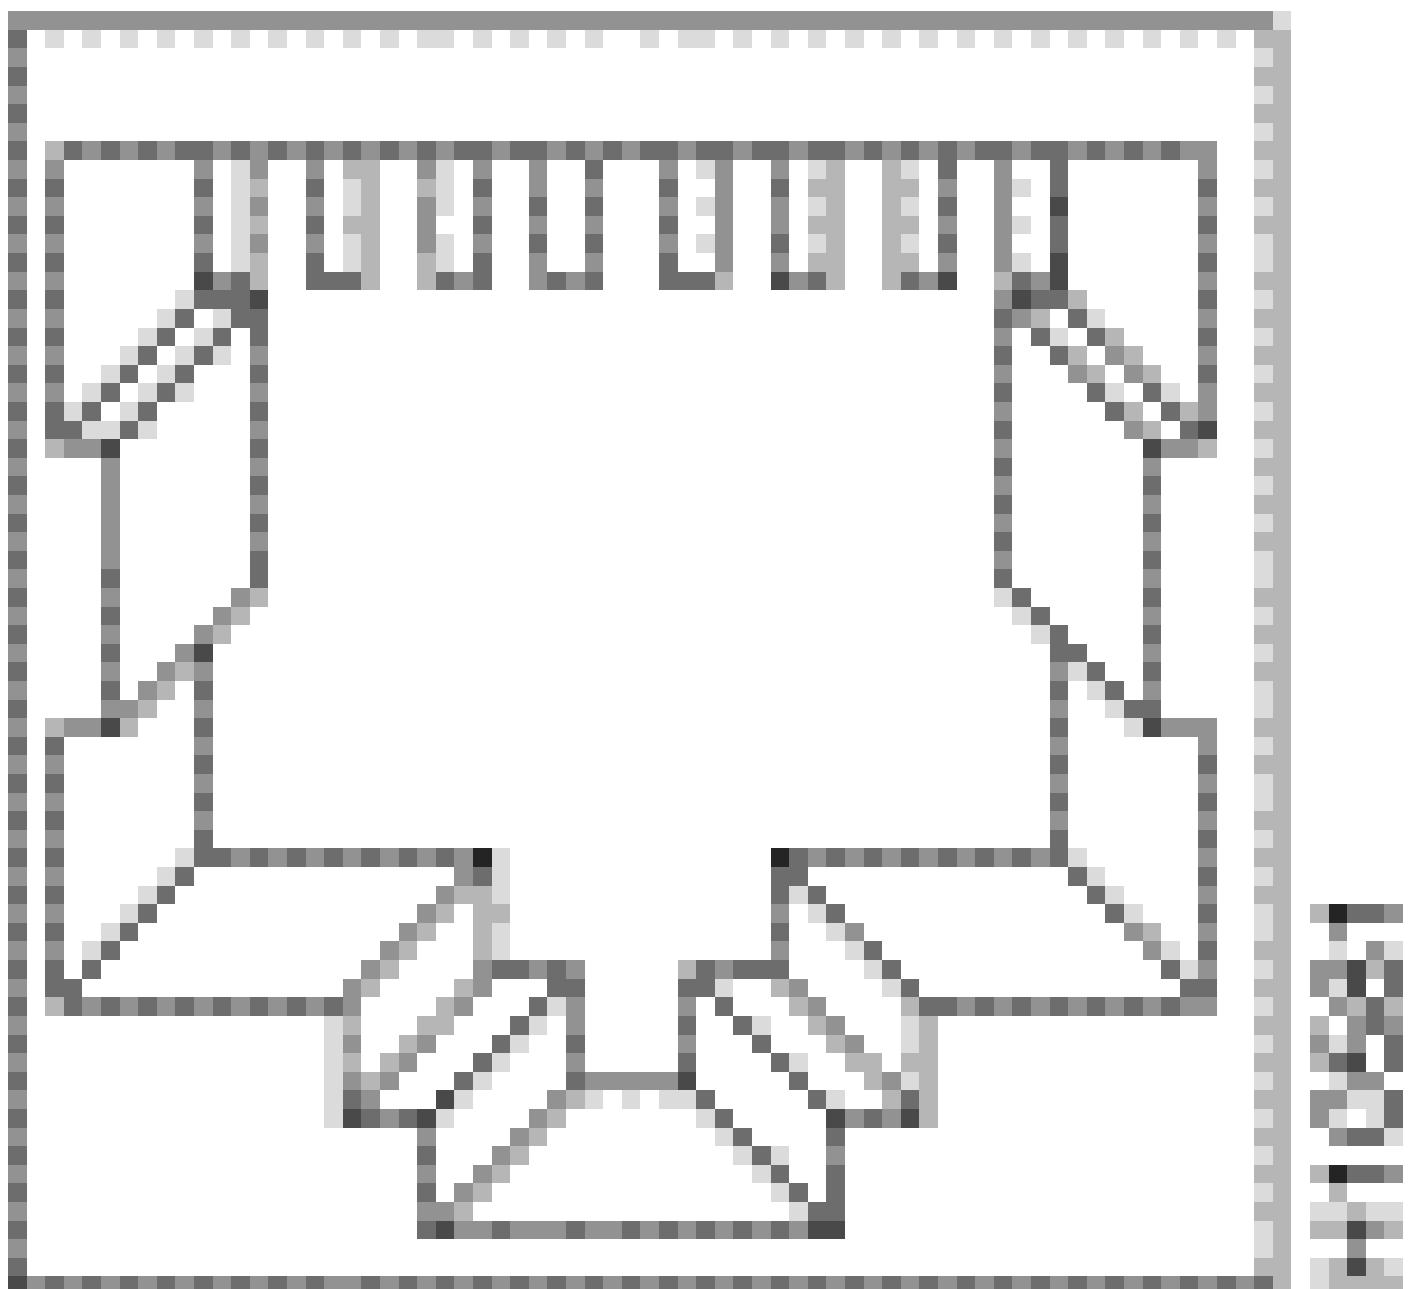
Four Twisted-Pair Crossover Cable Schematics for 10/100/1000 and 1000BASE-T GBIC Module Ports

Four Twisted-Pair Crossover Cable Schematics I

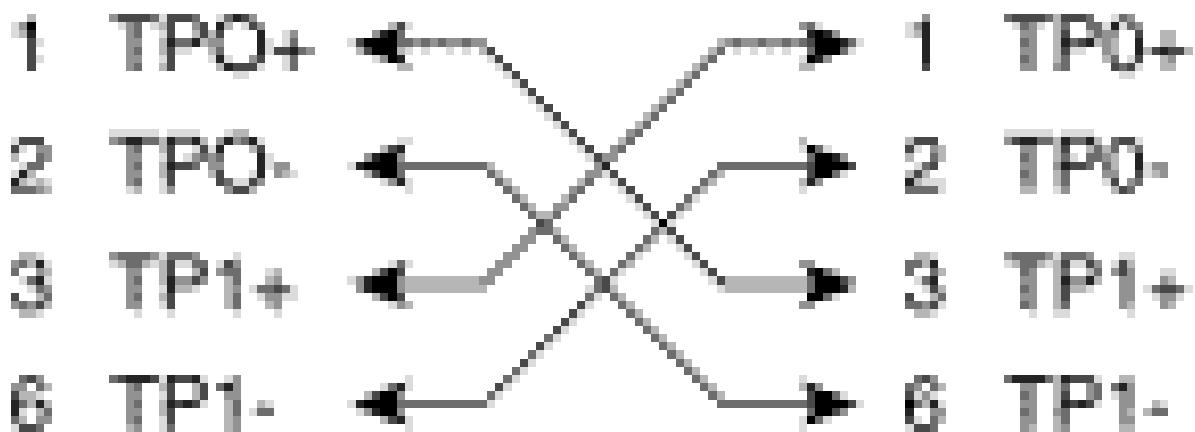
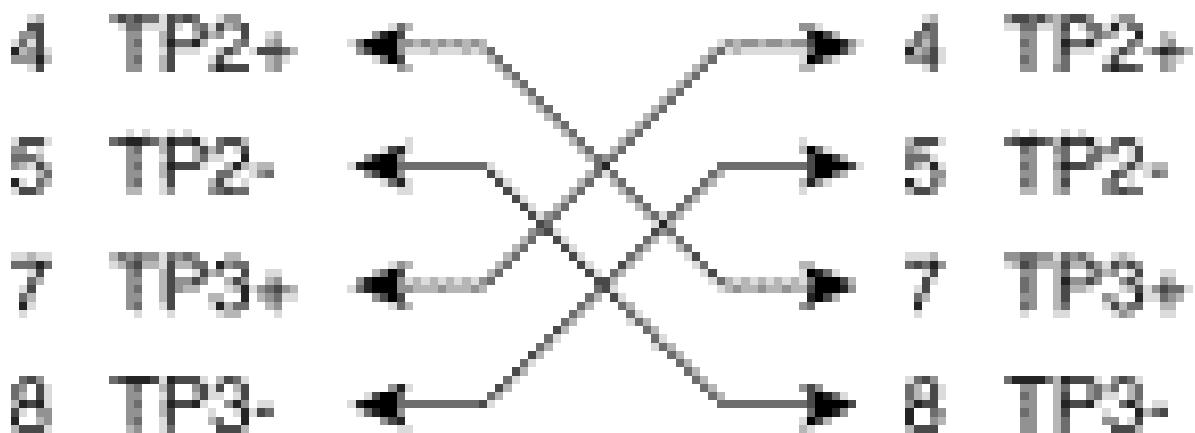
Four Twisted-Pair Crossover Cable Schematics 2
