DOCSIS Configuration

This chapter identifies those functions you must check or configure to bring a BACC DOCSIS deployment into operation. It also provides information required prior to configuration, and describes the available tools.

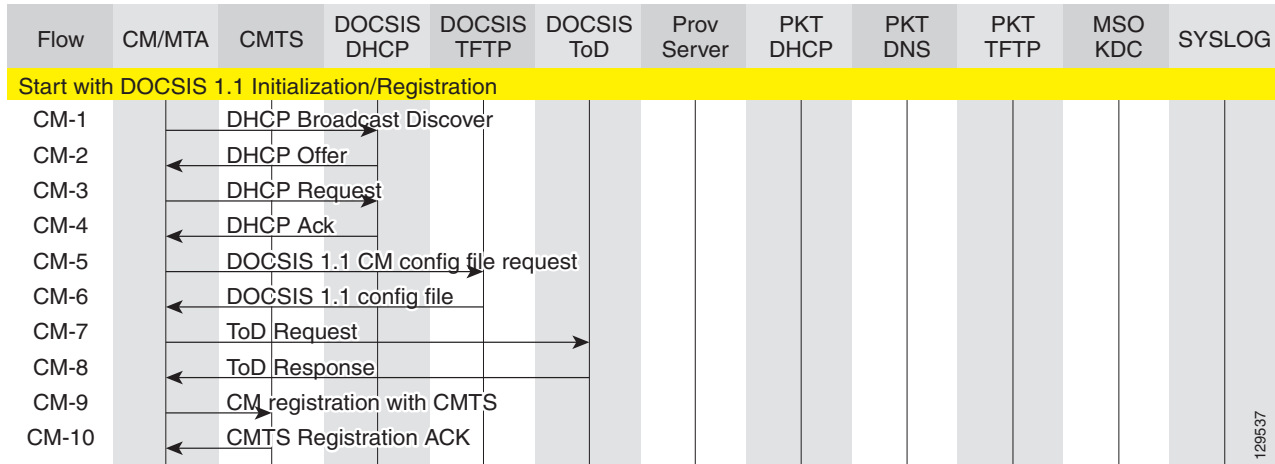
Figure 4-1 DOCSIS Provisioning Flow

The provisioning (workflow) steps contained in the DOCSIS Provisioning Specification are shown in [Figure 4-1](#).

[Table 4-1](#) describes the potential problems that can exist at various DOCSIS provisioning steps illustrated in [Figure 4-1](#).
