Cisco ONS 15454 DWDM Troubleshooting Guide

Product and Software Release 7.0
June 2012

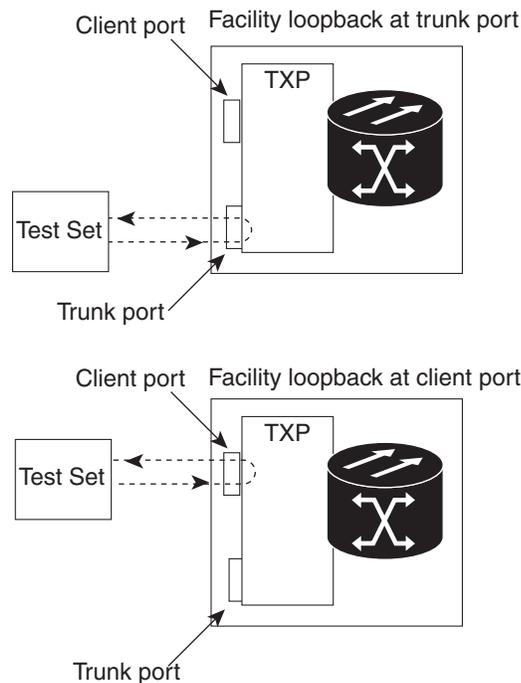
145758

To test a card LIU, connect an optical test set to a trunk or client port and perform a facility loopback. Alternately, use a loopback or hairpin circuit on a card that is farther along the circuit path. For example, [Figure 1-1](#) shows a facility loopback at a trunk port and at a client port on a TXP card.

Figure 1-1 Facility Loopback Path on a Near-End Transponder Card

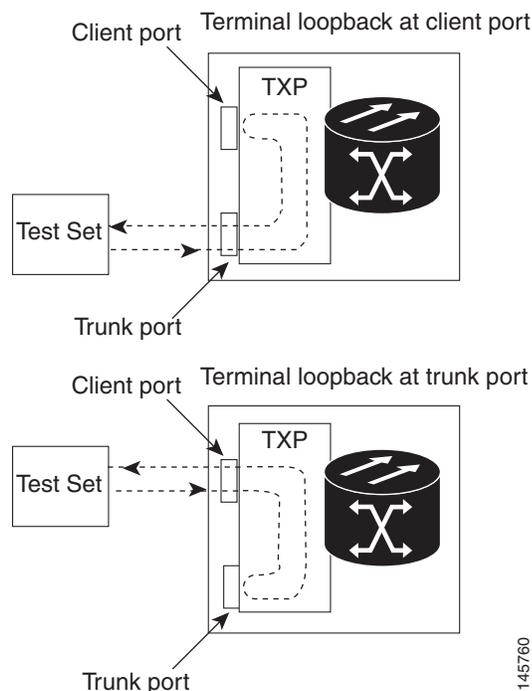
145760

A terminal loopback tests a circuit path as it passes through a TXP or MXP card and loops back. For example, as shown in [Figure 1-2](#), there are two types of terminal loopbacks shown for a TXP card.

This test verifies that the terminal circuit paths are valid, but does not test the LIU on the TXP card.

Figure 1-2 Terminal Loopback on a TXP Card

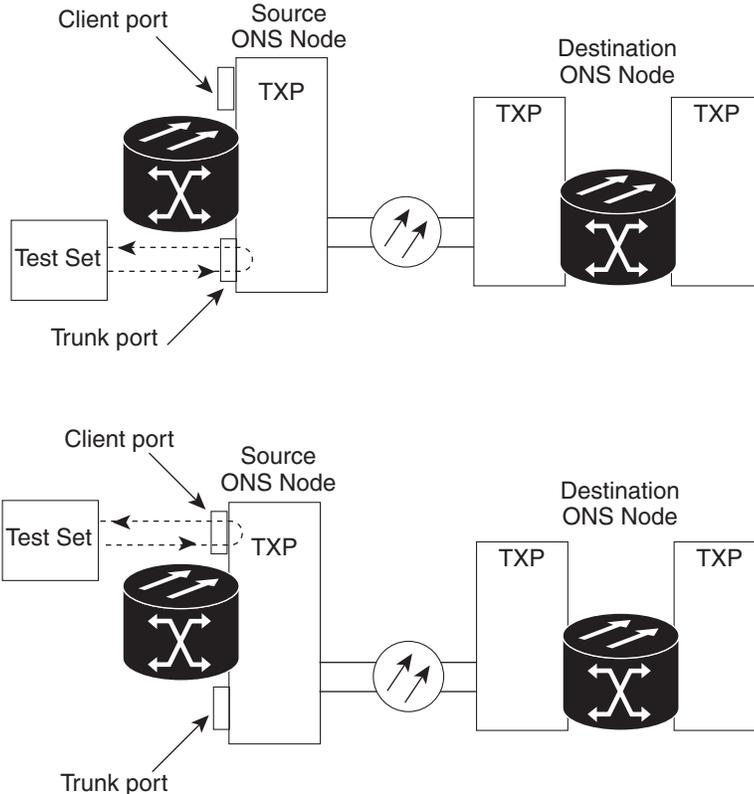
This facility loopback test is performed on the node source port in the network circuit. In the testing situation used in this example, the source muxponder or transponder port under test is located in the source node. Facility loopback can be performed at the trunk port or at a client port. Completing a successful facility loopback on this port isolates the source MXP or TXP port as a possible failure point. [Figure 1-3](#) shows the facility loopback examples on source ONS node TXP ports (client and trunk).

Figure 1-3 Facility Loopback on a Circuit Source MXP or TXP Port

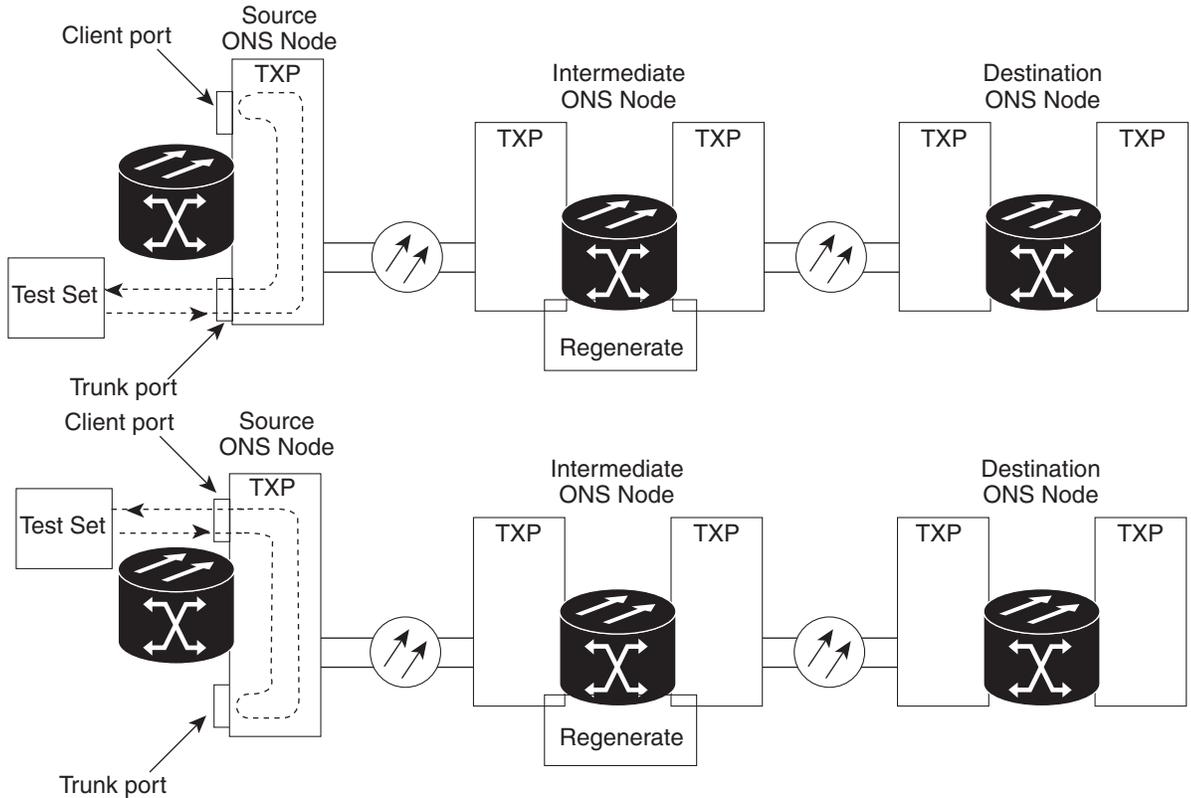
145760

The terminal loopback test is performed on the node source MXP or TXP muxponder or transponder port. For the circuit in this example, it is the source TXP trunk port or a client port in the source node. Completing a successful terminal loopback to a node source port verifies that the circuit is through the source port. [Figure 1-4](#) shows an example of a terminal loopback on a source TXP port and a client TXP port.

Figure 1-4 Terminal Loopback on a Source-Node MXP or TXP Port

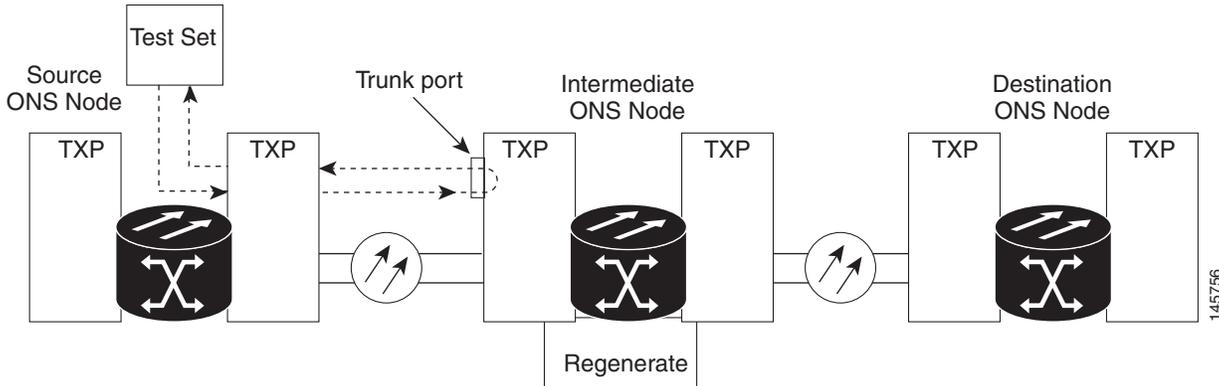
Performing the facility loopback test on an intermediate port isolates whether this node is causing circuit failure. In the situation shown in [Figure 1-5](#), the test is being performed on an intermediate MXP or TXP port.

Figure 1-5 Facility Loopback on an Intermediate-Node MXP or TXP Port

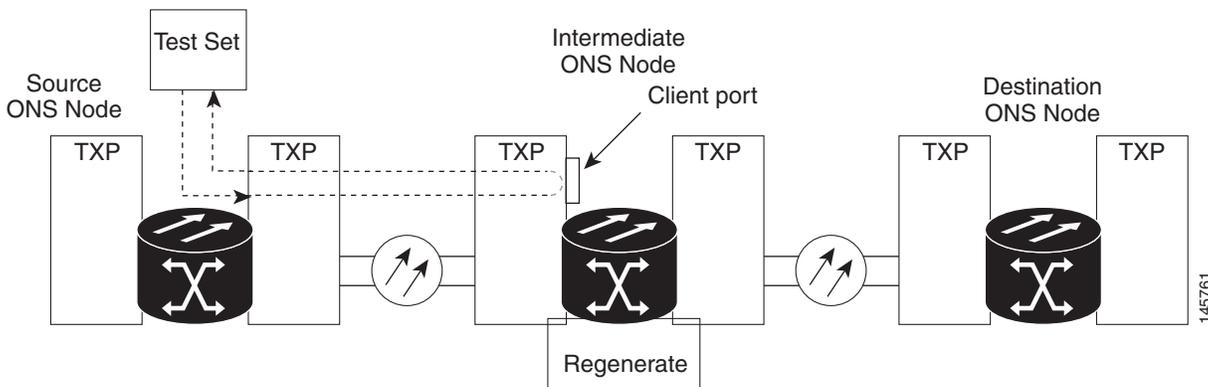
In the next troubleshooting test, you perform a terminal loopback on the intermediate-node port to isolate whether the intermediate client or trunk port is causing circuit trouble. In the example situation in [Figure 1-6](#), the terminal loopback is performed on an intermediate MXP or TXP port in the circuit. If you successfully complete a terminal loopback on the node, this node is excluded from possible sources of circuit trouble.

Figure 1-6 Terminal Loopback on an Intermediate-Node MXP or TXP Port

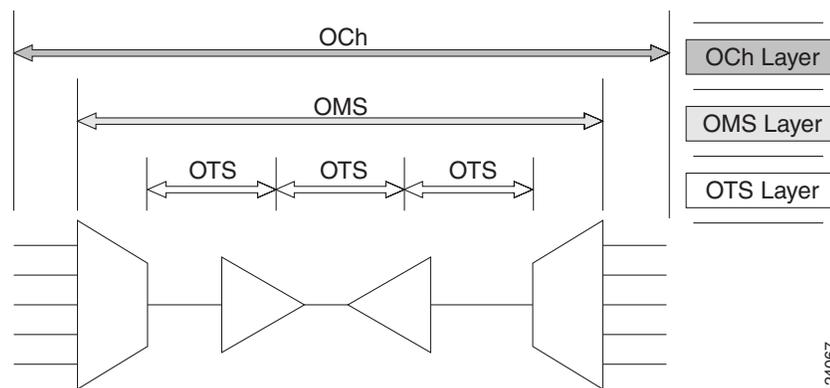
Like traditional SONET networks, ITU-T G.709 optical networks have a layered design (Figure 1-9). This structure enables localized monitoring that helps you isolate and troubleshoot network problems.

Figure 1-9 Optical Transport Network Layers

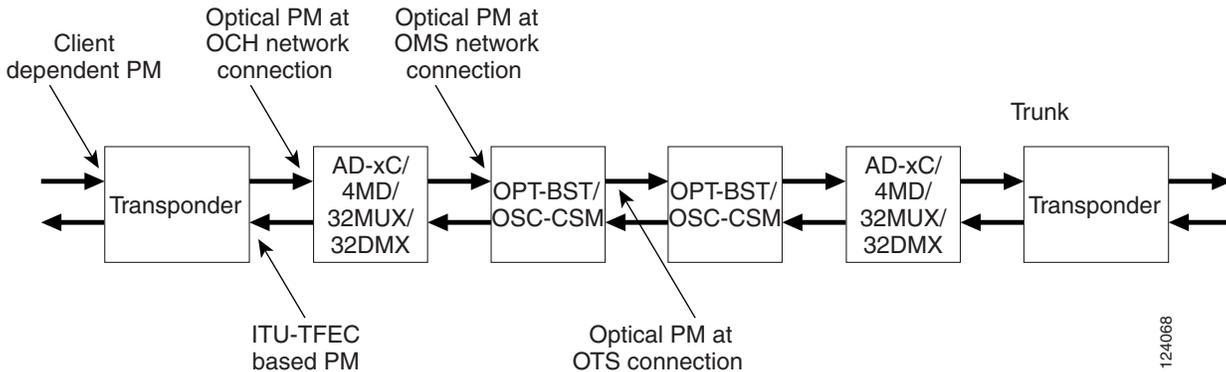
Different PM count parameters are associated with different read points in a network. [Figure 1-10](#) illustrates the PM read points that are useful in identifying DWDM circuit points of failure. The “Performance Monitoring” chapter in the *Cisco ONS 15454 DWDM Reference Manual* lists all PM parameters and provides block diagrams of signal entry points, exit points, and interconnections between the individual circuit cards. Consult these specifications to determine which PM parameters are associated with the system points you want to monitor or provision with CTC or TL1. The monitoring points might vary according to your configuration.

Figure 1-10 Performance Monitoring Points on ONS DWDM

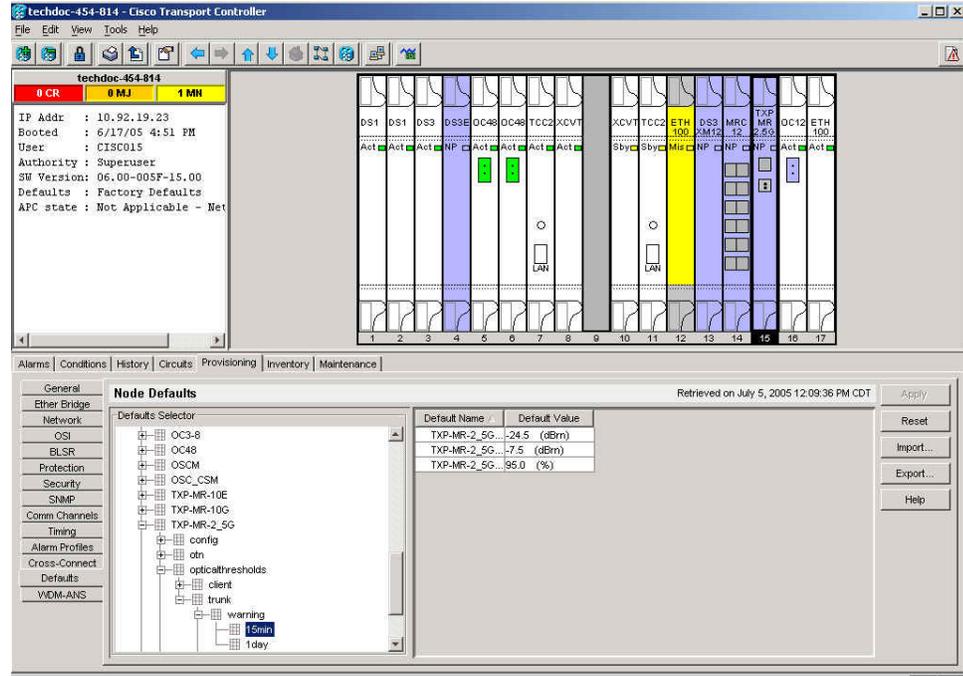
-
- Step 1** In node view (single-shelf mode) or multishelf view (multishelf mode), click the **Provisioning > Defaults** tabs (Figure 1-11).

Figure 1-11 Set Default BBE/SES Card Thresholds

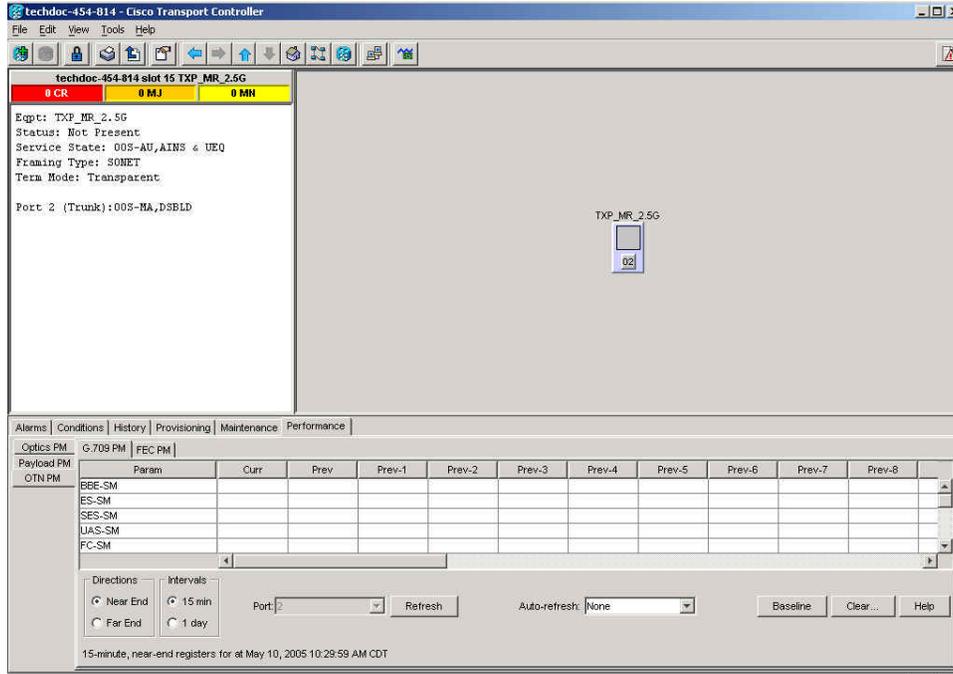
- Step 1** In node view (single-shelf mode) or shelf view (multishelf mode), double-click the applicable transponder or muxponder card (TXP_MR_10G, TXPP_MR_2.5G, or MXP_2.5G_10G.)
- Step 2** Click the **Provisioning > OTN > G.709 Thresholds** tabs (Figure 1-12).

Figure 1-12 Provision Card BBE/SES Thresholds

- Step 3** In the Directions area, click the **Near End** radio button.
- Step 4** In the Intervals area, click the **15 Min** radio button.
- Step 5** In the Types area, click the **PM (ODUk)** radio button.
- Step 6** In the SES and BBE fields, enter threshold numbers, for example 500 and 10000.

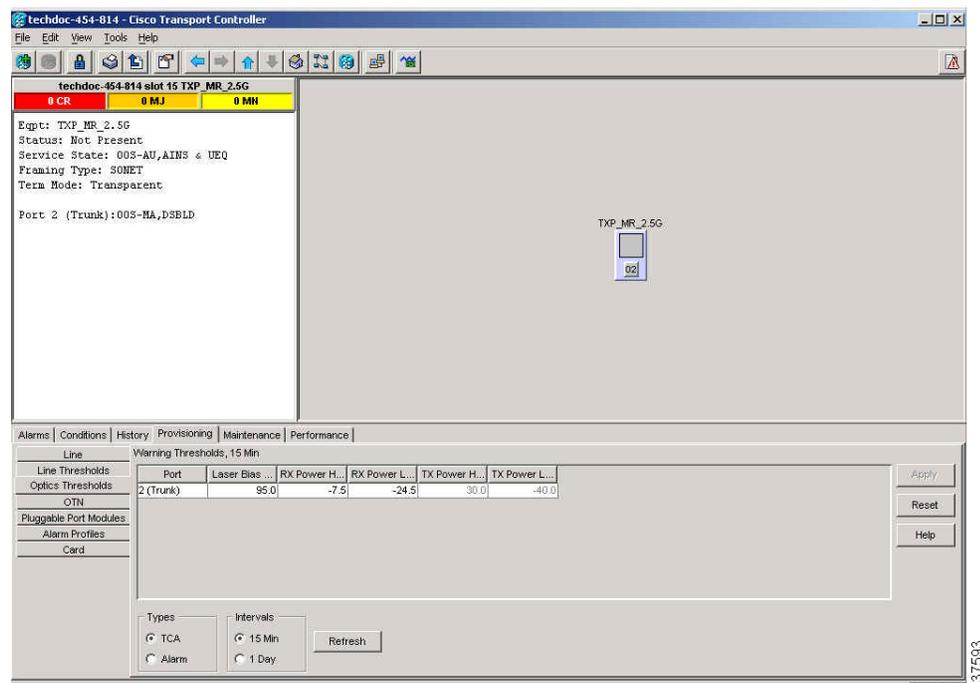
- Step 1** In card view, click the **Provisioning > Optics Thresholds** tabs (Figure 1-13).

Figure 1-13 Provision Optical TCA Thresholds

- Step 2** In the Types area, click **TCA**.
- Step 3** In the Intervals area, click **15 Min**.
- Step 4** In the Laser Bias High (%) field, enter the threshold value, for example, 81.0 percent.

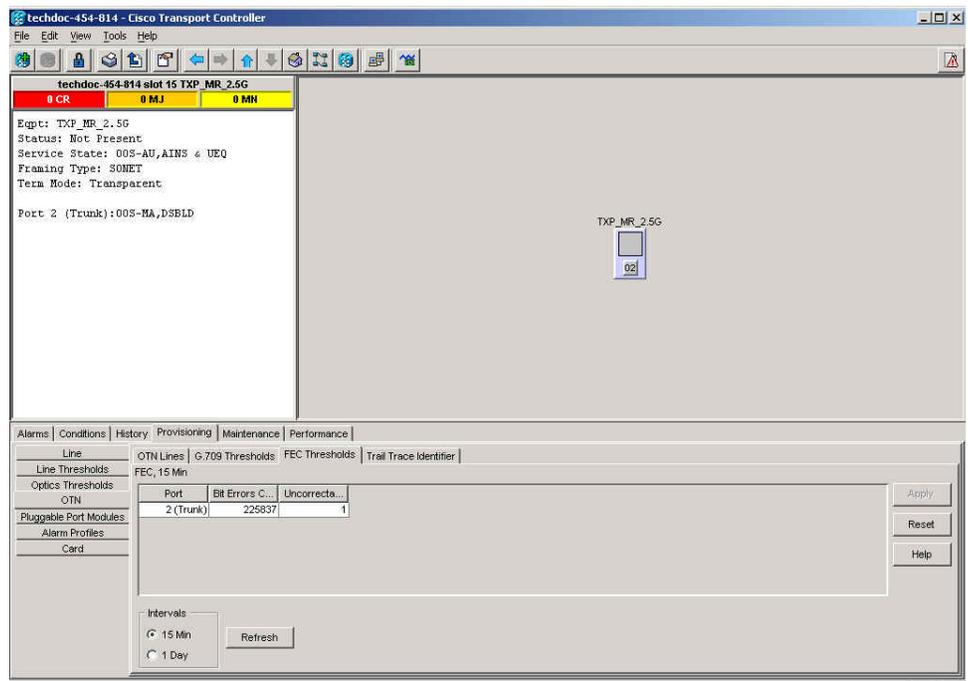
- Step 1** In node view (single-shelf mode) or shelf view (multishelf mode), double-click a transponder or muxponder card to open the card view. (In this example, cards such as the TXP_MR_10G, TXPP_MR_2.5G, and MXP_2.5G_10G are applicable.)
- Step 2** Click the **Provisioning > OTN > FEC Thresholds** tabs (Figure 1-14).

Figure 1-14 Provision Card FEC Thresholds

- Step 3** In the Bit Errors Corrected field, enter a threshold number, for example 225837.
- Step 4** In the Uncorrectable Words field, enter a threshold number, for example, 2.
- Step 5** In the Intervals area, click **15 Min**.

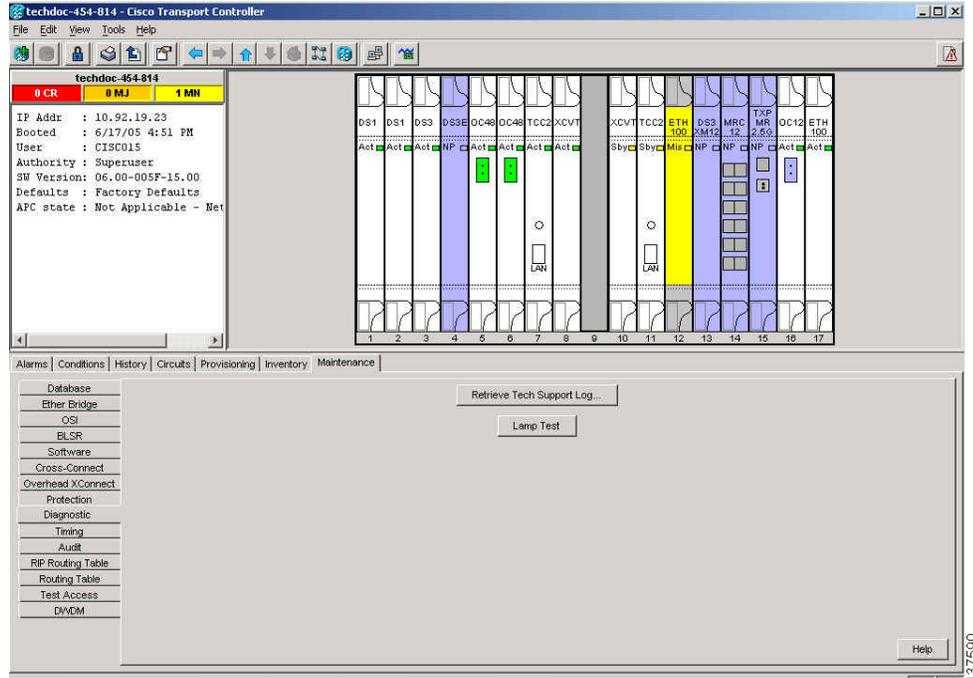
-
- Step 1** In node view (single-shelf mode) or shelf view (multishelf mode), click the **Maintenance > Diagnostic** tabs ([Figure 1-15](#)).

Figure 1-15 ONS 15454 Node View Diagnostic Window

-
- Step 1** In node view (single-shelf mode) or shelf view (multishelf mode), click the **Maintenance > Diagnostic** tabs ([Figure 1-15](#)).
- Step 2** Click **Retrieve Tech Support Log**.
- Step 3** In the Saving Diagnostic File dialog box, navigate to the directory (local or network) where you want to save the file.
- Step 4** Enter a name in the File Name field.
- You do not have to give the archive file a particular extension. It is a compressed file (gzip) that can be unzipped and read by Cisco Technical Support.
- Step 5** Click **Save**.
- The Get Diagnostics status window shows a progress bar indicating the percentage of the file being saved, then shows “Get Diagnostics Complete.”
- Step 6** Click **OK**.
-

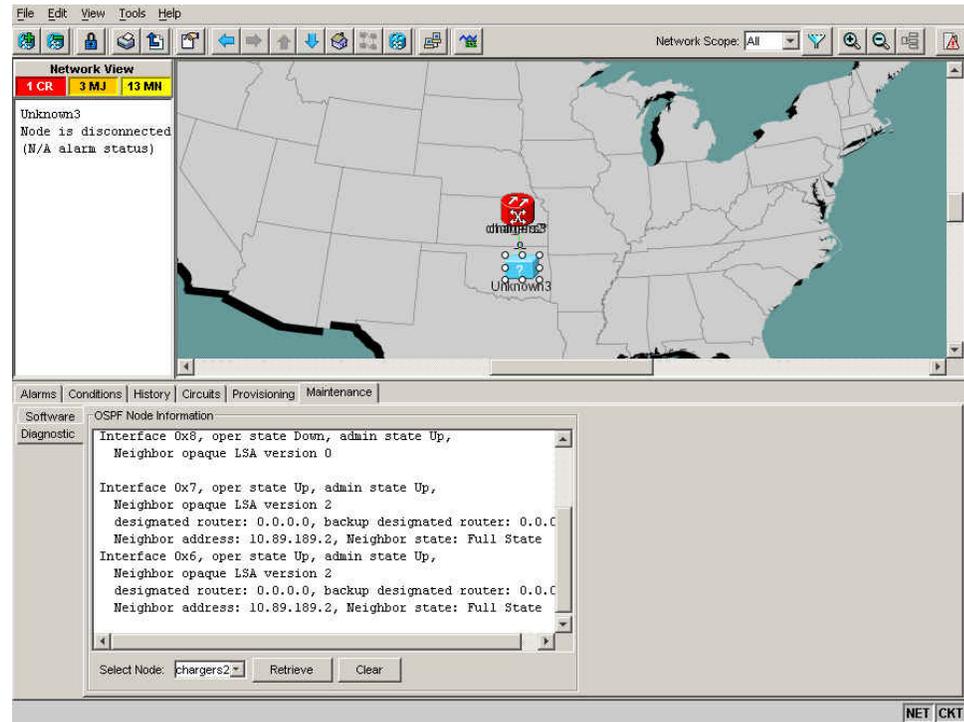
CTC contains a data communications network (DCN) tool that assists with network troubleshooting for Open Shortest Path First (OSPF) networks. This tool, located in network view, is shown in [Figure 1-16](#). It executes an internal dump command to retrieve information about all nodes accessible from the entry point.

Figure 1-16 DCN Tools OSPF Dump

The dump, which provides the same information as a dump executed by special networking commands, is available at the network view in the Maintenance > Diagnostic tab. You can select the access point node in the Select Node drop-down list. To create the dump, click Retrieve. (To clear the dump, click Clear.)

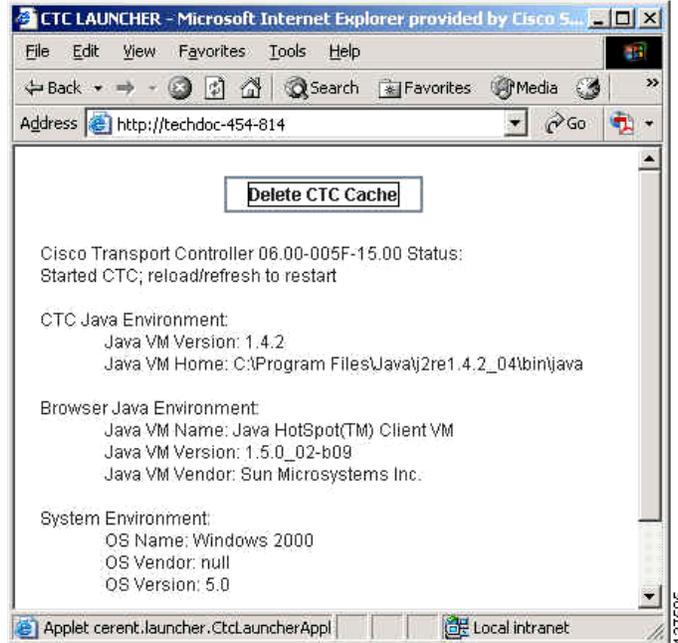
-
- Step 1** Enter an ONS 15454 IP address into the browser URL field. The initial browser window shows a **Delete CTC Cache** button.
- Step 2** Close all open CTC sessions and browser windows. The PC operating system does not allow you to delete files that are in use.
- Step 3** Click **Delete CTC Cache** in the initial browser window to clear the CTC cache. [Figure 1-17](#) shows the Delete CTC Cache window.

Figure 1-17 Deleting the CTC Cache

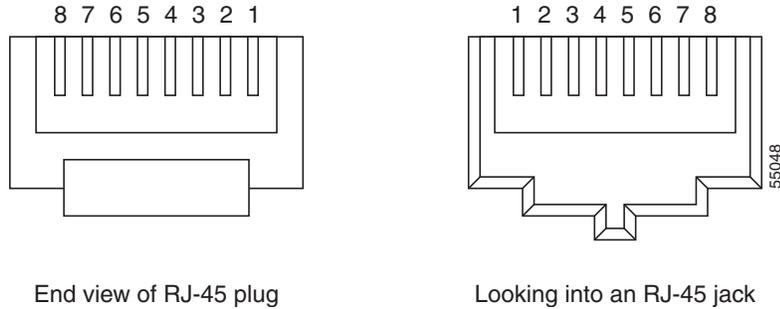
You can crimp your own LAN cables for use with the ONS 15454. Use a cross-over cable when connecting an ONS 15454 to a hub, LAN modem, or switch, and use a LAN cable when connecting an ONS 15454 to a router or workstation. Use CAT-5 cable RJ-45 T-568B, Color Code (100 Mbps), and a crimping tool. Figure 1-18 shows the wiring of an RJ-45 connector. Figure 1-19 shows a LAN cable layout, and Table 1-5 shows the cable pinouts. Figure 1-20 shows a cross-over cable layout, and Table 1-6 shows the cross-over pinouts.

Figure 1-18 RJ-45 Pin Numbers

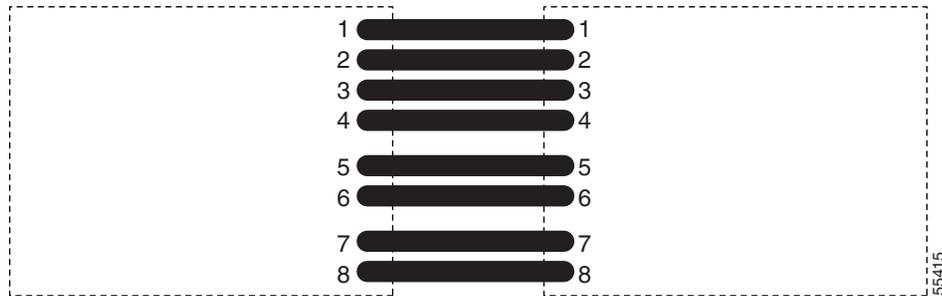
Figure 1-19 LAN Cable Layout

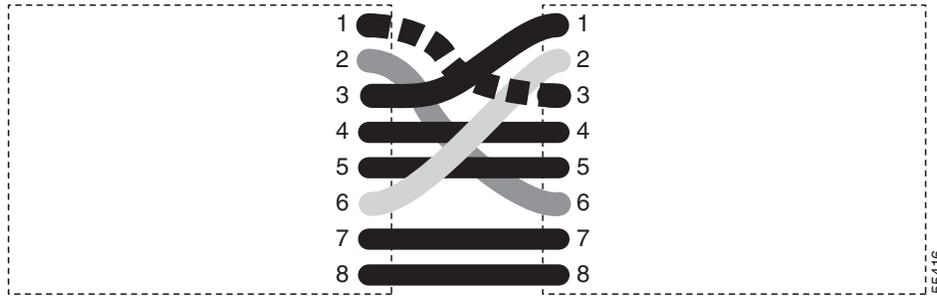
Figure 1-20 Cross-Over Cable Layout

Pin	Color	Pair	Name	Pin
1	white/orange	2	Transmit Data +	3
2	orange	2	Transmit Data –	6
3	white/green	3	Receive Data +	1
4	blue	1	—	4
5	white/blue	1	—	5
6	green	3	Receive Data –	2
7	white/brown	4	—	7
8	brown	4	—	8

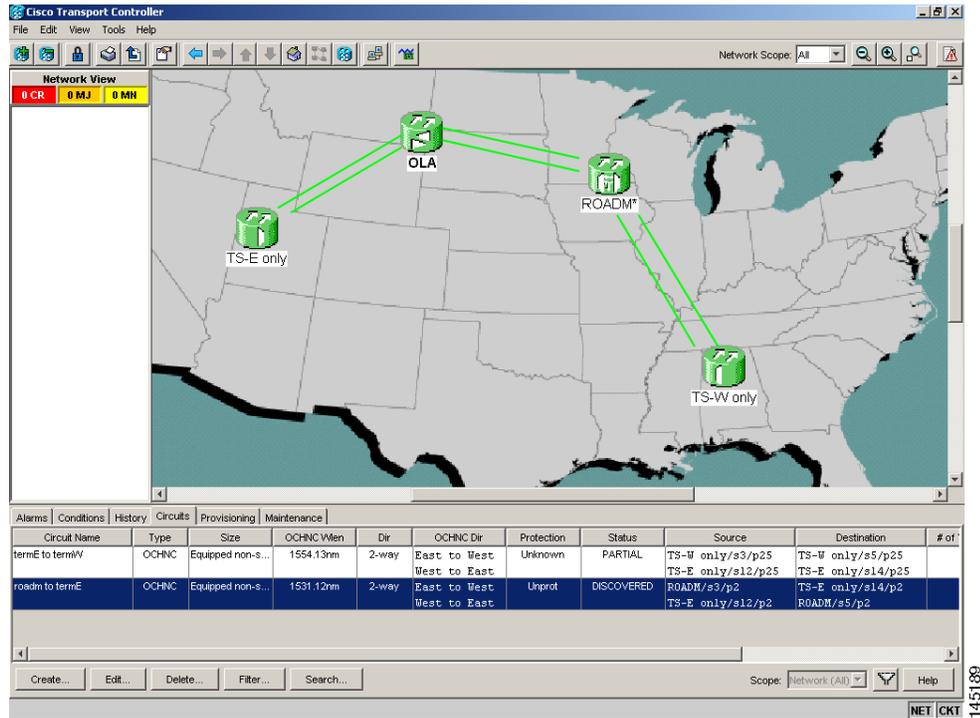
Figure 1-21 Linear Network, With No Fiber Cut

Different symptoms and scenarios can occur, depending on the network ALS settings. Consider the linear network (four nodes) in [Figure 1-21](#) as a reference. The scenarios are presented after the figure.

The symptoms of the possible span loss scenarios (except for span loss decrease) are described in the following paragraphs. Refer to the linear network in [Figure 1-21 on page 1-61](#) during the discussion of the scenarios.

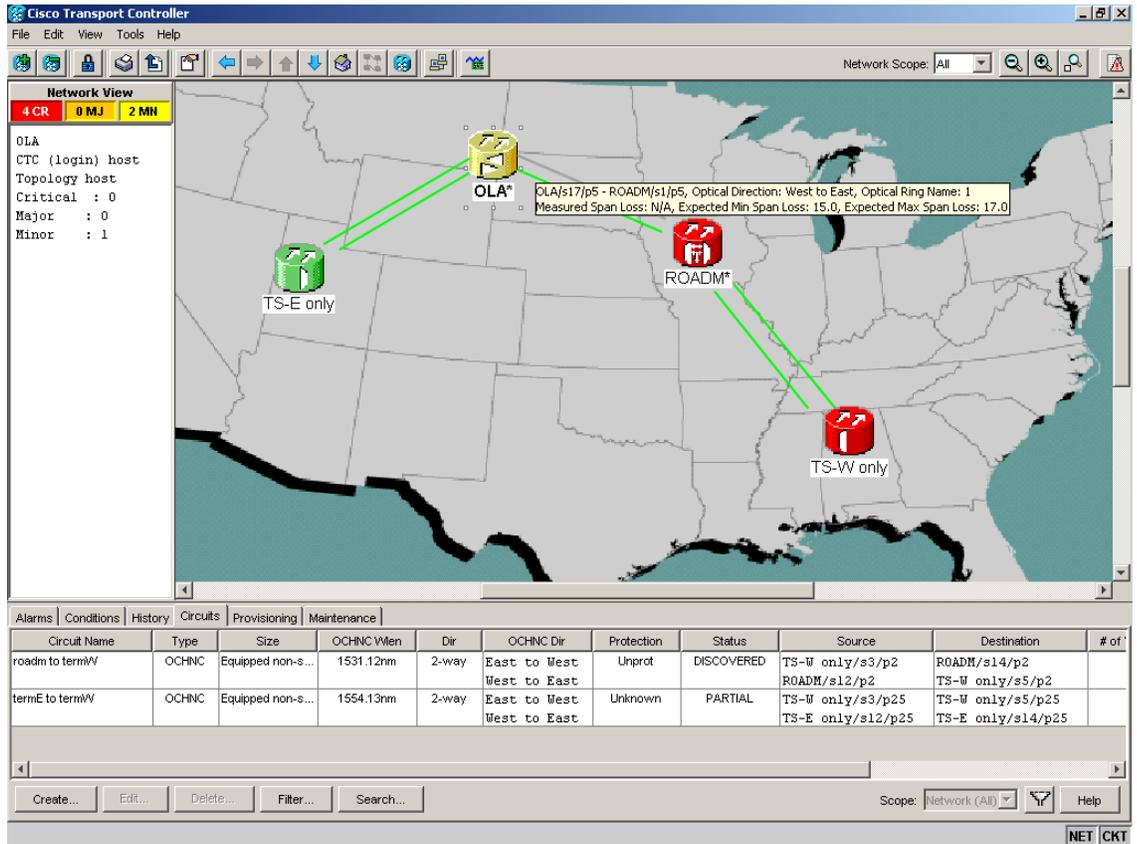
Figure 1-25 Network View Fault Condition for Fiber Cut with ALS Mode Disabled

The LOS (OTS or AOTS) alarm is raised by the ROADM-RX node that was receiving the signal coming from the broken fiber. The final fault condition of the network is shown in Figure 1-25.

In network view (Figure 1-25), only the actual affected fiber becomes gray, whereas the traffic (and OSC signal as well) on the good fiber is active and fault identification is immediate.

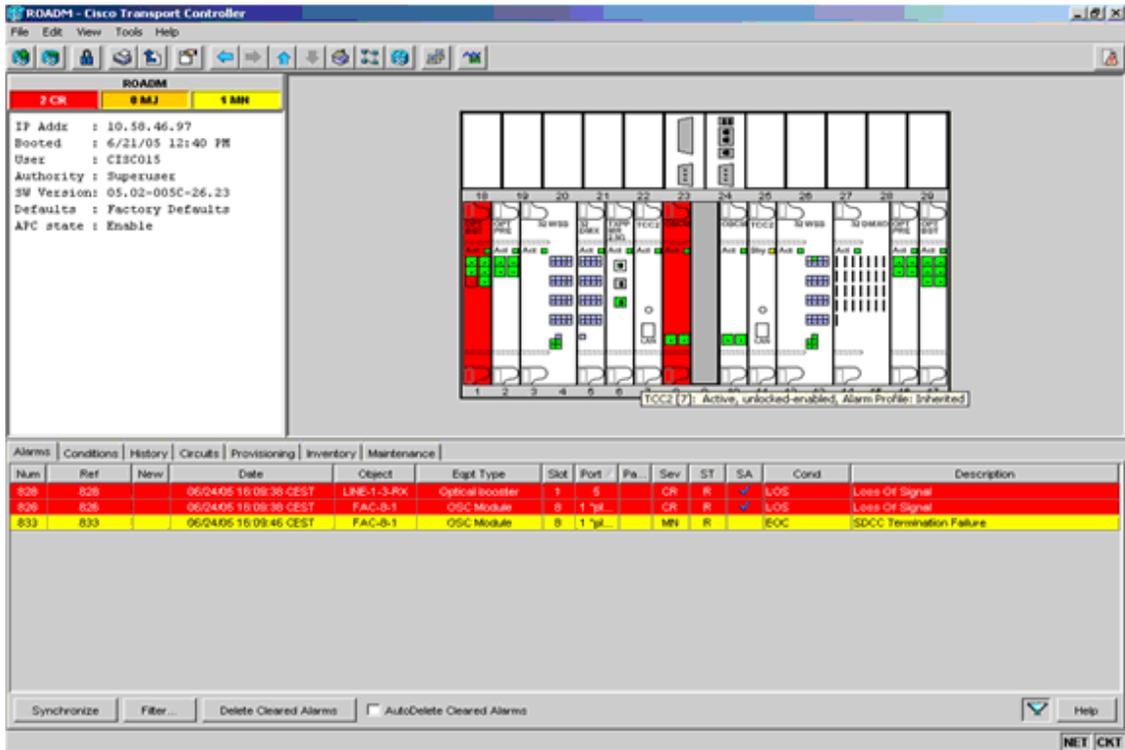
Figure 1-26 ONS 15454 SDH ROADM Node View with Fault Condition for ALS MODE Disabled

In node view (single-shelf mode) or shelf view (multishelf mode) (Figure 1-26 and Figure 1-27), the alarm panel of the receiving node (ROADM in this example) reports the LOS (OTS), while the transmitting node (OLA) reports only an EOC alarm.

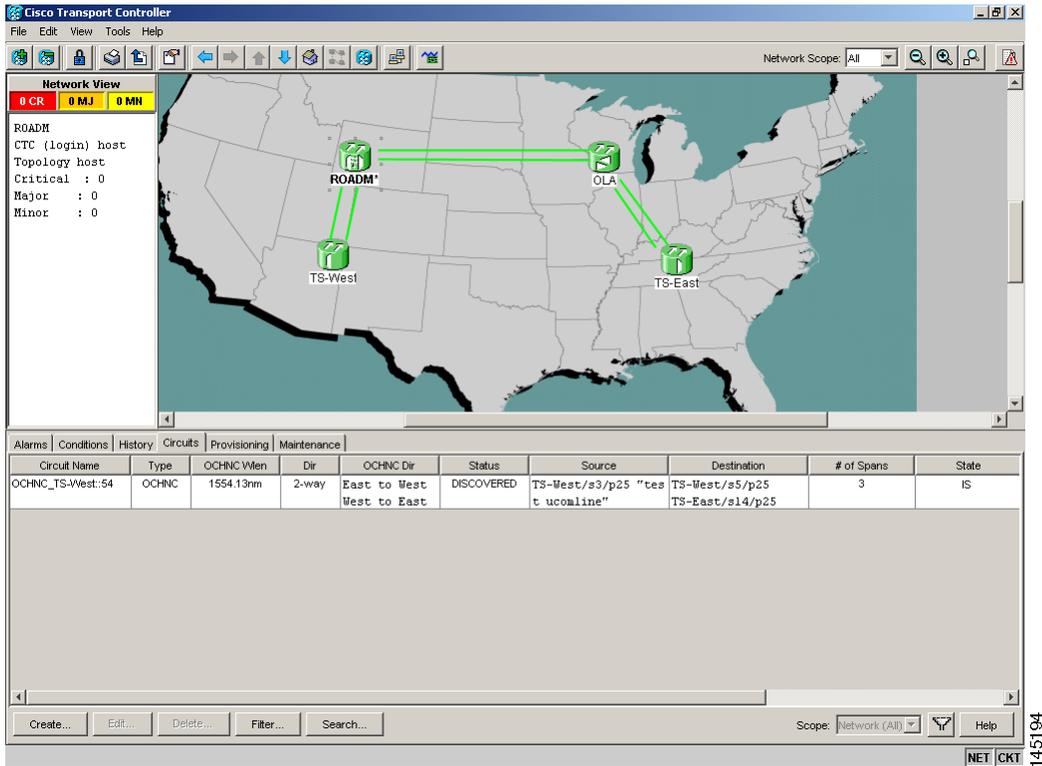
Figure 1-29 OCHNC Circuit Successfully Completed

OCHNC circuit creation is successfully completed when the CTC circuit table reports the situation shown in [Figure 1-29](#).

- The Circuit Status has turned to DISCOVERED.
- The # of spans field shows the correct number of hops among different nodes that the OCHNC circuit passes through to reach the final destination.
- Circuit State reports IS (or unlocked).

The screenshot shows the Cisco Transport Controller (CTC) interface. The top left pane displays network statistics: 0 CR, 0 MJ, and 0 MH. The main pane shows a map of the United States with four nodes: ROADM, OLA, TS-West, and TS-East. Green lines connect ROADM to OLA, and both ROADM and OLA to TS-West and TS-East. The bottom pane shows a table of circuits.

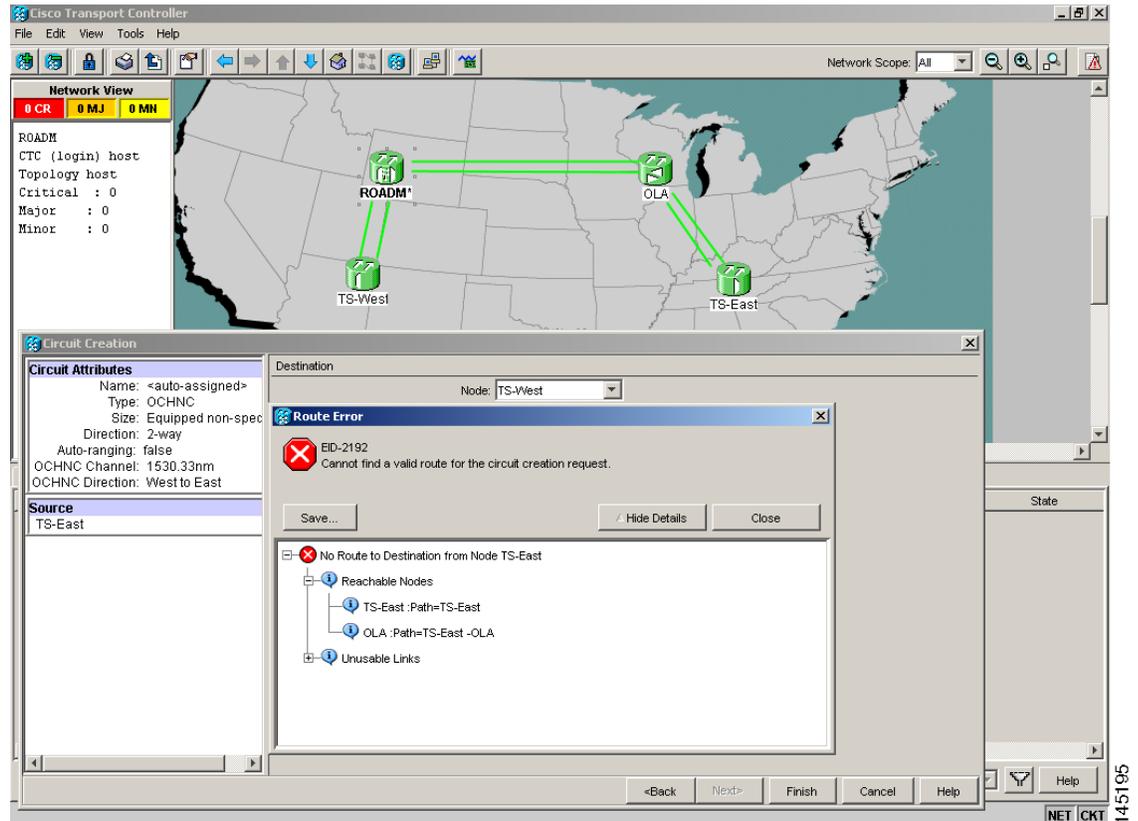
Figure 1-30 Partial Circuit

- If the WPP wizard cannot complete the circuit creation procedure, CTC displays the error message shown in [Figure 1-30](#). In the message, click **Details** to see the partial connections that WPP can set up. Start troubleshooting the problem in the first node that is unreachable along the path.

To troubleshoot and eventually fix issues related to the faulty OCHNC circuit creation shown in [Figure 1-30 on page 1-81](#), the following procedure must be performed.

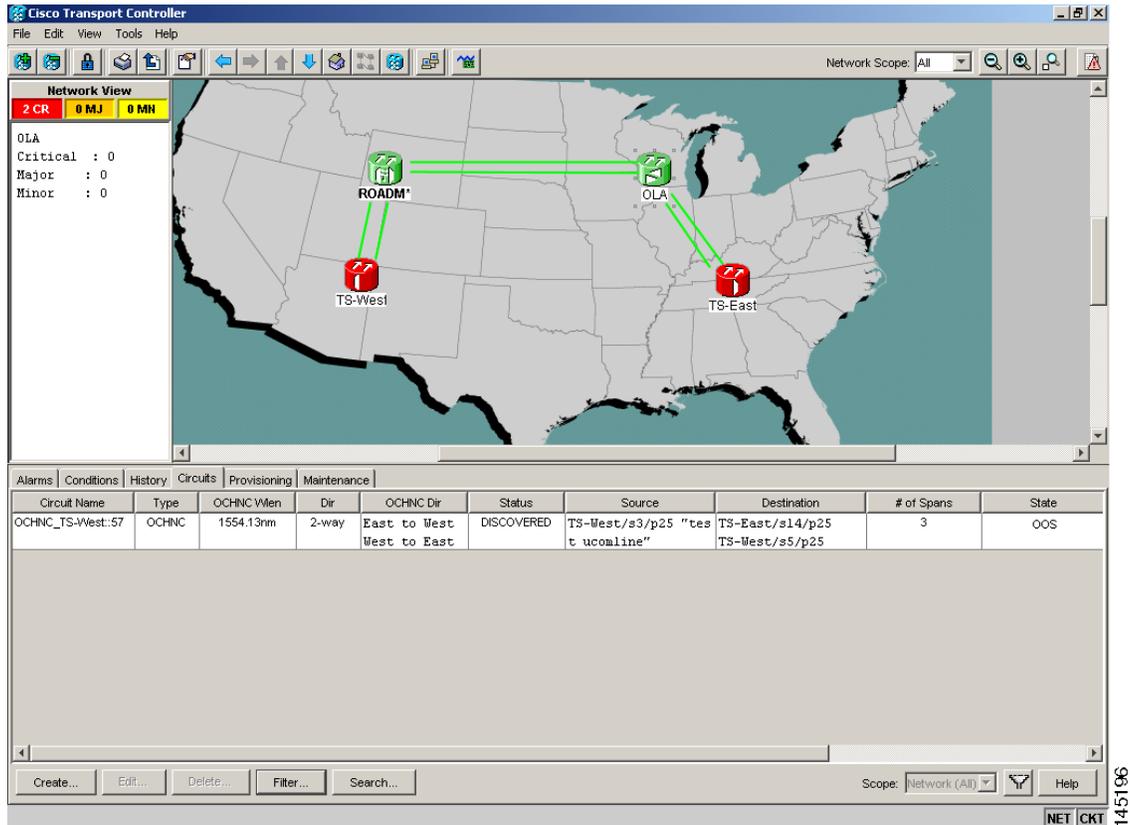
Figure 1-31 Circuit Discovered, State OSS

- The circuit is successfully created and reported under the Circuits tab, the Status field turns to DISCOVERED, but the Circuit State is OOS (locked). The condition is shown in [Figure 1-31](#).

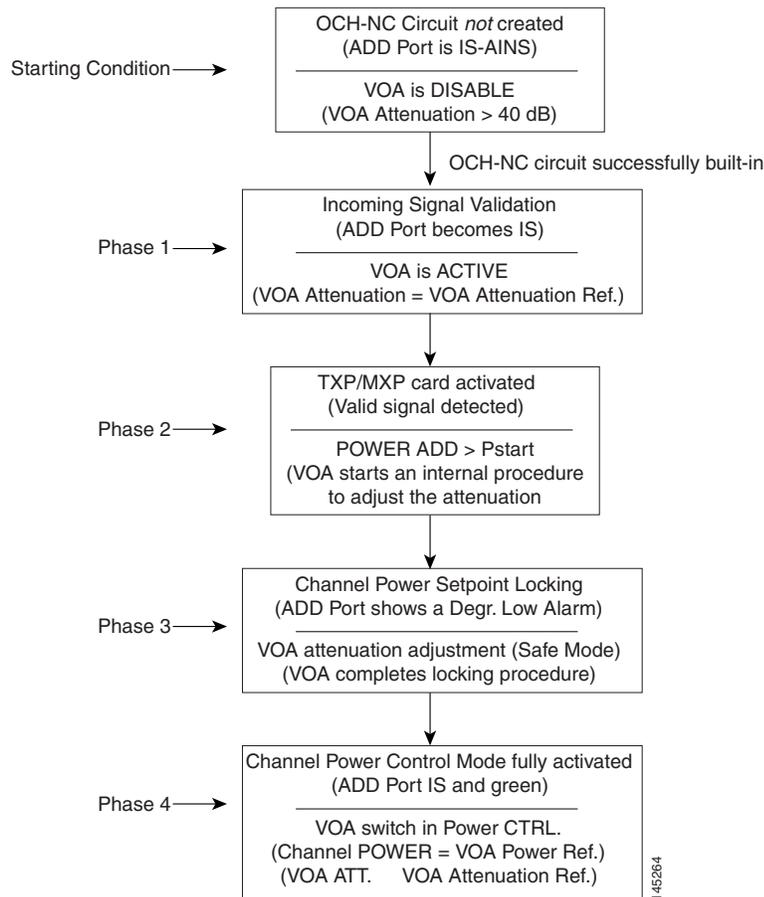
Figure 1-32 VOA Startup Procedure

The final VOA condition is achieved through a startup procedure divided into the four sequential phases shown in [Figure 1-32](#).

Until the VOA has completed all the phases shown in [Figure 1-32](#), the power control mode is not fully activated.

When the power is lower than expected, the start-up procedure can stop at Phase 1, Phase 2, or Phase 3 (see [Figure 1-32](#)). The point at which the start-up procedure stops depends on the amount of power missing.

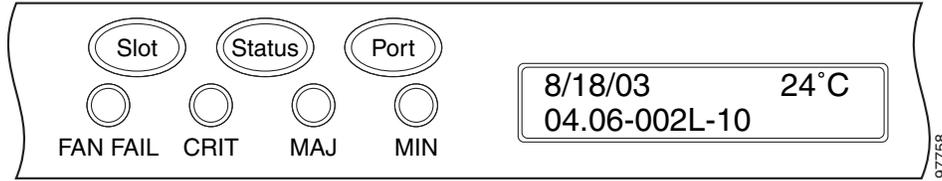
Figure 2-1 Shelf LCD Panel

- Step 1** View the temperature displayed on the ONS system LCD front panel. For example, the ONS 15454 front panel is illustrated in [Figure 2-1](#).

-
- Step 1** Check for any outstanding alarms that were raised against the active and standby TCC2/TCC2P and resolve them.
- Step 2** If the alarm does not clear, determine whether the LCD display on the fan tray ([Figure 2-1 on page 2-64](#)) is blank or if the text is garbled. If so, proceed to [Step 8](#). If not, continue with [Step 3](#).
- Step 3** At the earliest maintenance window, reset the standby TCC2/TCC2P:

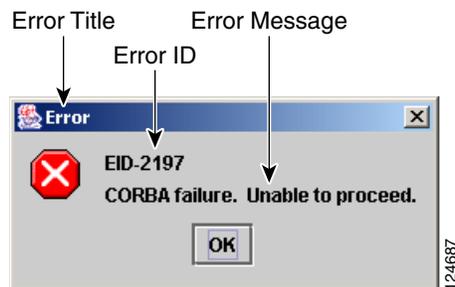
Figure 4-1 Error Dialog Box

This chapter lists the error messages for the Cisco ONS 15454 Multi-Service Transport Platform (MSTP). The error dialog box in [Figure 4-1](#) consists of three parts: the error title, error ID, and error message.
