## Cisco Nexus 5000 Series and Cisco Nexus 2000 Series Release Notes, Release 4.0(1a)N2(1)

Current Release: 4.0(1a)N2(1) -February 26, 2009  
Part Number: OL-16601-01 H0

This document describes the features, caveats, and limitations for Cisco Nexus 5000 Series switches and the Cisco Nexus 2000 Series Fabric Extenders. Use this document in combination with documents listed in the “[Related Documentation](#)” section on page 28.

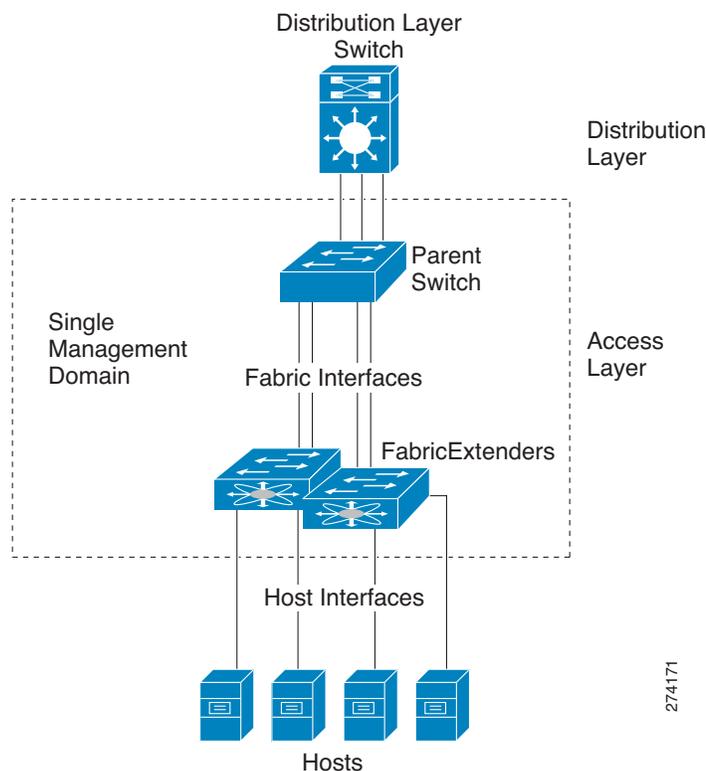
**Figure 1-1** Single Management Domain

The Fabric Extender integrates with its parent switch, allowing zero-touch provisioning as well as automatic configuration. This integration allows large numbers of servers and hosts to be supported using the same feature set as the parent Nexus 5000 Series switch, including security and quality of service (QoS) configuration parameters, with a single point of management as shown in [Figure 1-1](#). Spanning Tree Protocol (STP) is not required between the Fabric Extender and its parent switch, because the Fabric Extender and its parent switch allow you to enable a large multi-path, loop-free, active-active topology.
