Cisco Nexus 5000 Series and Cisco Nexus 2000 Series Release Notes, Releases 4.2(1)N1(1), 4.2(1)N2(1), and 4.2(1)N2(1a)

Release: 4.2(1)N2(1a) -October 13, 2010
Part Number: OL-22747-01 E0

This document describes the features, caveats, and limitations for Cisco Nexus 5000 Series switches and the Cisco Nexus 2000 Series Fabric Extenders. Use this document in combination with documents listed in the “[Related Documentation](#)” section on page 27.

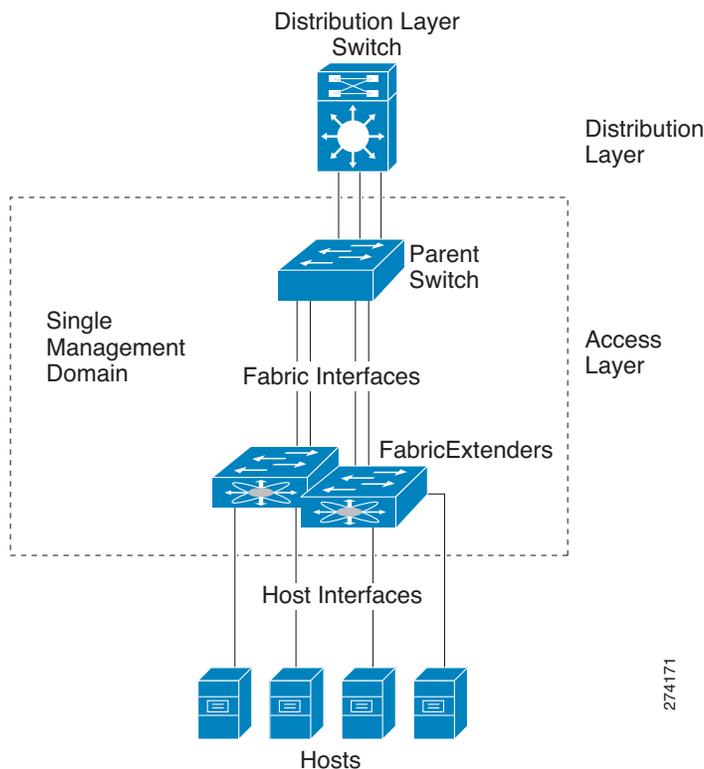
Figure 1-1 Single Management Domain

The Fabric Extender integrates with its parent switch, allowing zero-touch provisioning as well as automatic configuration. This integration allows large numbers of servers and hosts to be supported using the same feature set as the parent Nexus 5000 Series switch, including security and quality of service (QoS) configuration parameters, with a single point of management as shown in [Figure 1-1](#). Spanning Tree Protocol (STP) is not required between the Fabric Extender and its parent switch, because the Fabric Extender and its parent switch allow you to enable a large multi-path, loop-free, active-active topology.
