Cisco Nexus 5500 Series NX-OS Software Upgrade and Downgrade Guide, Release 7.0(1)N1(1)

This document describes how to upgrade or downgrade Cisco NX-OS software on Cisco Nexus 5500 Series switches and Cisco Nexus 2000 Series Fabric Extenders. Use this document in combination with documents listed in the [“Obtain Documentation and Submit a Service Request”](#) section on page 51.

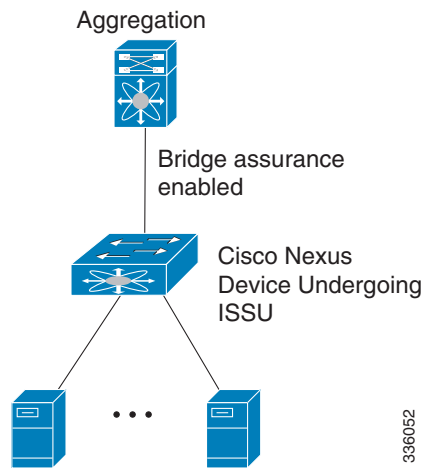
Figure 11 shows a Cisco Nexus device that is running Bridge Assurance with another switch.

Figure 11 Cisco Nexus Device Running Bridge Assurance with Another Switch
