Cisco Nexus 5500 Series NX-OS Software Upgrade and Downgrade Guide, Release 7.3(0)N1(1)

This document describes how to upgrade or downgrade Cisco NX-OS software on Cisco Nexus 5500 Series switches and Cisco Nexus 2000 Series Fabric Extenders. Use this document in combination with documents listed in the [“Obtain Documentation and Submit a Service Request”](#) section on page 53.

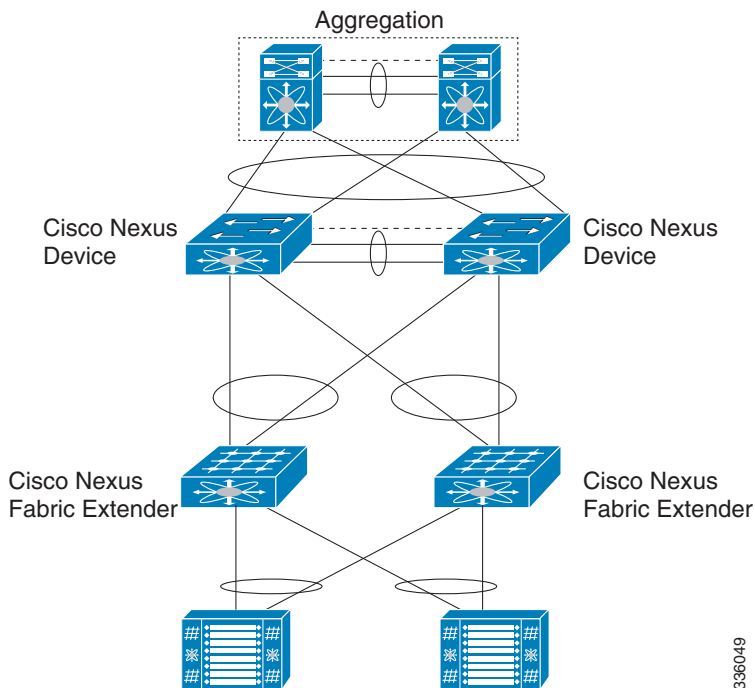
336049

Figure 8 shows a vPC-peered dual-supervisor virtual modular system with dual-homed FEXs.

Figure 8 vPC Peered Dual-Supervisor Virtual Modular System Dual-Homed FEXs
