Upgrading Cisco UCS Hardware

Upgrading Fabric Interconnects

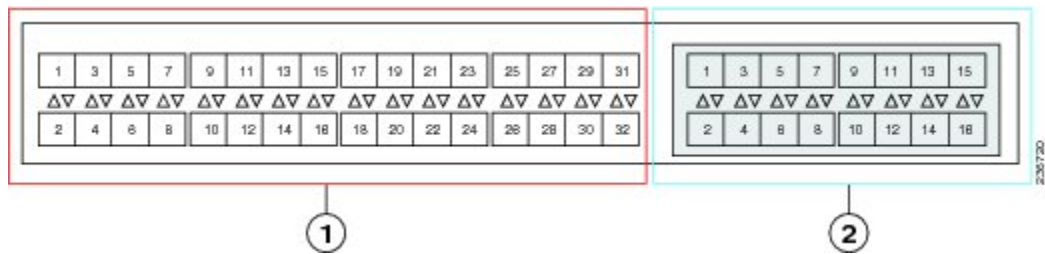
Figure 1: Cisco UCS 6248 Port Numbering

1	Slot 1, 32 fixed universal ports	2	Slot 1, 16 expansion universal ports
---	----------------------------------	---	--------------------------------------

Since a UCS 6140 has 40 ports on slot 1 and a UCS 6248 has 32 ports, any ports currently configured on ports 1/33 to 1/40 of the UCS 6140 will have to be moved during the upgrade process.

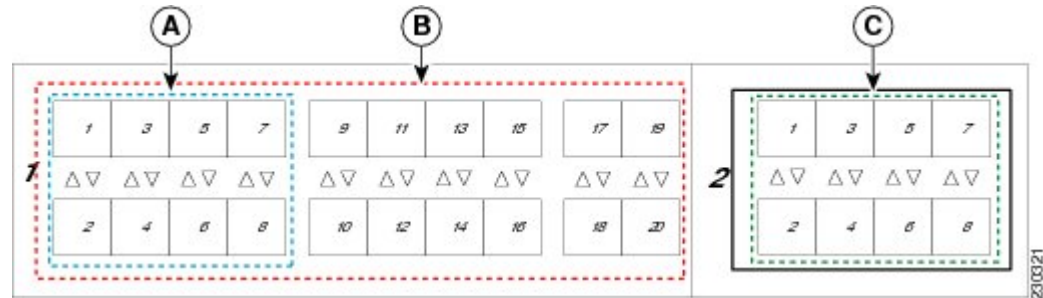
Figure 2: Cisco UCS 6120 Port Numbering when Configured with the N10-E0080 Expansion Module

A	Slot 1, ports 1 through 8: 10-Gigabit or 1 Gigabit Ethernet capable ports	C	Slot 2 Fibre Channel ports 1 through 8
B	Slot 1, ports 1 through 20: 10-Gigabit Ethernet ports

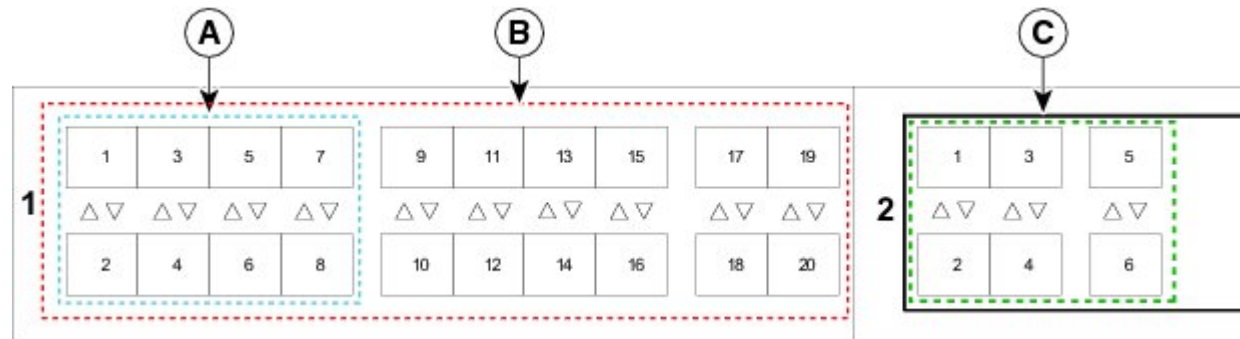
Figure 3: Cisco UCS 6120 Port Numbering when Configured with the N10-E0060 Expansion Module

A	Slot 1, ports 1 through 8: 10-Gigabit or 1 Gigabit Ethernet capable ports	C	Slot 2 Fibre Channel ports 1 through 6
B	Slot 1, ports 1 through 20: 10-Gigabit Ethernet ports

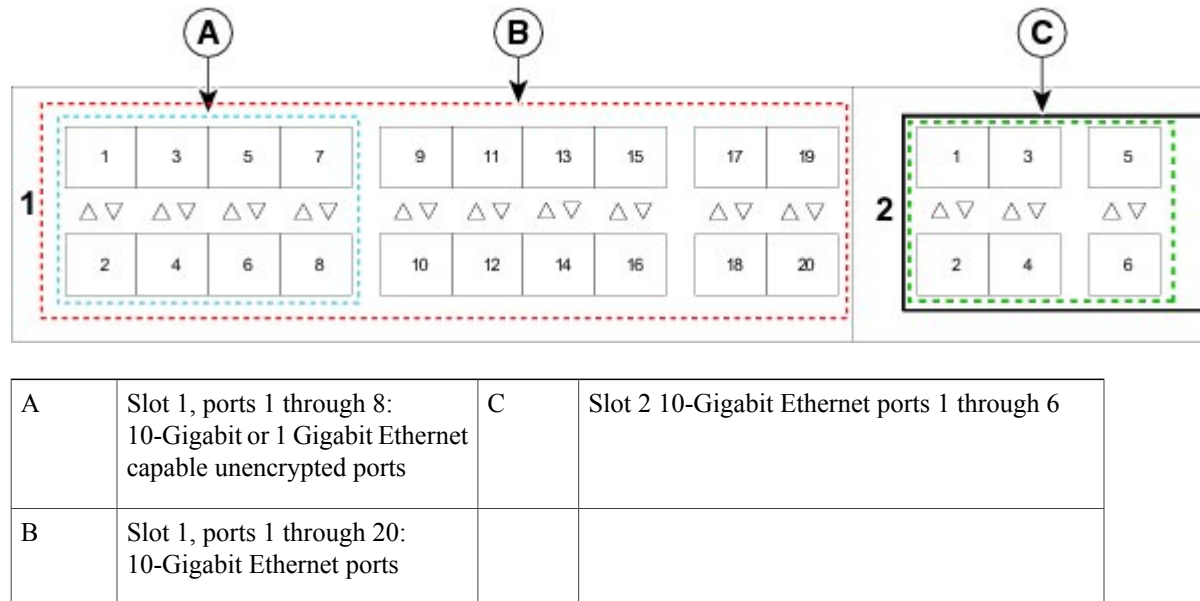
Figure 4: Cisco UCS 6120 Port Numbering when Configured with the N10-E0600 Expansion Module

- If you have an N10-E0600 Fibre channel expansion module in your UCS 6120, the existing Ethernet configurations can simply carry over to the UCS 6248, with ports 2/7 to 2/16 potentially configurable for either Ethernet or FC.

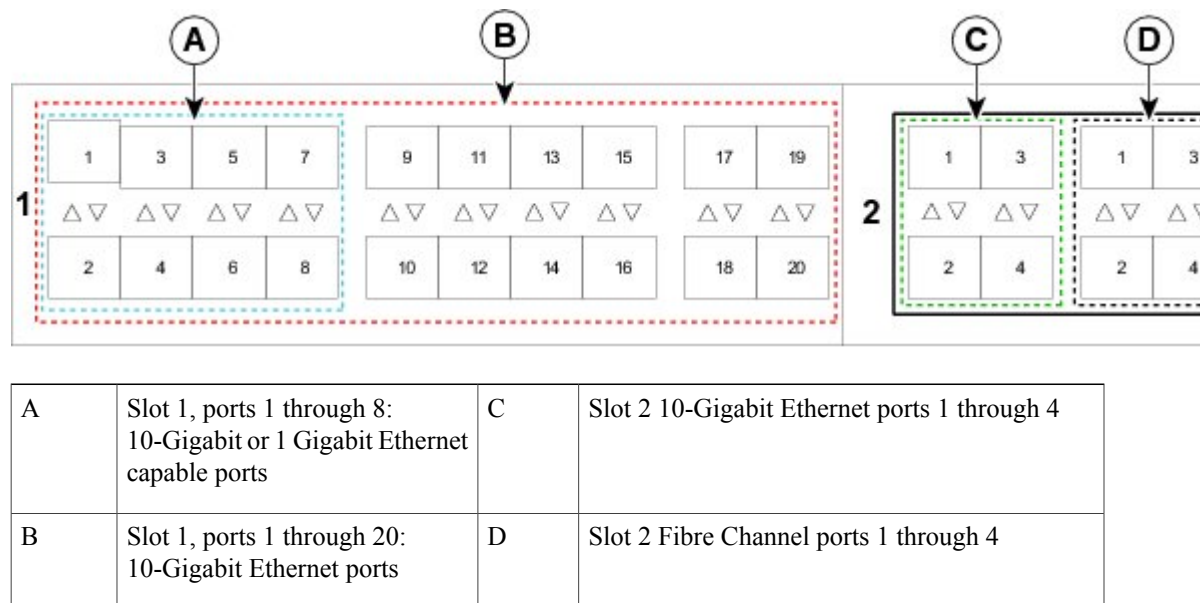
Figure 5: Cisco UCS 6120 Port Numbering when Configured with the N10-E0440 Expansion Module

- If you have an N10-E0440 expansion module in your UCS 6120, the simplest direct mapping would be to allow Ethernet ports 2/1 to 2/4 on the UCS 6248 to carry over, then remap the fibre channel ports to new port numbers on either slot 1 or slot 2.
