# CHAPTER 3

## Troubleshooting PRE Modules

This chapter describes how to troubleshoot Performance Routing Engine (PRE) modules. It provides information on troubleshooting PRE fault states, the management Ethernet port, and the serial port.

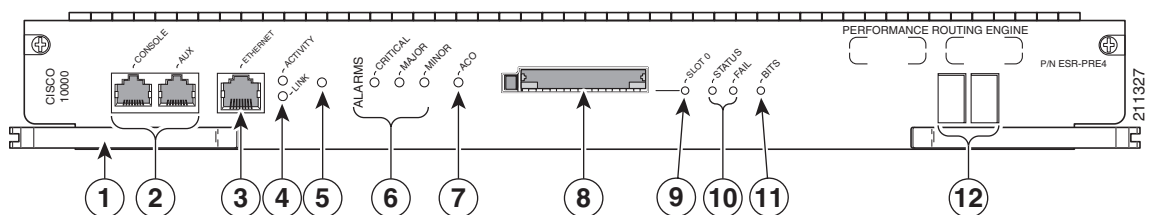
**Figure 3-2** Cisco PRE4 Faceplate

1	Ejector levers	7	ACO (Alarm Cut-Off button)
2	Console and Auxiliary ports	8	CompactFlash Disk slot
3	Network Management Ethernet (NME) port	9	Slot 0 (disk0) LED
4	NME Activity and Link LEDs	10	STATUS, FAIL LEDs
5	Reset button	11	Building Internal Timing Source (BITS) LED
6	Alarms: CRITICAL, MAJOR, MINOR LEDs	12	Alphanumeric display

Pressing the ACO button on the (primary) PRE during an alarm condition shuts off the external alarm, but does not deactivate the alarm LEDs on the PRE front panel. Alarm LEDs on the front panel are deactivated only after the condition that caused the alarm is corrected.

Table 3-2 describes the LEDs and buttons on the PRE front panel (see Figure 3-1 and Figure 3-2). The slot and some of the LEDs are specific to the PRE4 front panel.
